Annual Implementation Report (AIR)

Prepared by the National Marine Fisheries Service

Summary Report for the Shasta River Template Safe Harbor Agreement Implementation in 2021

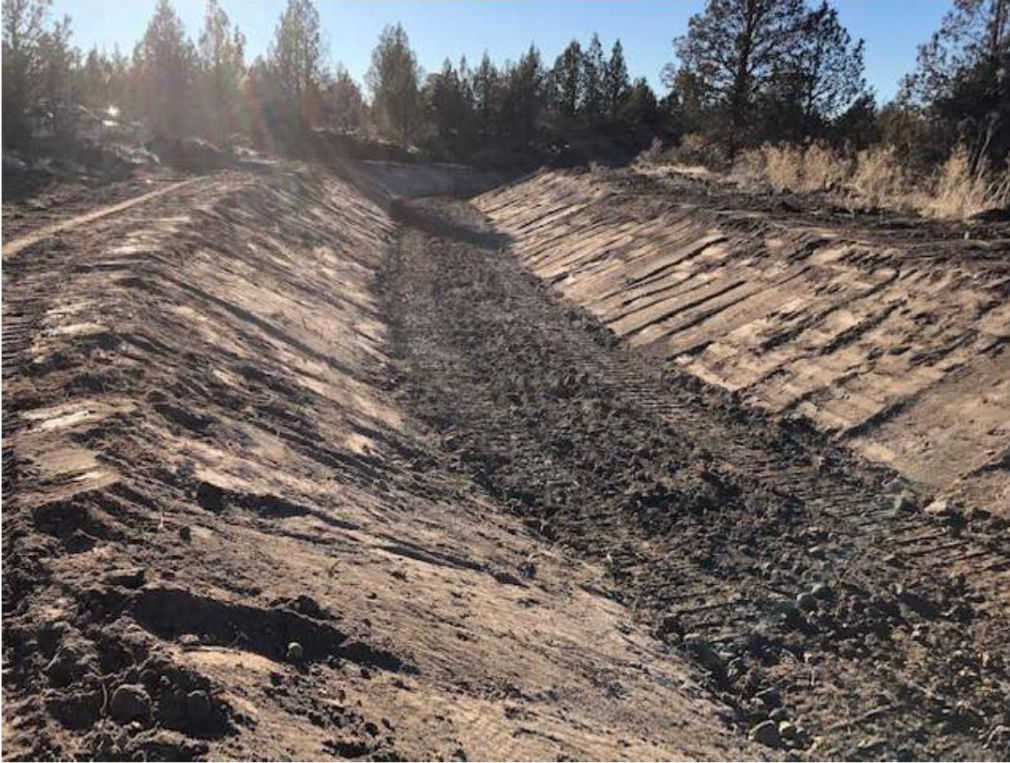
MWCD-Main Canal Lining 2020/2021

Canal reach being prepared to receive geo-membrane liner

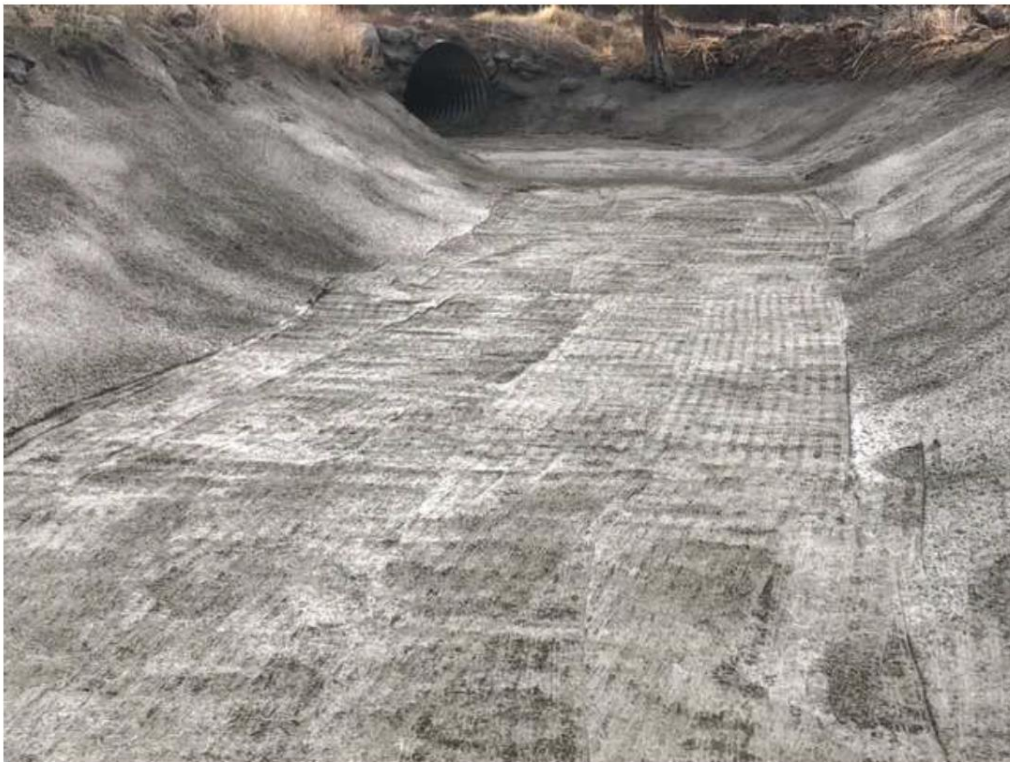
Main Canal lining at Hwy A-12 culvert crossing

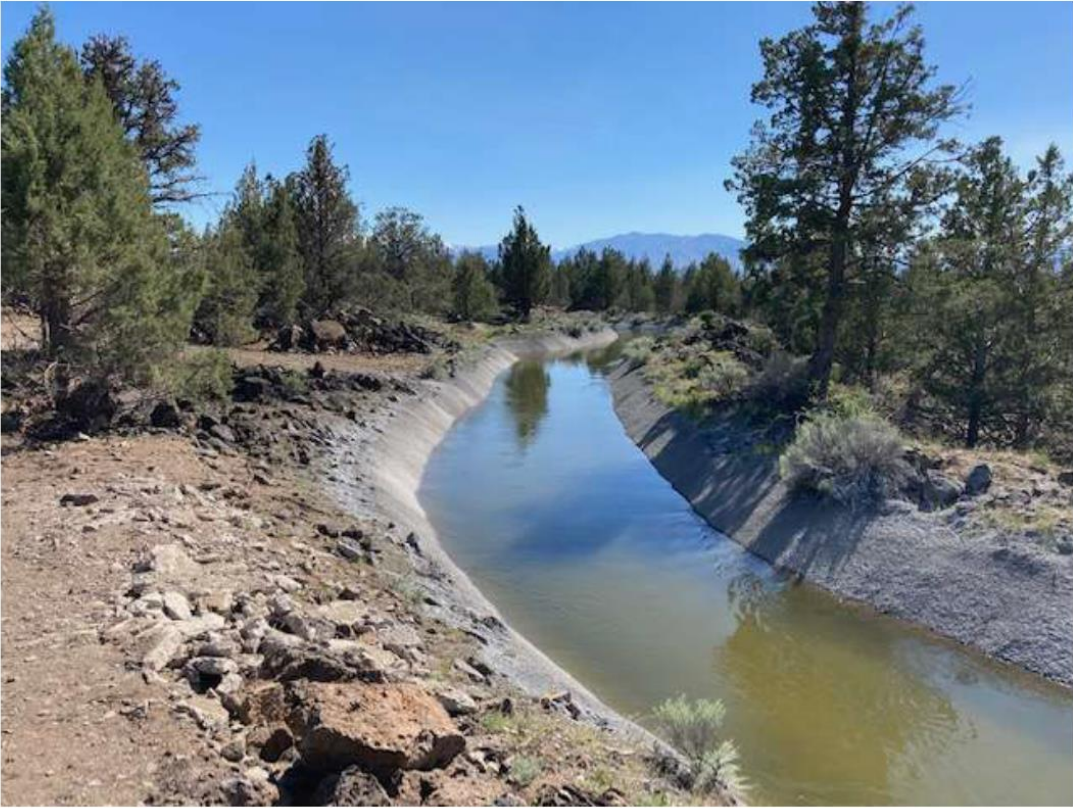
Reach of recently lined canal during spring of 2021

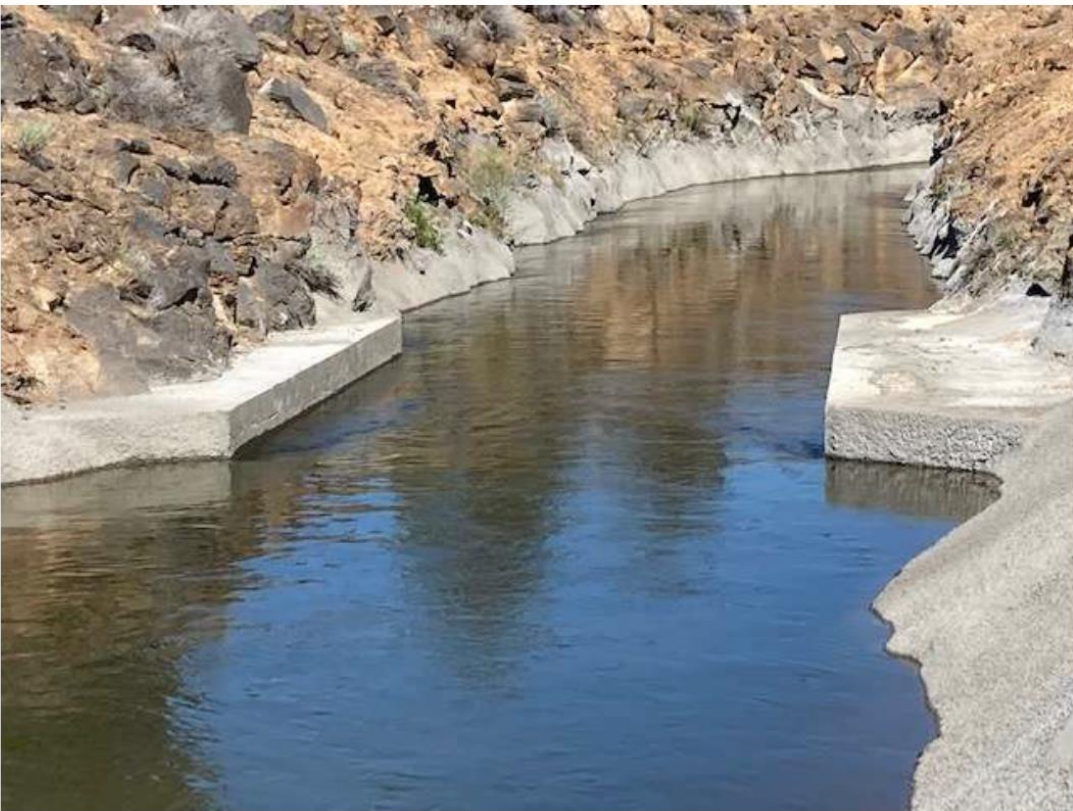
Flow Measuring Site within recently constructed reach

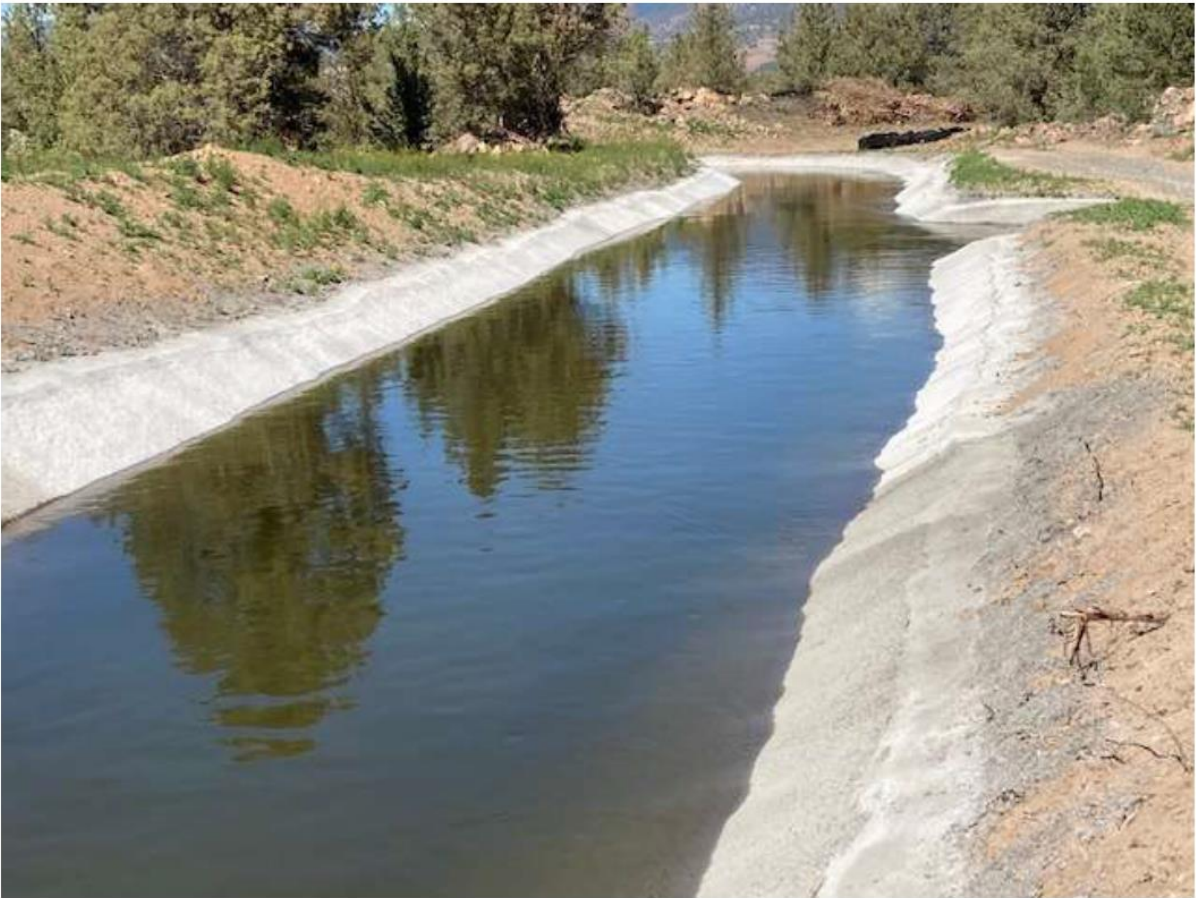
Looking downstream at canal lining reach completed in spring 2021.

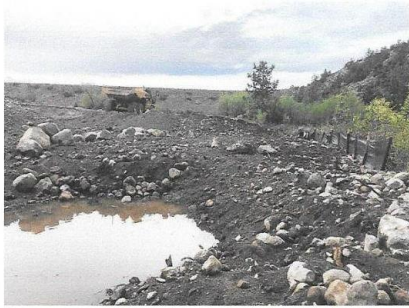
Above: Excavation and grading of upper end of site

Below: Installation and backfill of water source pipes

-MWCD completed the construction of a dedicated cold water habitat at the base of Dwinnell Dam to accept 5.5 cfs of cold groundwater. Maintaining water temperatures leaving MWCD property close to or below 18 degrees C.

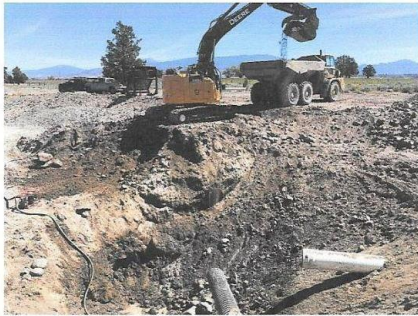
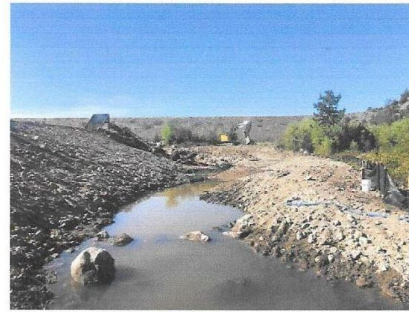
Above: Final grading of channel

Below: Loading the channel with wood and structures

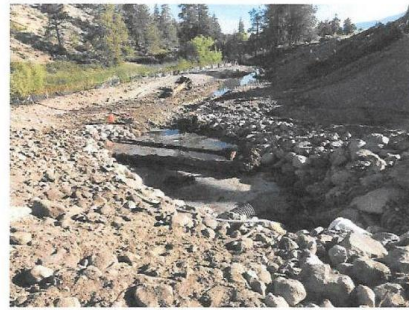
Above: Introduction of flow into channel after cuttings and irrigation are installed

Below: Habitat during the fall of 2020 showing wetland and riparian growth.

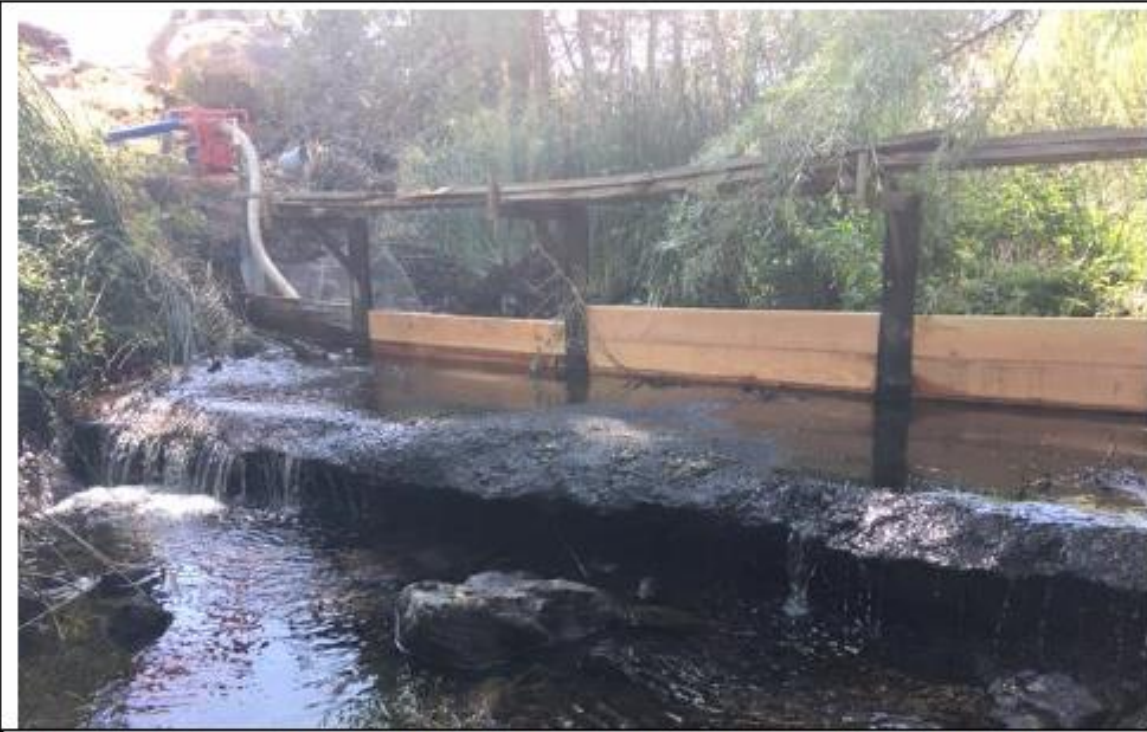
Photo Point 2- Pre project condition just downstream of the concrete sill and barrier looking south

- The fish barrier at Seldom Seen diversion was eliminated by constructing a roughened channel

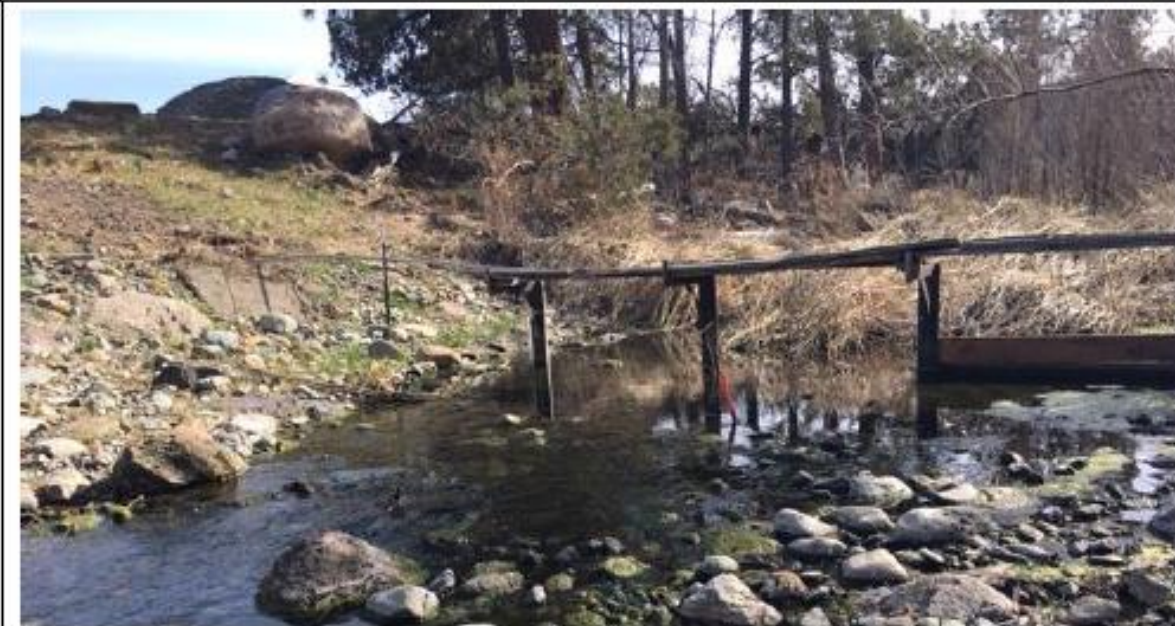
Photo Point 2- Post project conditions just downstream of concrete sill. Roughened channel backwaters the structure.

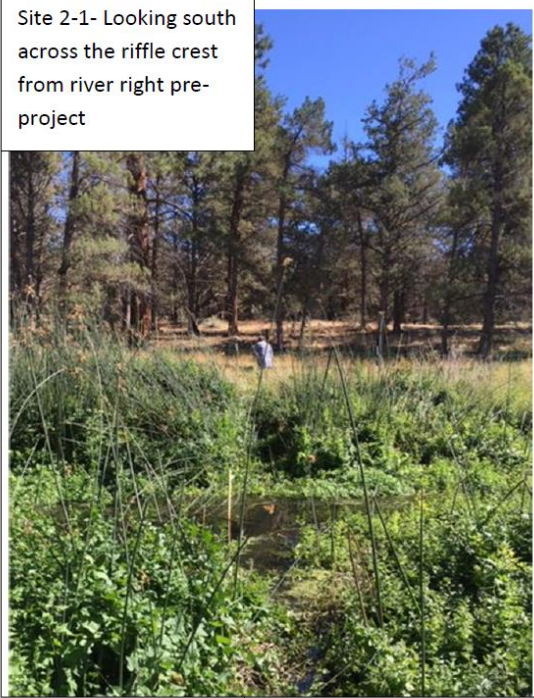
Site 2-1- Looking south across the riffle crest from river right pre-project

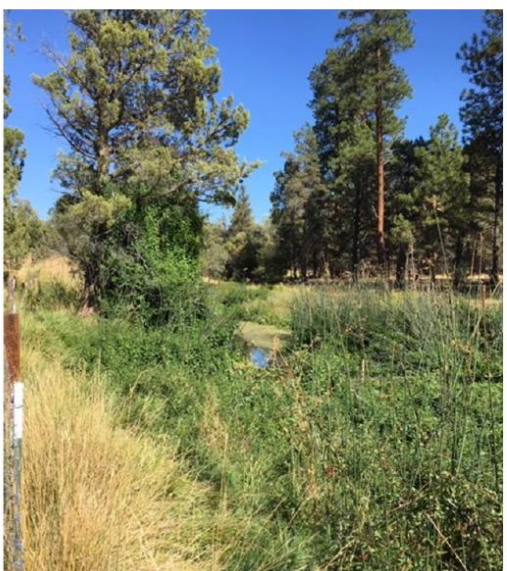
Site 2-1- Looking upstream at riffle site from river right

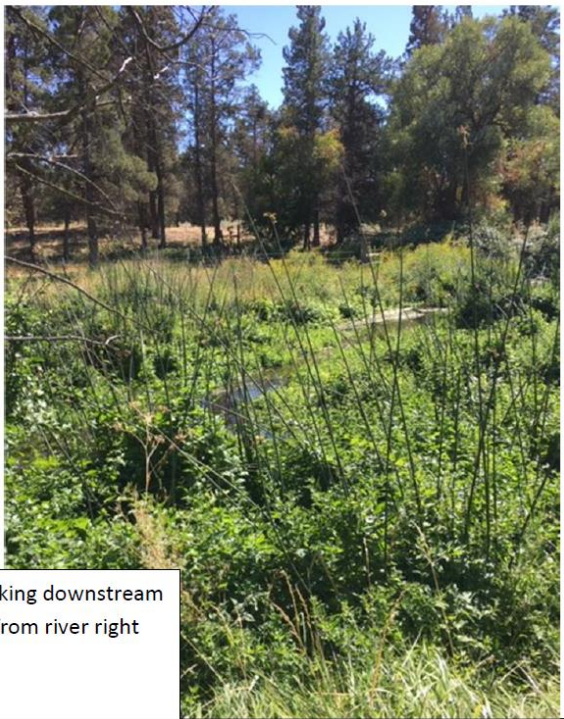
Site 2-1- Looking downstream at riffle site from river right

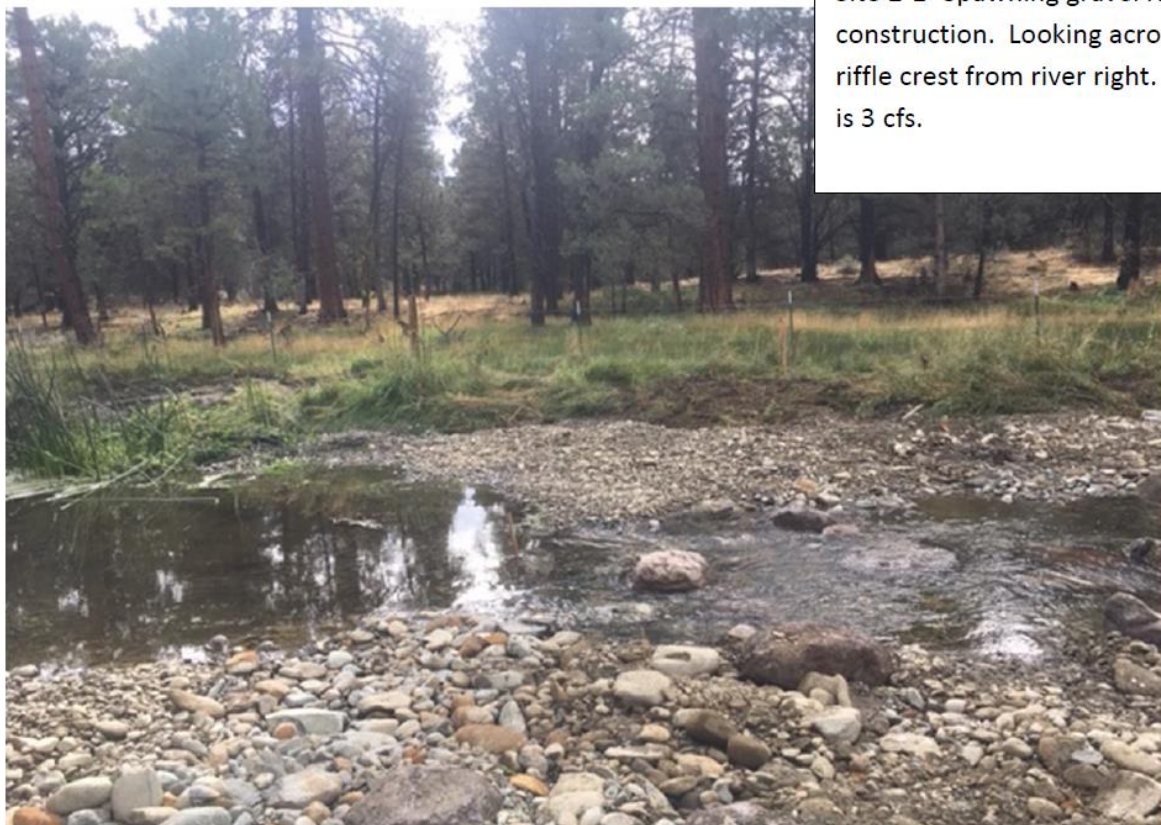
Site 2-1- Spawning gravel riffle construction. Looking across riffle crest from river right. Flow is 3 cfs.

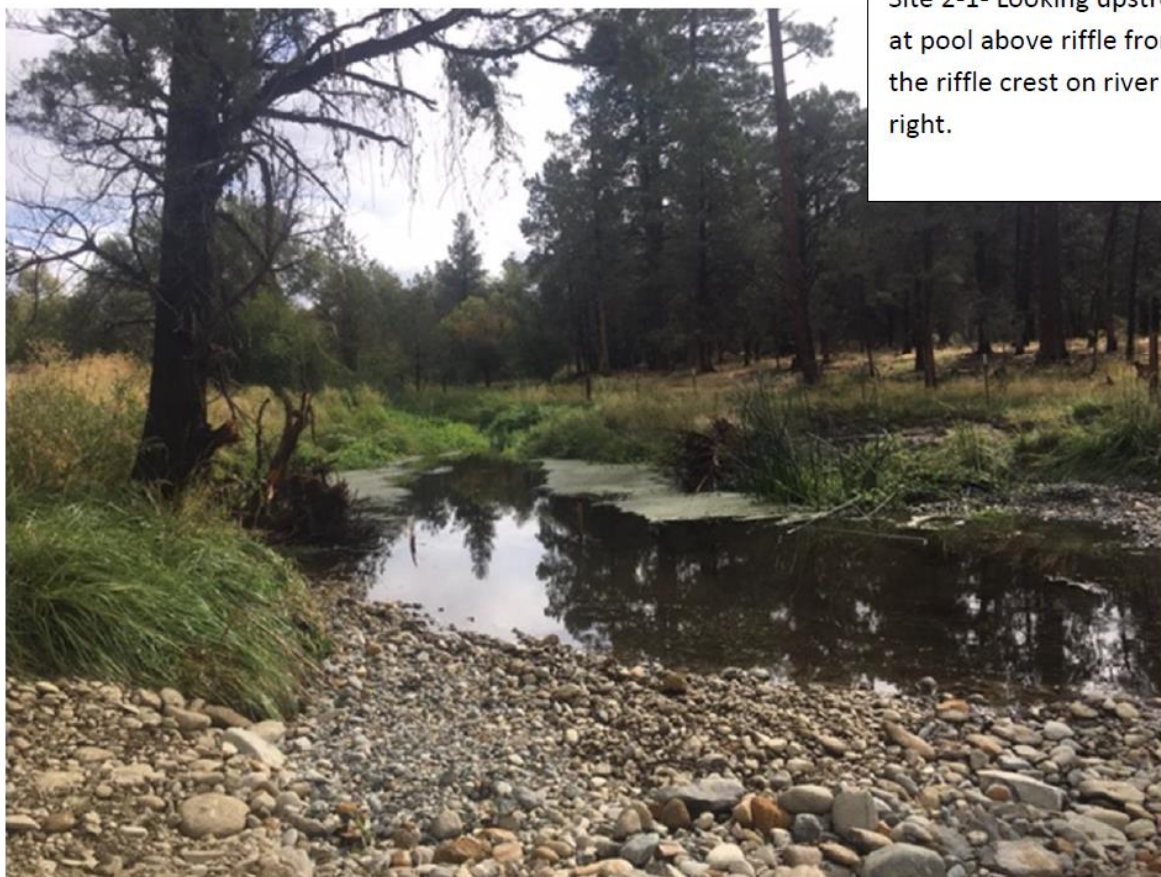
Site 2-1- Looking upstream at pool above riffle from the riffle crest on river right.

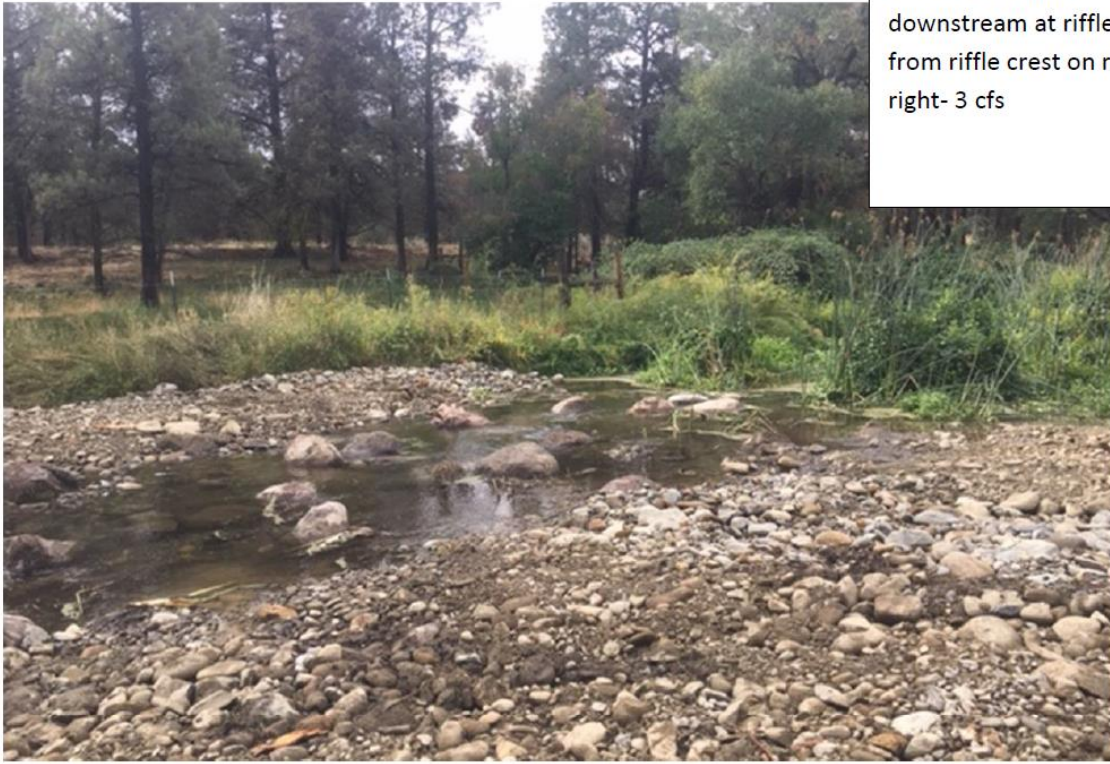
Site 2-1- Looking downstream at riffle from riffle crest on river right- 3 cfs

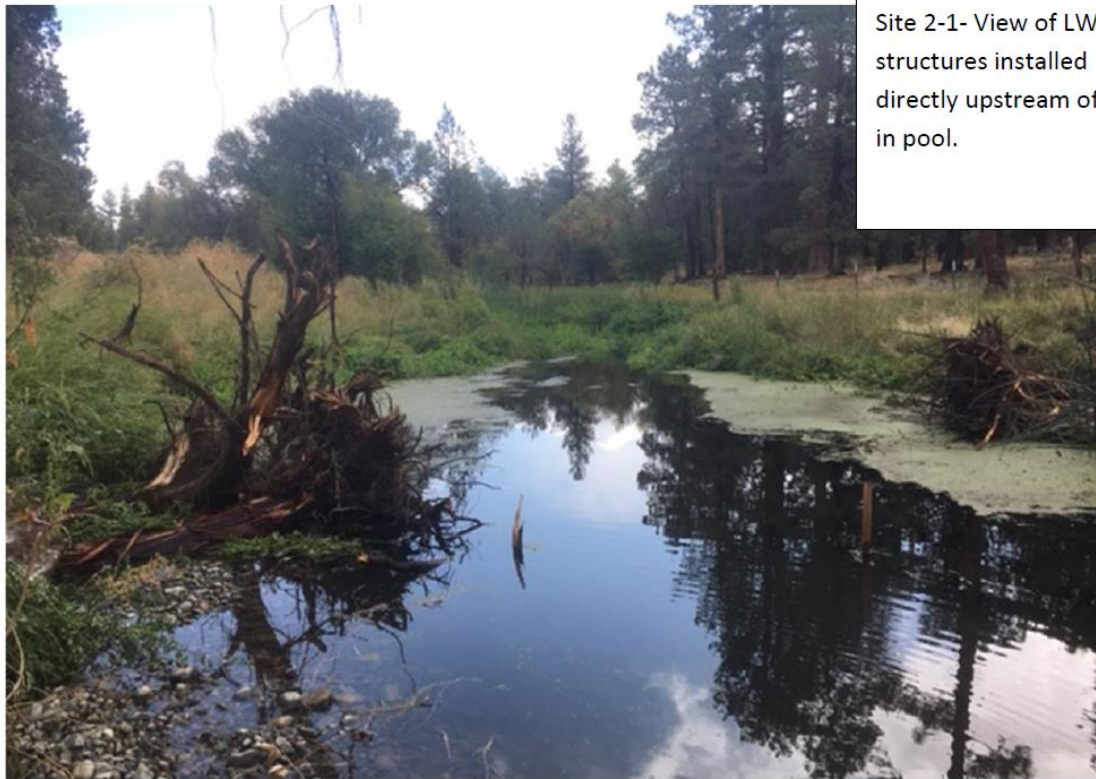
Site 2-1- View of LWD structures installed directly upstream of riffle in pool.

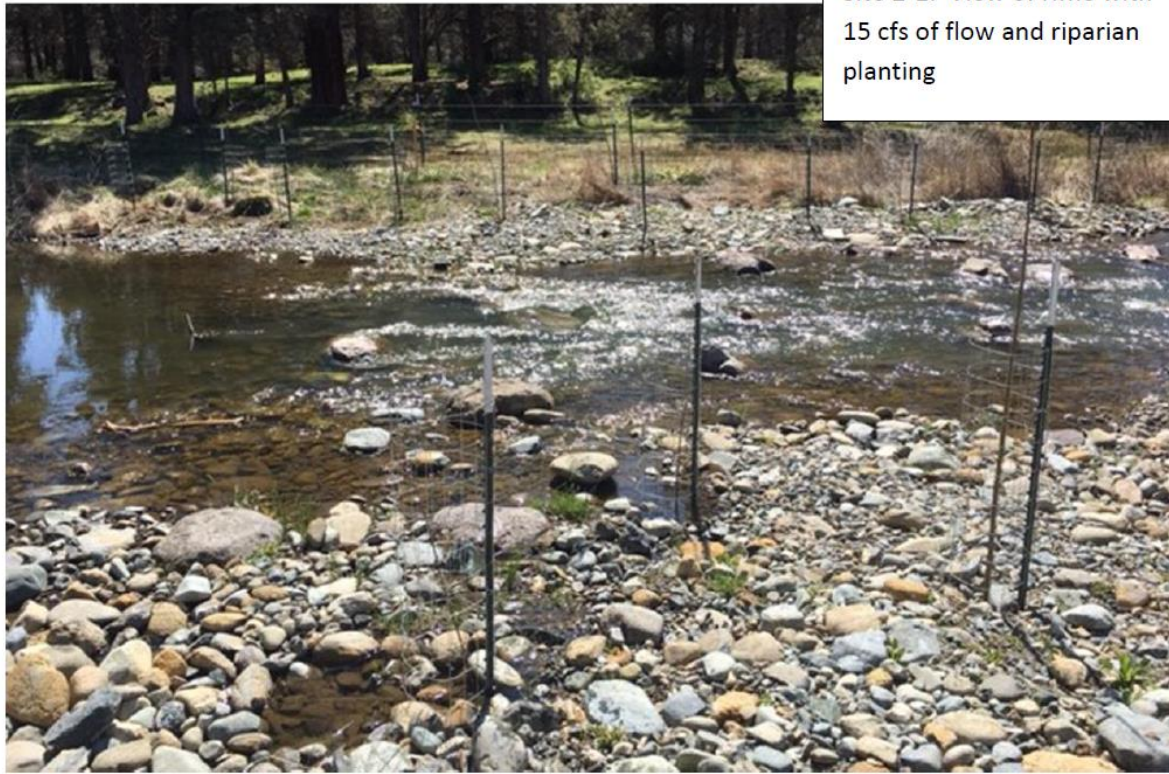
Site 2-1: View of riffle with 15 cfs of flow and riparian planting

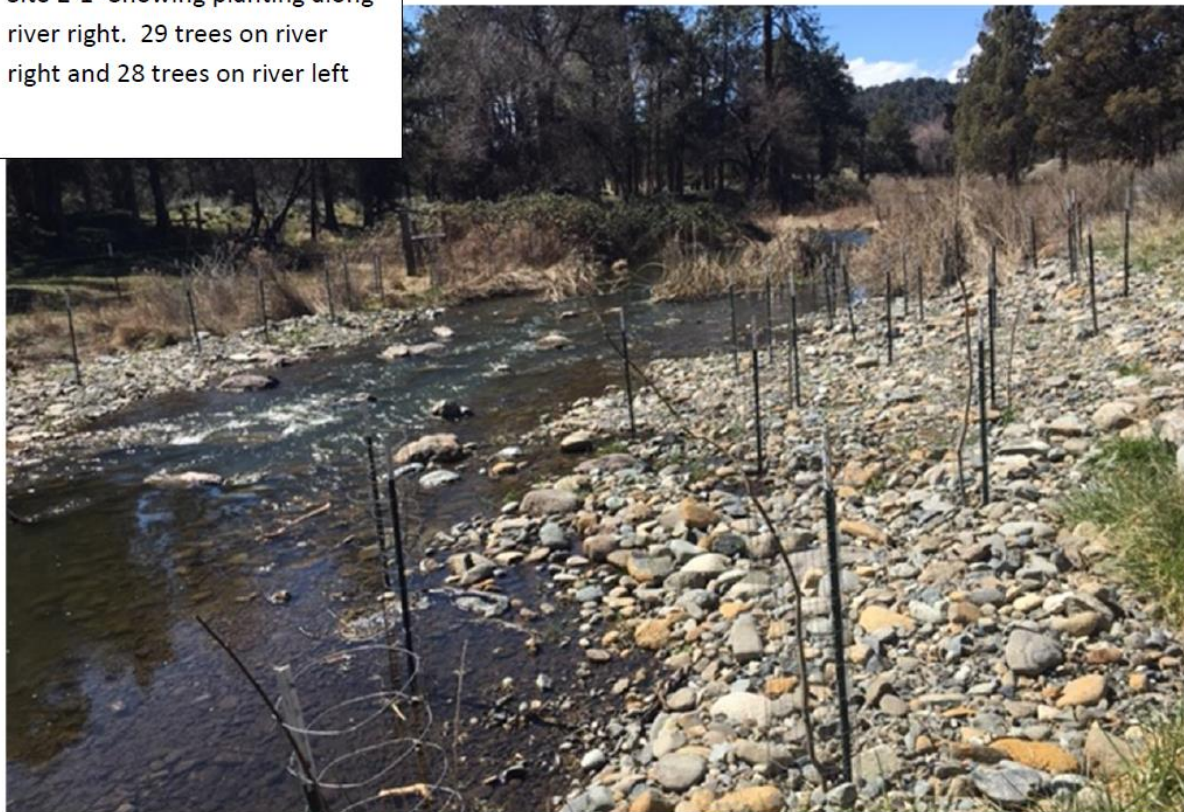
Site 2-1- Showing planting along river right. 29 trees on river right and 28 trees on river left

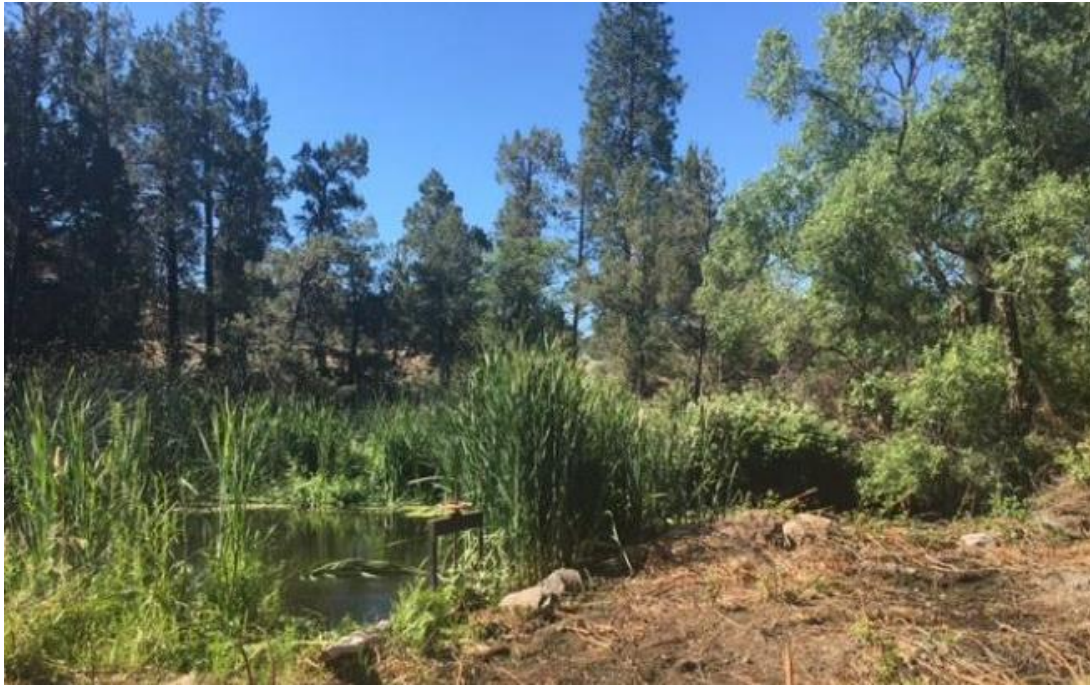
Looking downstream above HVR head gate- Fish Screen is down ditch

-Hidden Valley Ranch's fish screen was relocated onto the Shasta River and efficiency improvements were made to keep more water instream. The project included real-time monitoring station equipment to record prior right use, spring water use and release to the river.

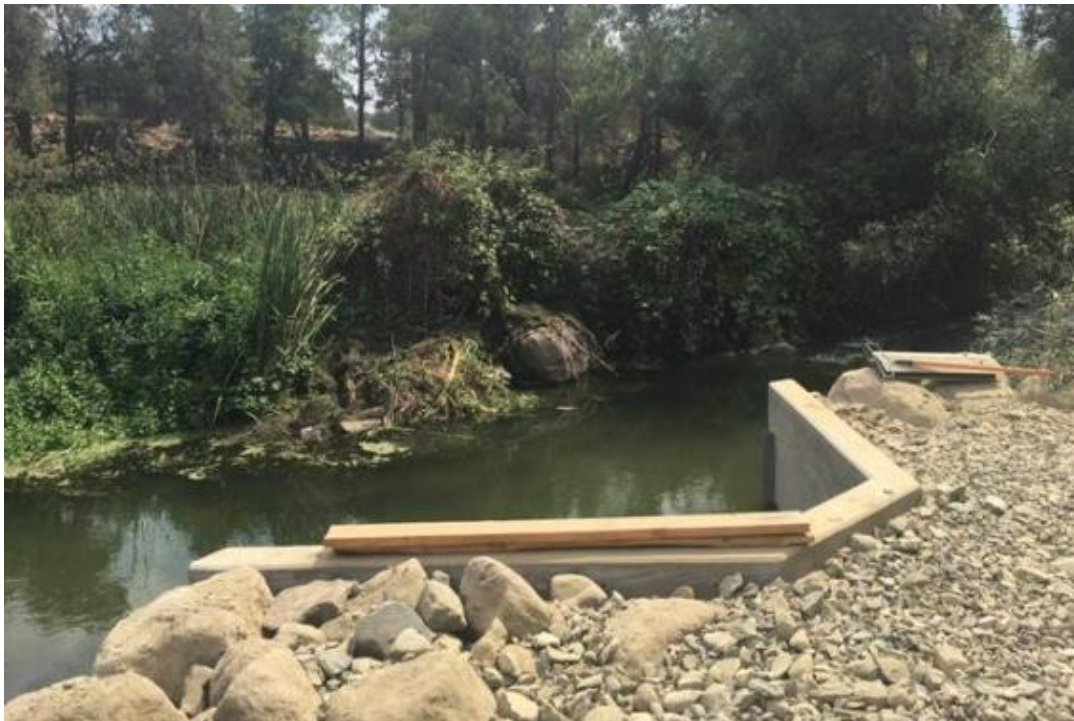
Looking downstream above HVR new on-channel fish screen

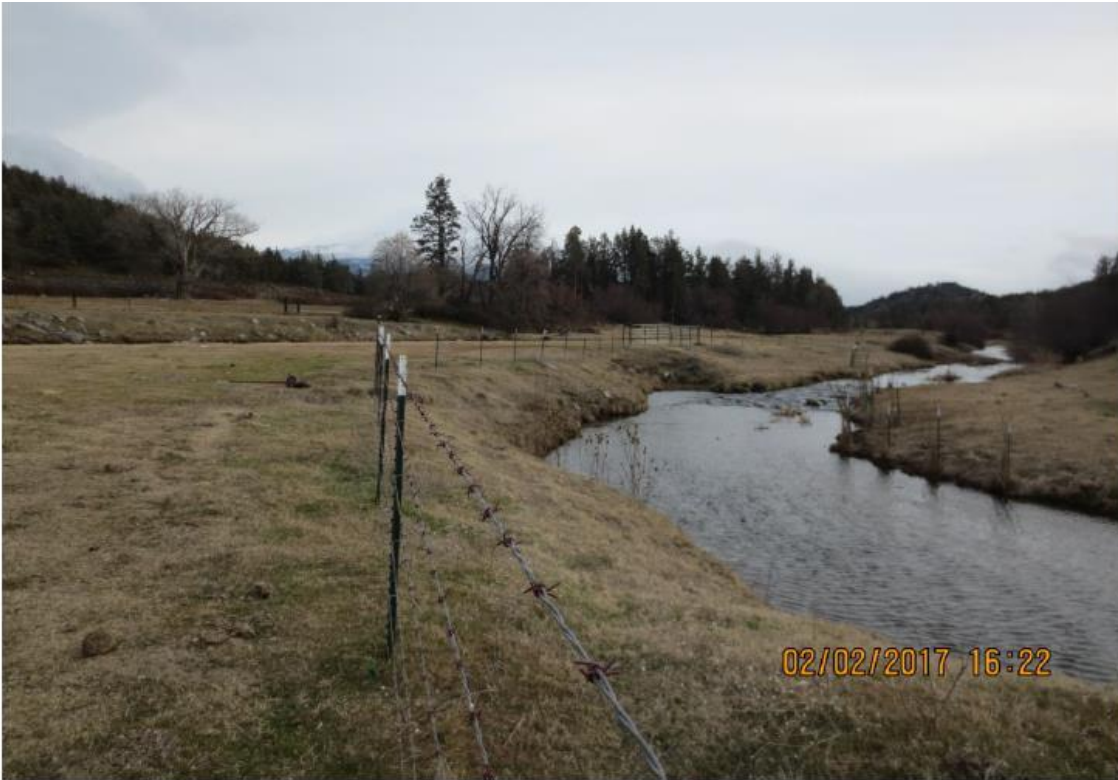
Pre construction HV4D_Pre_2.2.17

-Hidden Valley Ranch installed a pipeline connecting an upgradient spring to the Shasta River to enable cold water to be released to the river when available.

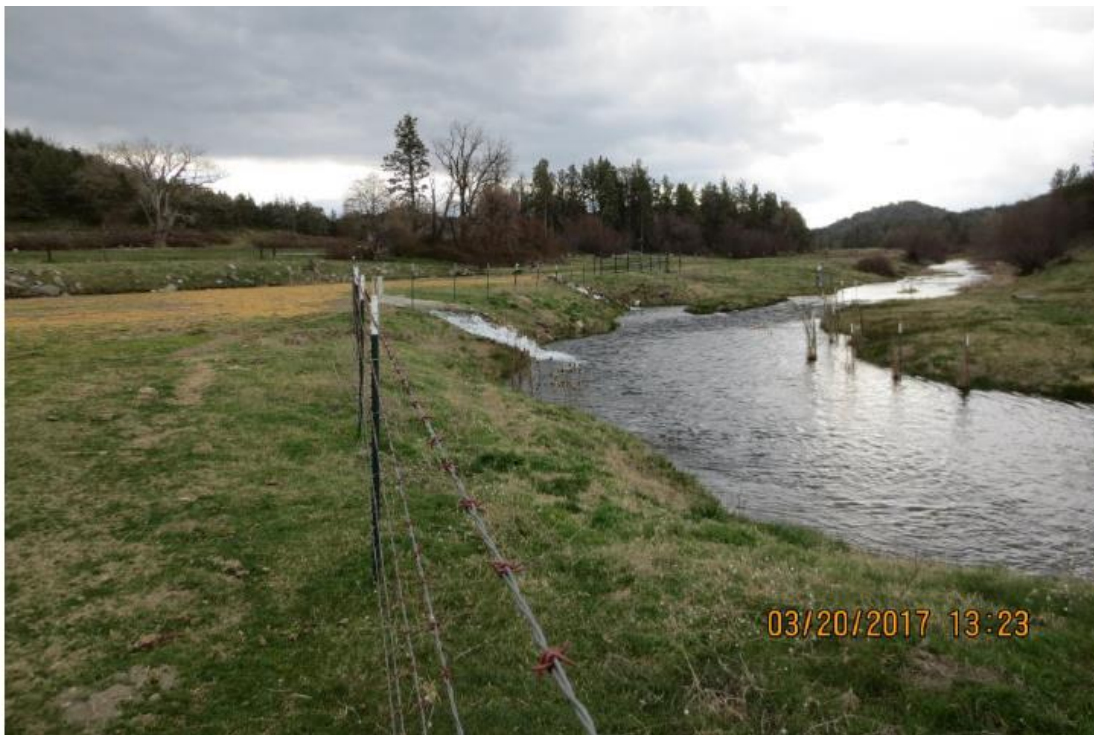
Post construction HV4D_PC_3.20.17

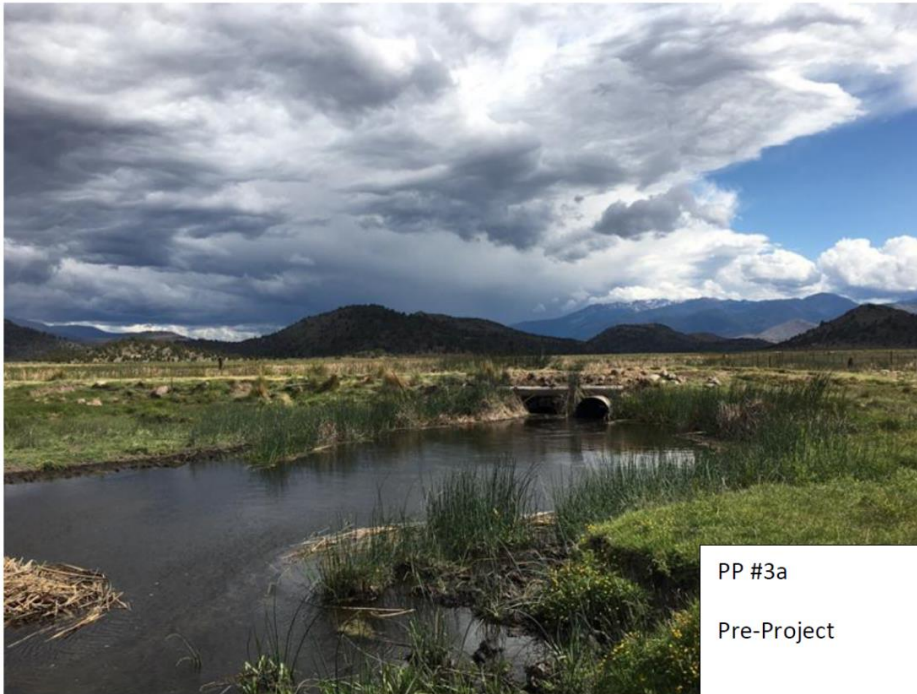
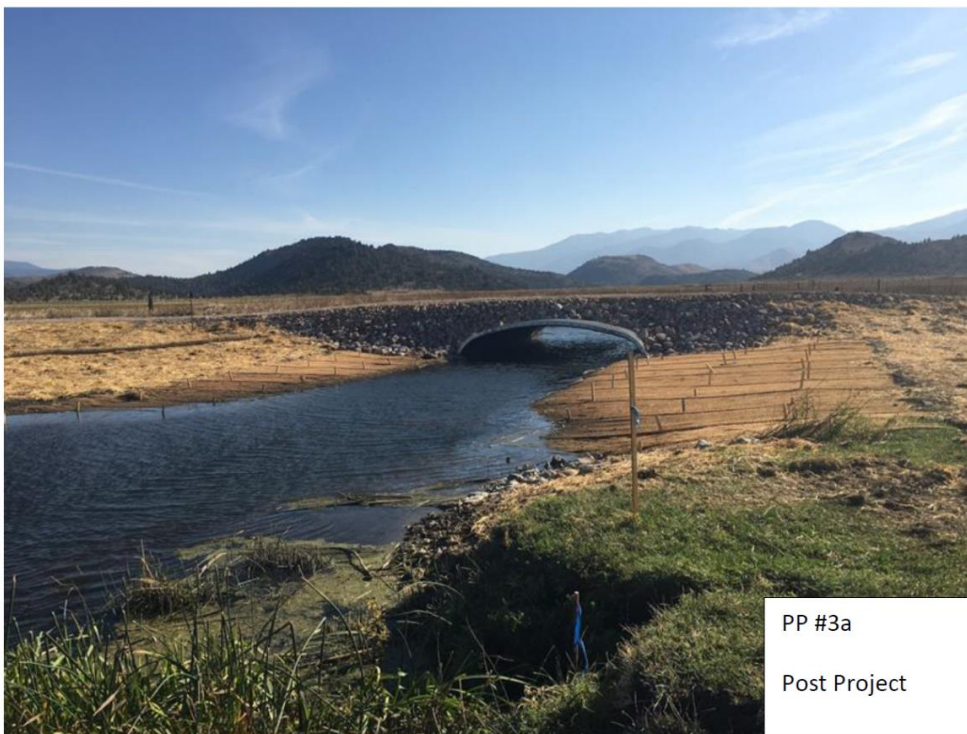
Parks Creek Fish Passage Component

The fish barrier on lower parks on the Hole in the Ground Ranch was removed in 2021 and replaced with a fish friendly culvert.

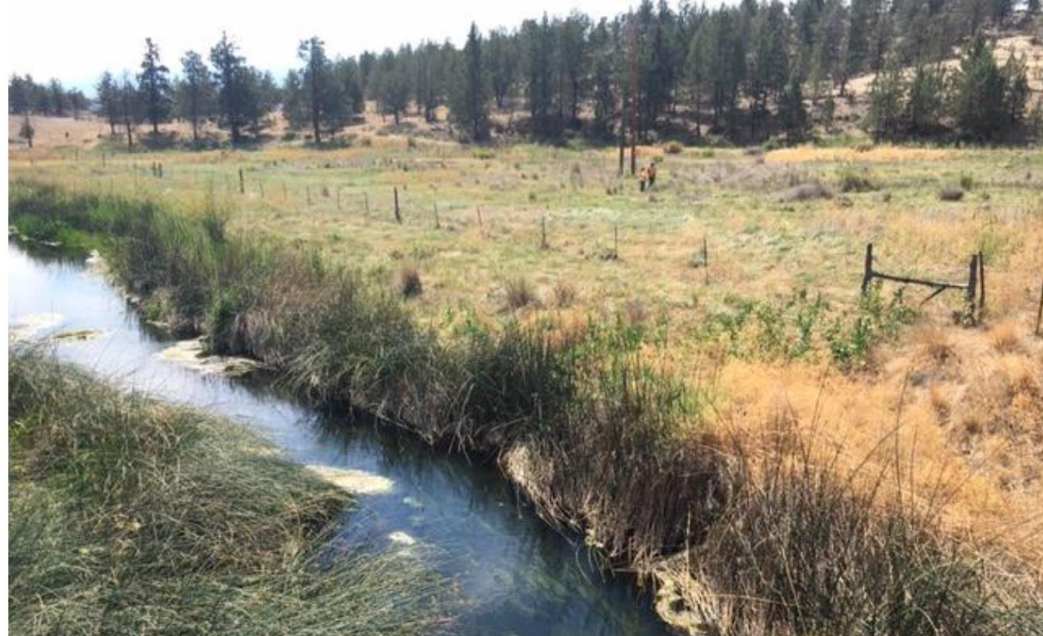
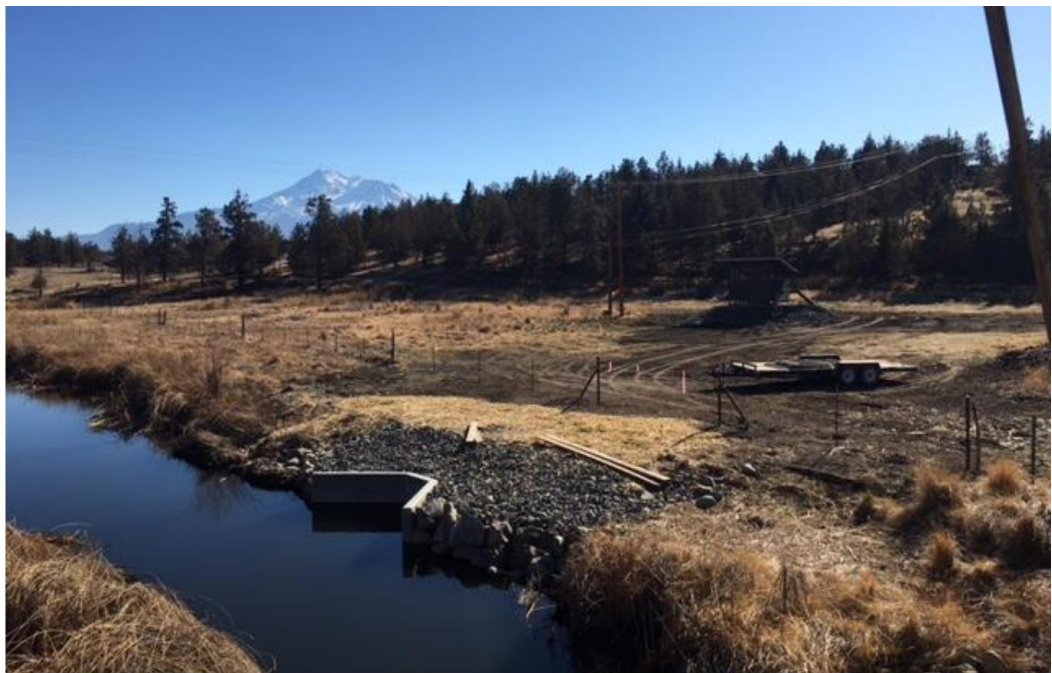
Shasta River- upstream of Louie Road bridge- Pre-project August 2020

Fish Screen completed. Fencing and testing of the system to complete the phase.

- The Cardoza point of diversion was moved 3 miles downstream to the Shasta River, enhancing flows in lower Parks Creek and eliminating the fish passage barrier. A new pump station and more than 3 miles of efficiency pipeline was installed to effectively conserve 435 acre-feet during the 2021 irrigation season.

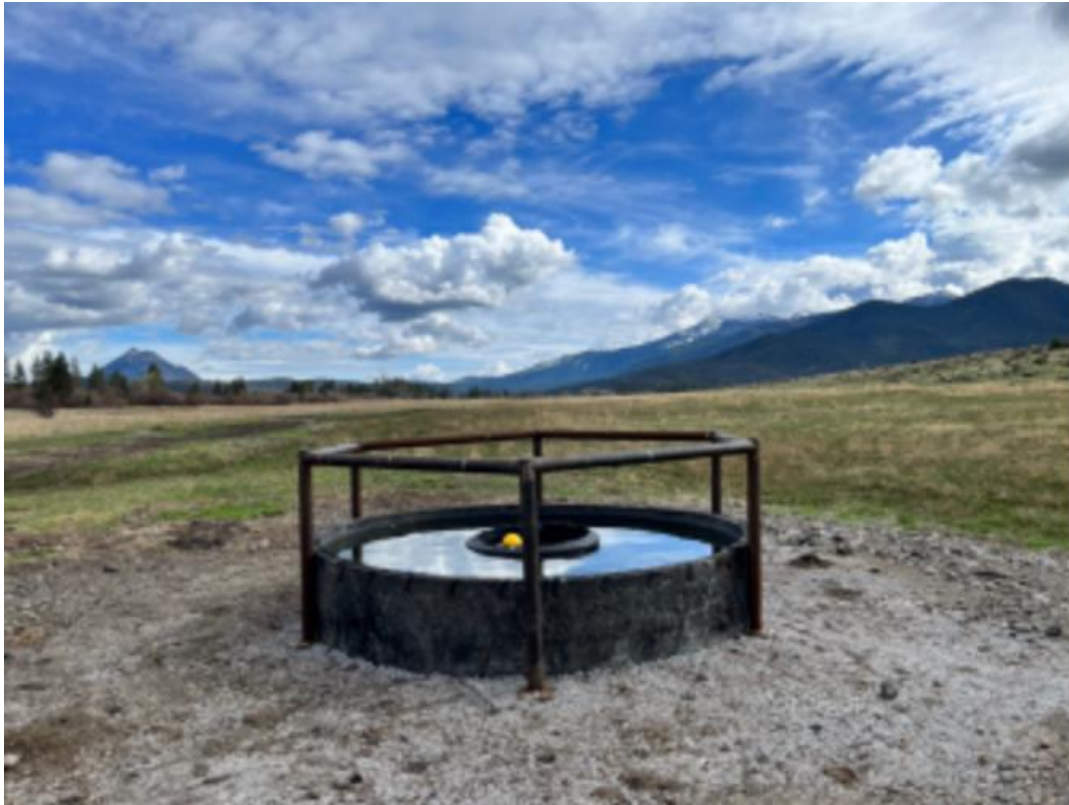
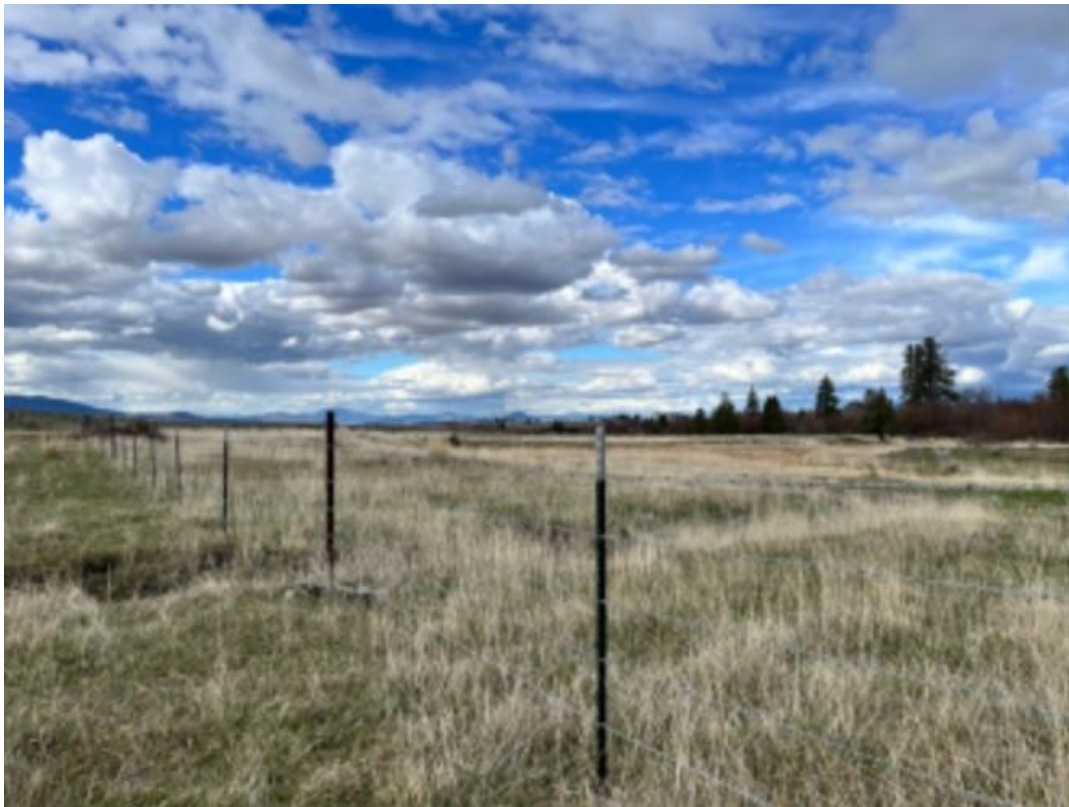
-Park Creek Ranch constructed over 20,000 feet of riparian exclusion fencing, completing Reach 2, 3, 4, and 5 of the upper Parks Creek. Over 17,000 feet of water line was installed to supply stock water to 6 different troughs in pastures now excluded from parks creek.

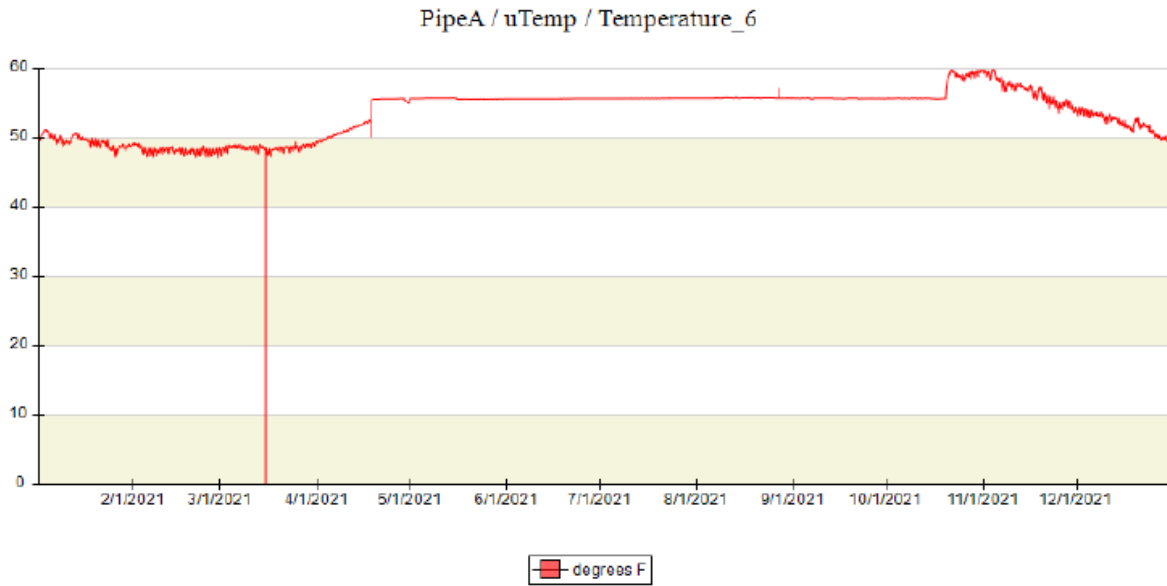
Flying L Temperatures-Note: Some of this data is ambient temperature when the pump was not running. Groundwater is a constant 55 degrees F (12.7 degrees C)
