Annual Implementation Report (AIR)

Prepared by the National Marine Fisheries Service

Summary Report for the Shasta River Template Safe Harbor Agreement Implementation in 2021

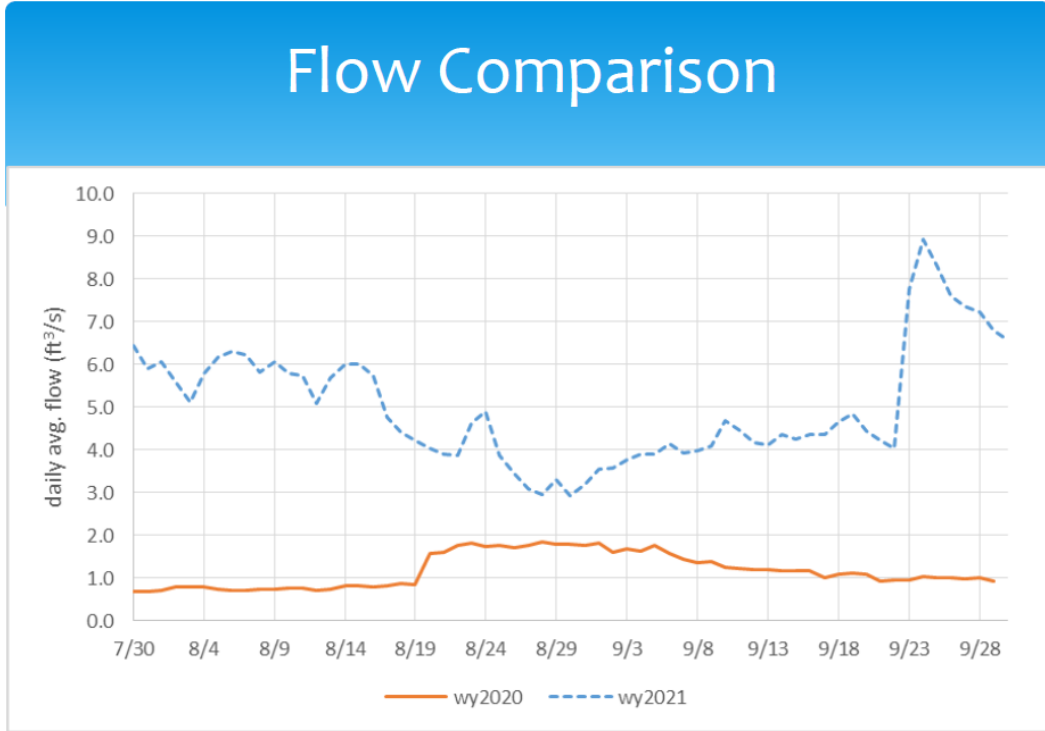
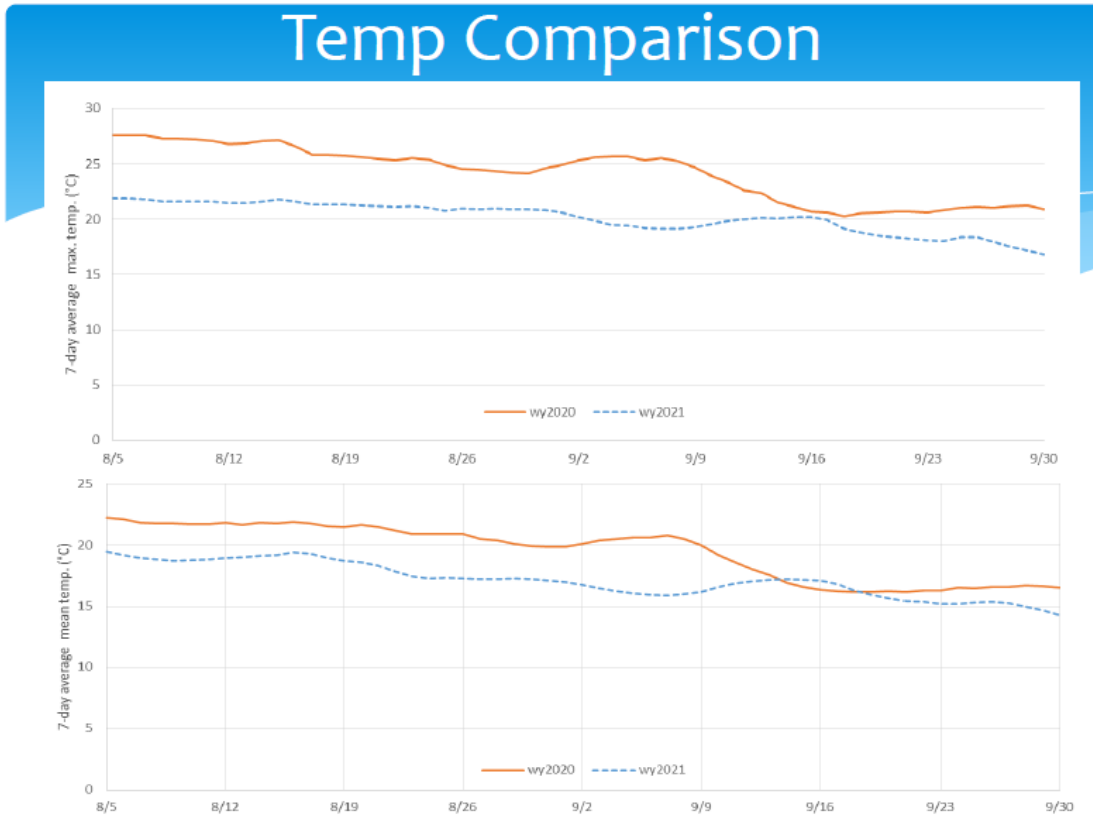
Data Comparison at PBS Before (WY2020) and After (WY2021) the Cardoza POD was moved (graphs prepared by UCD):
