EXPERIMENTAL MODELING OF LARGE WHALE ENTANGLEMENT INJURIES

ABSTRACT

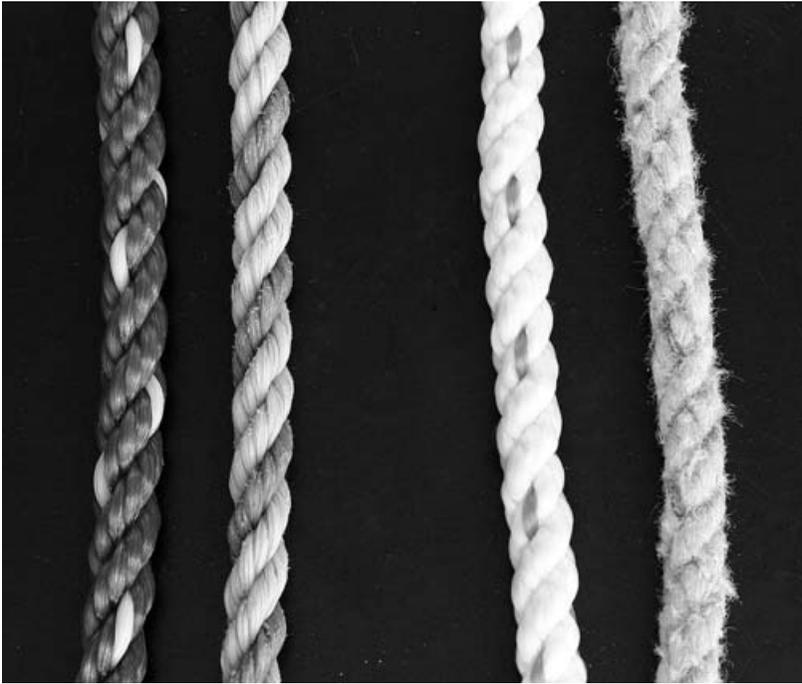
Figure 2. Rope samples, 9.5 mm in diameter, used during comparative line tests. From left to right: new float line, old float line, new sink line, old sink line. Old samples contain visibly fraying fibers.

Abrasive tests were conducted using 9.5-mm diameter line commonly used in commercial fixed gear fisheries in Maine¹ and Massachusetts (McKirenan *et al.* 2002). Both polypropylene float and polypropylene/polyester blend sink lines were tested, including new and used samples of each type of rope (Fig. 2). Rope samples designated as “old” were obtained from a local lobster fishery (Southwest Lobster and Fish Unlimited, Southwest Harbor, ME). Old lines had been previously used for lobstering and contained ingrained mud and fraying rope fibers. All samples were of a three-strand twisted construction.

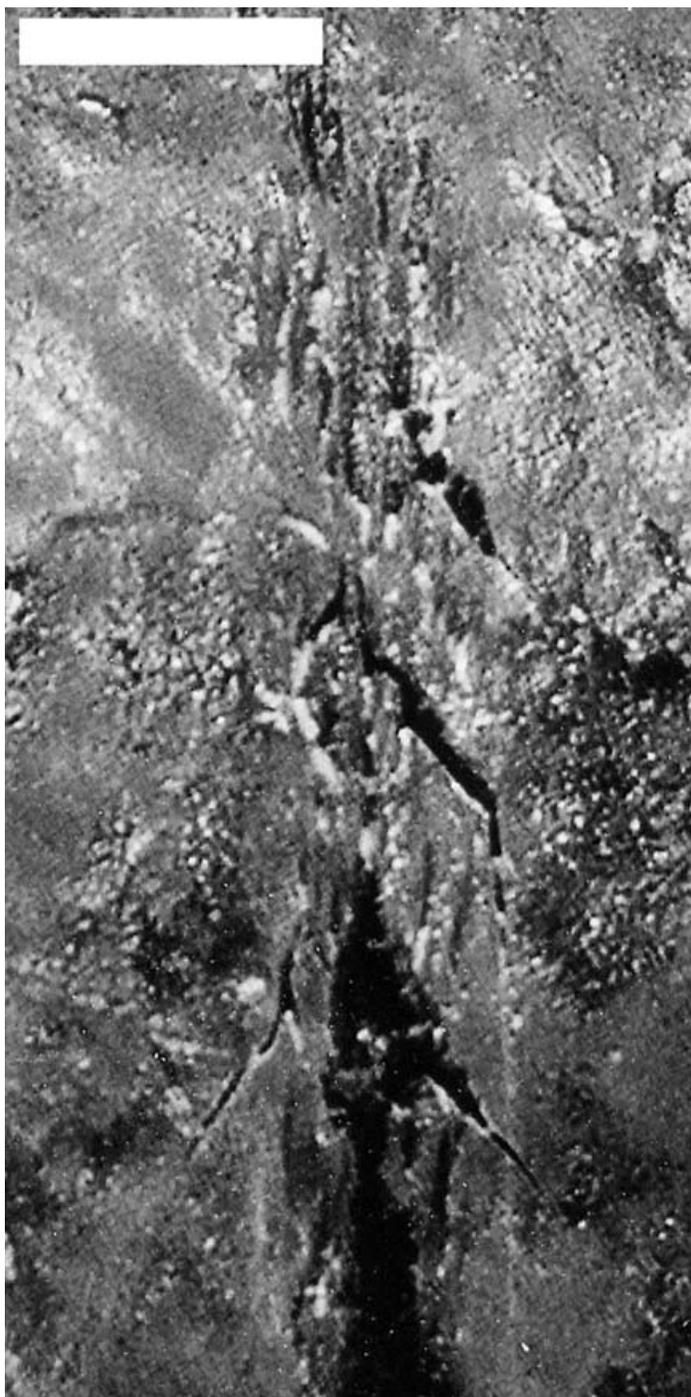
Figure 4. Mini-cuts found in compression furrow produced by 9.5-mm old float line during a 1-h test using a 4.5-kg dead weight and loading rate of 60 cycles/min. Scale bar represents 1 cm.
