**San Francisco – Oakland Bay Bridge
East Span Seismic Safety Project**

MARINE MAMMAL MONITORING ANNUAL REPORT

JANUARY 8, 2013 –JANUARY 7, 2014

**(In accordance with the Incidental Harassment
Authorization issued January 7, 2013)**

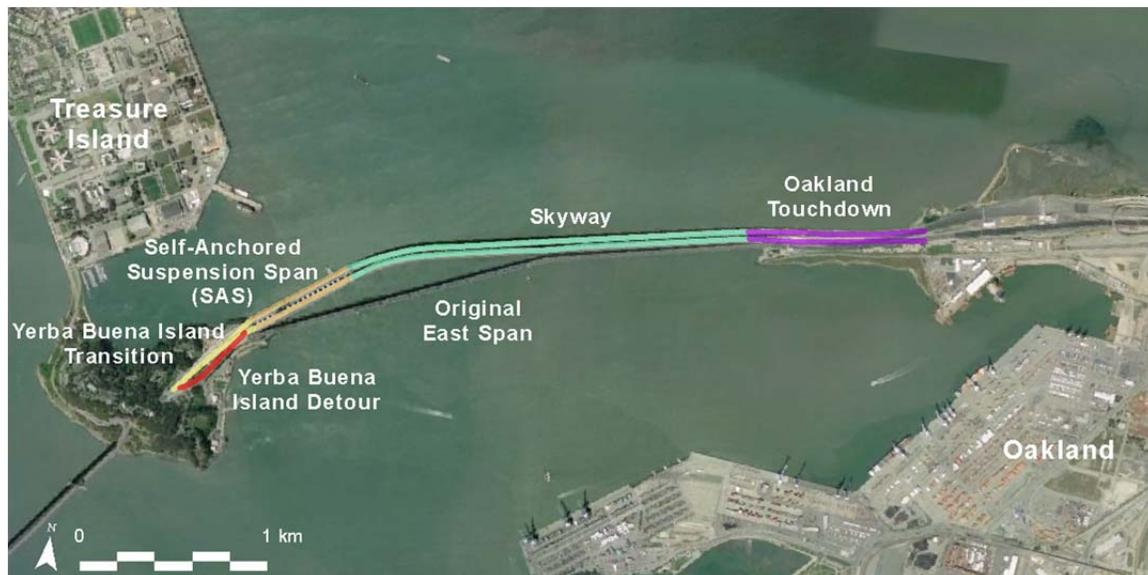
Figure 2. Sections of the Original East Span for Removal.

Dismantling of the original bridge has five components (see Figure 2):

- Yerba Buena Island Detour
- Cantilever Truss (Pier E1-E4)
- 504-Foot Span Steel Trusses (Piers E4-E9)
- 288-Foot Span Steel Trusses (Piers E9-E23)
- Marine Foundations

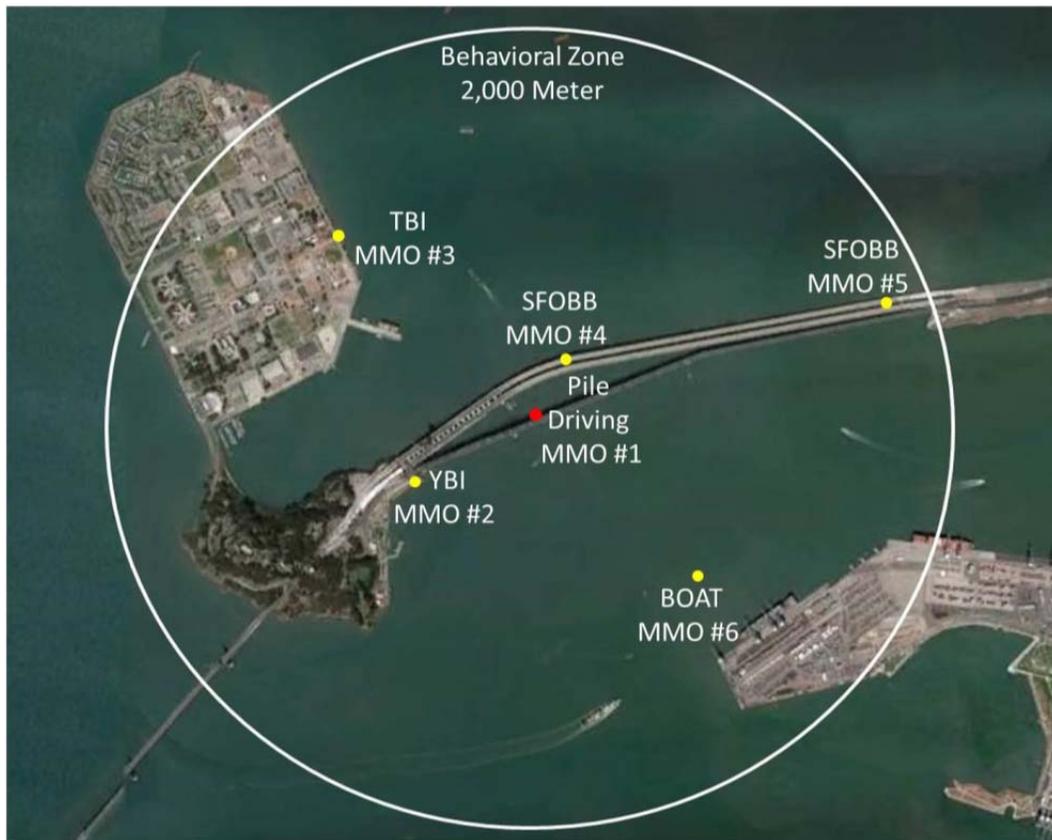
Figure 4. YBITS2 Falsework Test Pile Project Area with 2,000-meter (6,562-foot) (120 dB vibratory) Behavioral Harassment Zone.

The position of each Observer is shown in Figure 4. Because all pile driving that required monitoring was vibratory, there was no MMEZ and a Behavioral Zone of 2,000 meters (6,562 feet) was implemented for monitoring. Vibratory pile driving was conducted on two piles from 1107-1212 hours and 1416-1428 hours using the vibratory hammer. Observations were made from 0825 to 1500 hours.

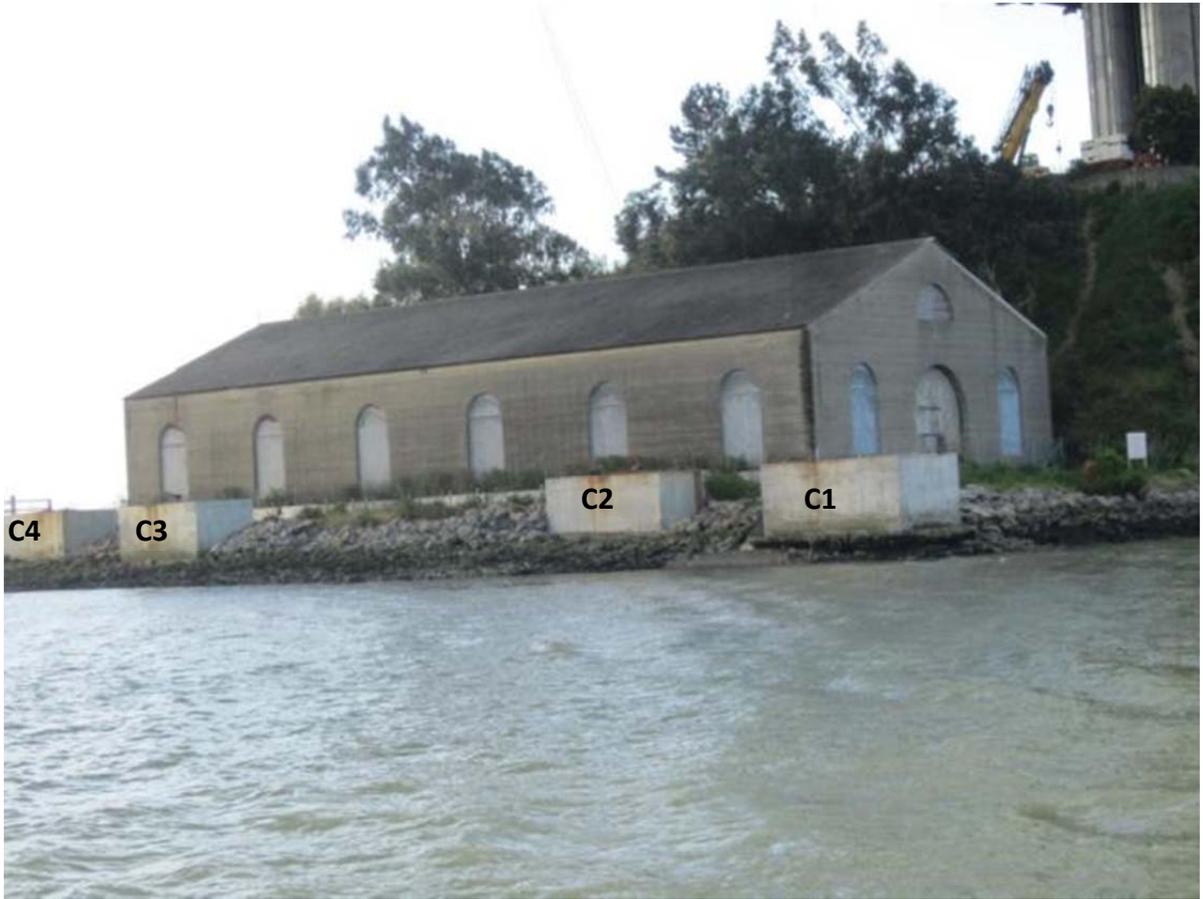
Figure 5. Temporary Tower C Foundations

As part of construction for the new east span, several temporary foundations were installed in order to support pieces of the bridge as they were installed. With the completion of the new east span, these foundations are no longer necessary and as such are being removed. The four Temporary Tower C foundations (C1, C2, C3 and C4) are located on YBI at the Bay shoreline interface (Figures 5 and 6). One of the foundations, C1 is located partially below the mean high water line (MHWL) and is subject to regular tidal action (Figure 5). The other three foundations are located on land above the mean high tide line and are subject to occasional tidal action.

The contractor utilized excavators located on crane mats placed to the east of each of the foundations. Excavators equipped with hydraulic hammers demolished the above surface portion of the foundation to just below the shoreline elevation. Following this, the rubble and steel reinforcement were removed and clean fill and rip rap were placed on top of the dismantled foundation footprint to bring the area back to preconstruction elevation and slope.

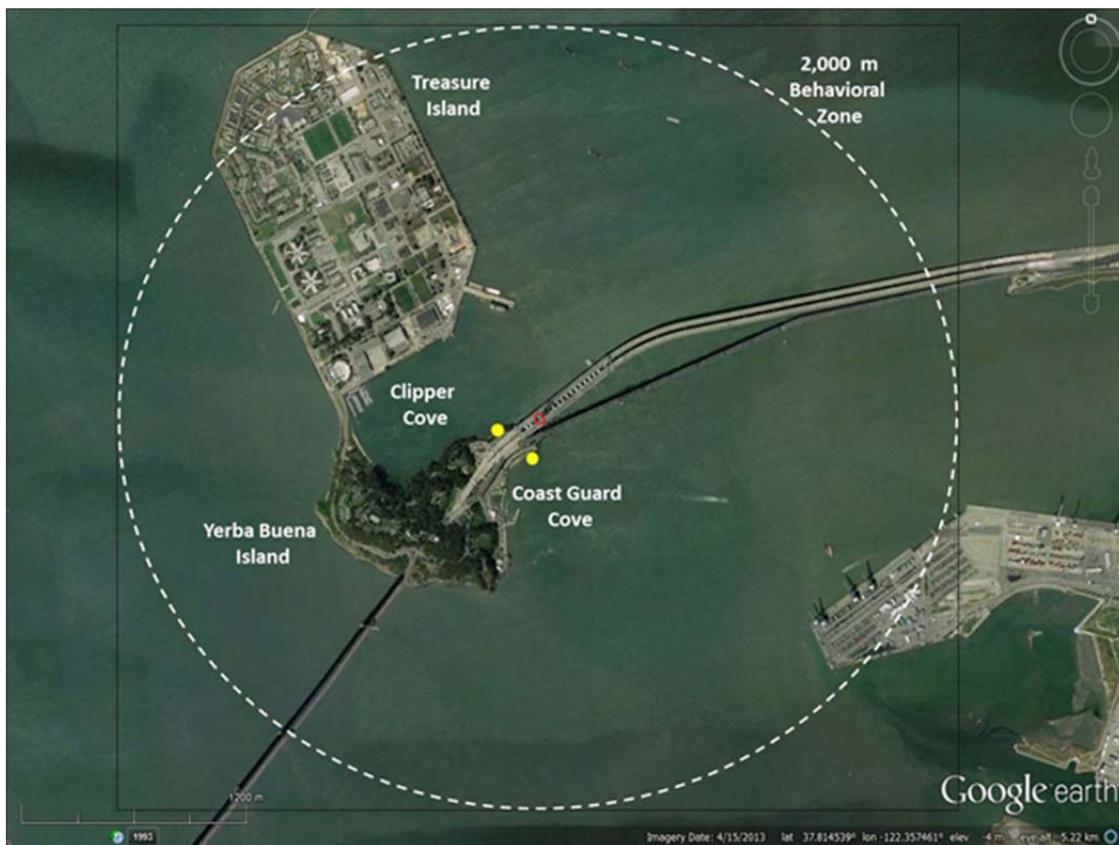
Figure 7. Aerial Photo of the Temporary Tower C Foundations and Marine Mammal Observer Locations.

The MMEZ for demolition using a hydraulic hammer was unknown; therefore, NMFS required a distance to 100 meters (328 feet) until hydroacoustic measurements could be made (Figure 7). After underwater sound level measurements were collected for the C3 Foundation, the MMEZ was eliminated as sound levels were well below the 180 or 190 dB re 1 μ Pa RMS thresholds required in the 2013 IHA (Illingworth & Rodkin Inc. 2013). The Behavioral Harassment Zone was estimated to be 2,000 meters (6,562 feet). Additional marine mammal and hydroacoustic monitoring were undertaken for the C1 Foundation because it was closer to the Bay waters than the previously monitored C3 Foundation, and therefore the demolition could potentially produce higher sound levels in the Bay.

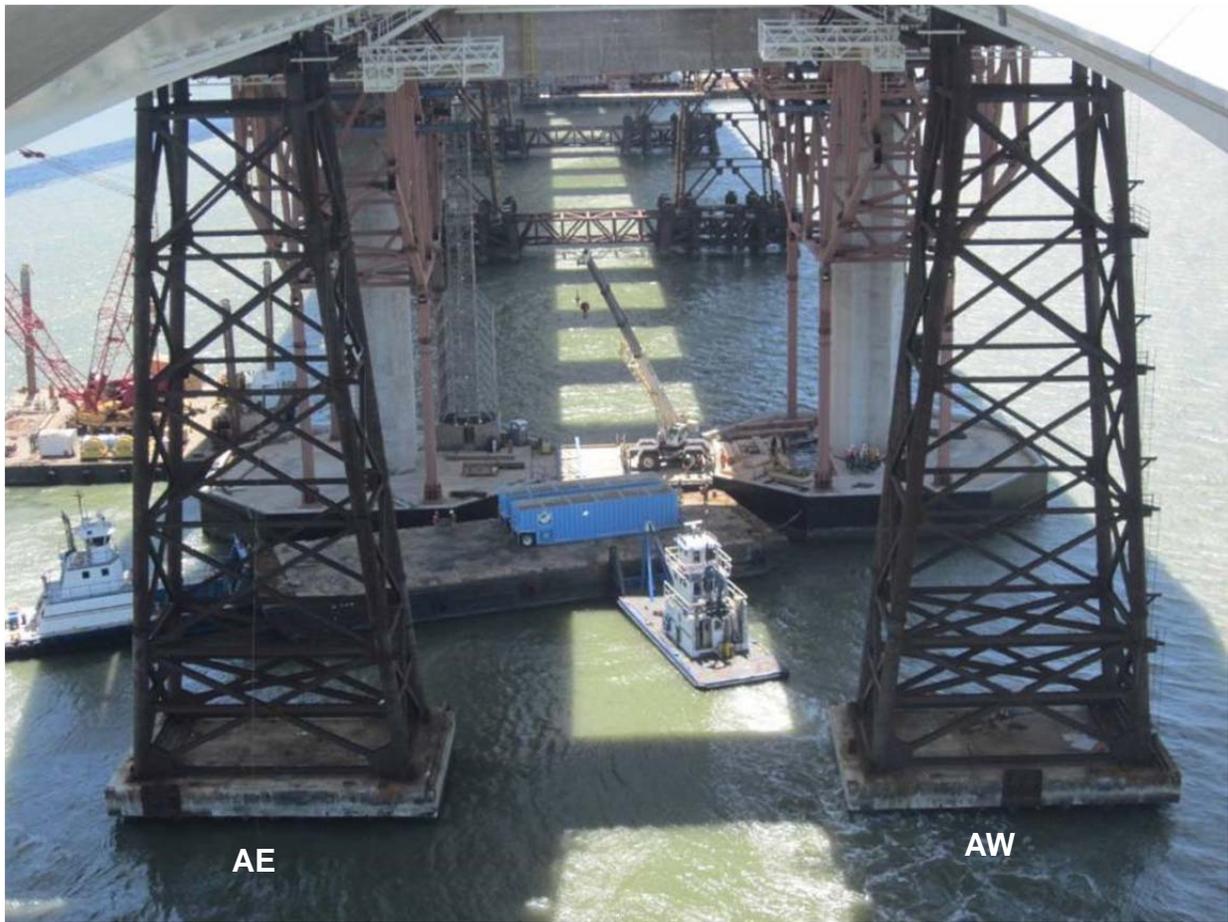
Figure 8. AE and AW Foundations.

AE and AW Foundations, were located underneath the eastern edge of the SAS span of the bridge where it connects to the Skyway (Figure 8). The contractor utilized excavators located on the pier deck to remove the cast-in-place portion of the pile cap. An excavator equipped with a hydraulic hammer was used to demolish the concrete and a second excavator equipped with rotating shears was used to cut the steel reinforcement. Once the cast-in-place concrete was removed, the precast slab was removed using an excavator equipped with a concrete cracking jaw. The excavator was operated from a barge. Following dismantling of the precast slab, the piles were cut off below the mudline and removed.

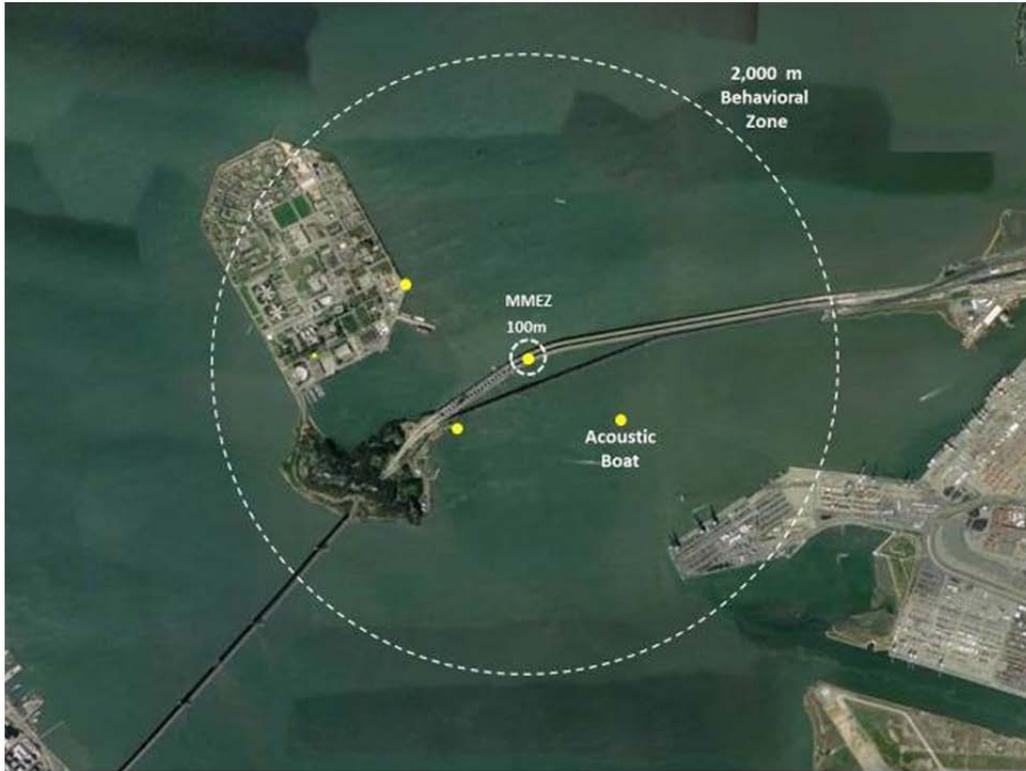
Figure 9. The AE Foundation Area with 100-meter (328 feet) MMEZ and 2,000-meter (6,562-foot). Behavioral Harassment Zone and Marine Mammal Monitor Observer Locations.

The MMEZ for demolition using a hydraulic hammer was unknown; therefore, NMFS required a distance of 100 meters (328 feet) until hydroacoustic measurements could be made (Figure 9). Initial Behavioral Harassment Zones for demolition are based on estimated distances to the 120 dB RMS isopleth. The estimated distance to the 120 dB RMS isopleth was 2,000 meters (6,562 feet).

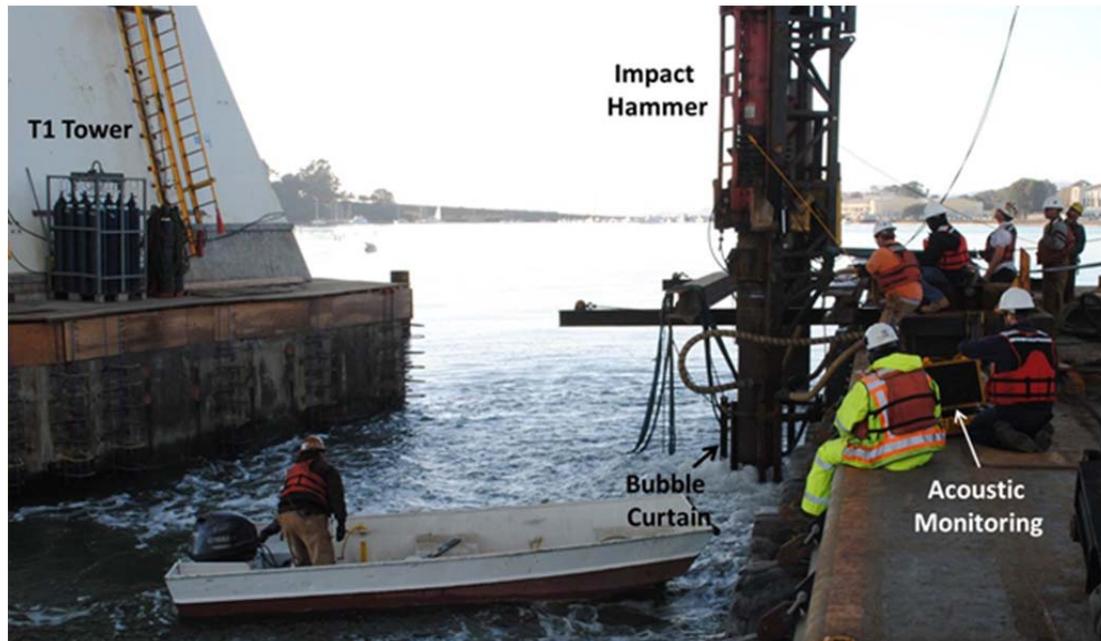
Figure 10. Photo of the T1 Fender Pile Driving.

Initial installation of the temporary piles was conducted using a vibratory hammer (APE Model 200). Once the pile was fully vibrated in or if the pile could not be fully vibrated in, an attenuation device (bubble curtain) was installed and subsequent impact hammering of the piles occurred as part of proof testing or installation completion using a Diesel Delmag D62-22 hammer (Figure 10).

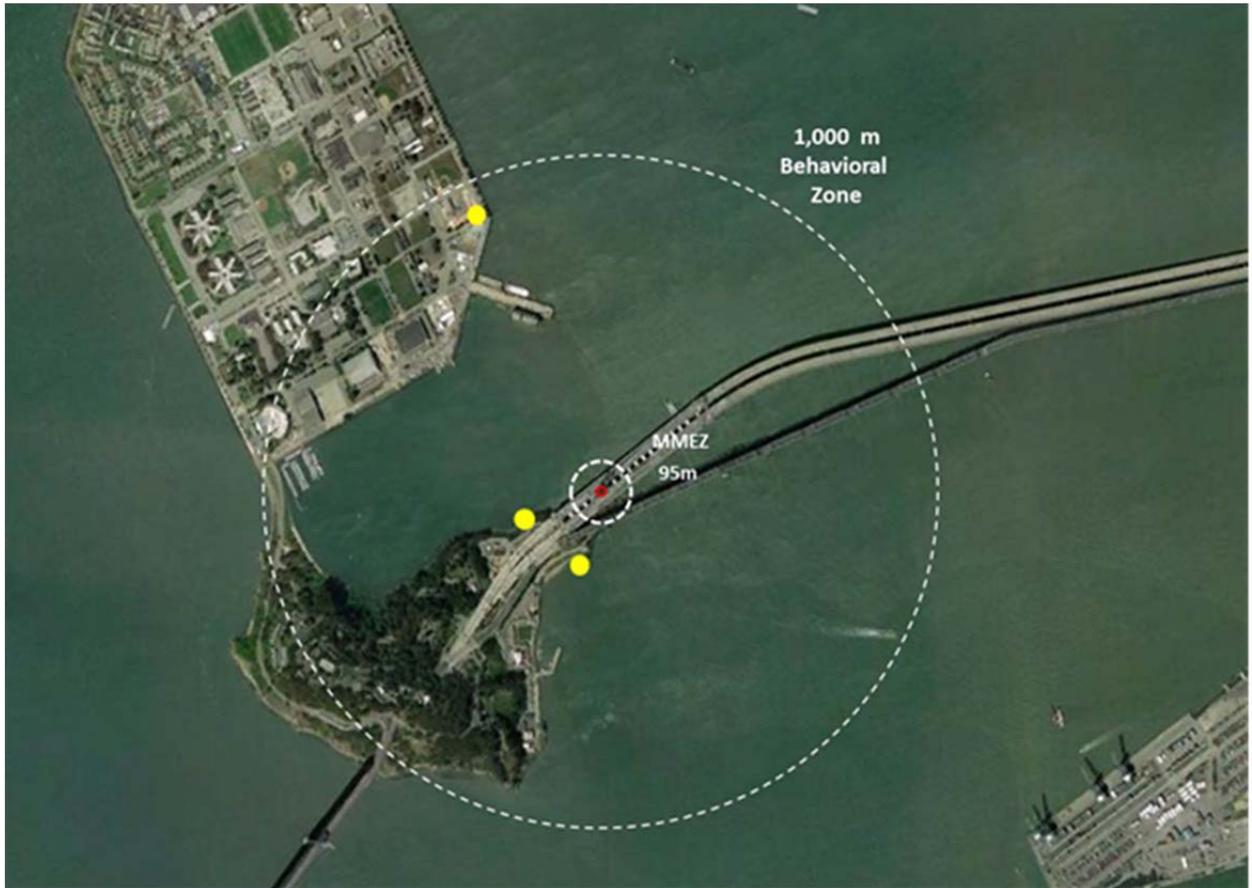
Figure 11. The T1 Fender Pile Area with a 95-meter (312-foot) MMEZ and 2,000-meter (6,562-foot) Behavioral Harassment Zone and Marine Mammal Monitor Observer Locations.

The MMEZ was initially implemented at 95 meters (312 feet; Figure 11) and was used until hydroacoustic monitoring showed that sound levels did not reach the 180 or 190 dB re 1 μ Pa RMS isopleth threshold for attenuated impact pile driving. Monitoring for all impact pile driving continued, but no MMEZ was implemented for the remainder of the project. The Behavioral Zones required monitoring for only 20% of the piles driven (2013 IHA), but because there was a mix of vibratory and impact pile driving each day, monitoring for the behavioral zones was conducted on 85% of the piles being driven.

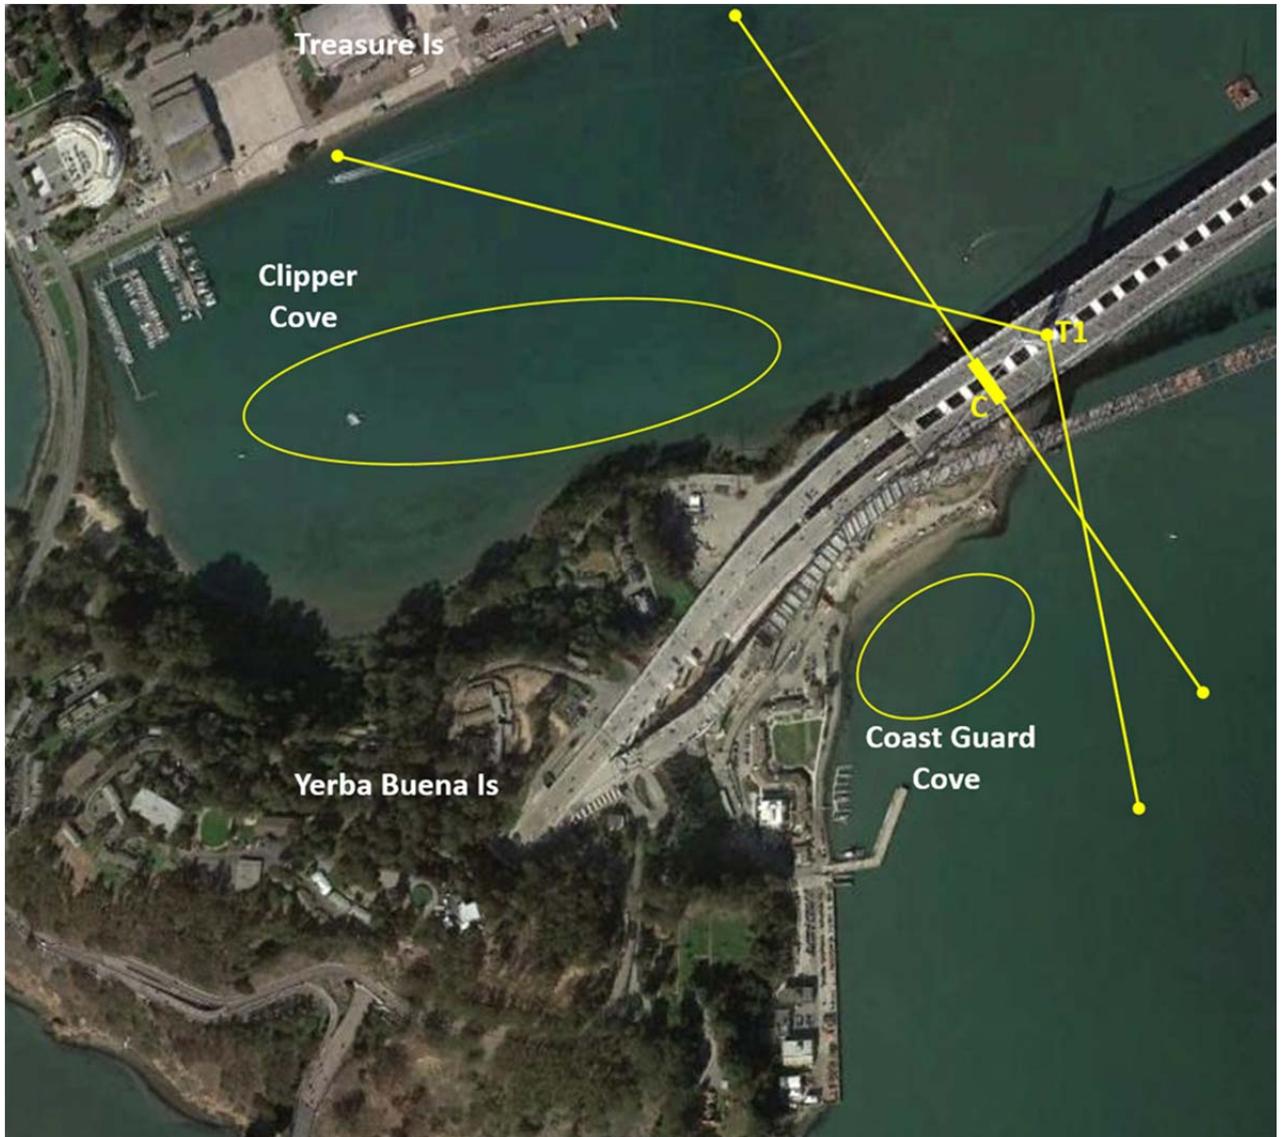
Figure 12. C represents the Temporary Tower C Foundation demolition area and T1 for the T1 Fender pile driving. The lines represent the “line of sight” for sound for each of the two projects with sound only propagating to the east of the lines as it is blocked by YBI. Circles represent the harbor seal foraging areas within the Coast Guard and Clipper Coves where the majority of harbor seal sightings occur.

Most of the observations of harbor seals within the behavioral zones occurred within the Coast Guard Cove or Clipper Cove. Certain sites such as the Temporary Tower C Foundations and the T1 fender piles are either completely on shore of YBI or just offshore off the northeastern side of YBI but are not within the acoustic “line of sight” (the direct path of sound within the water with no land masses, i.e., Yerba Buena Island, within that path) of one or both coves (See Figure 12). Table 7 summarizes the harbor seal and sea lion exposures based on 100% monitoring of each project but takes into effect that some sites do not create sound that transmits directly into the two coves (i.e., Coast Guard Cove and Clipper Cove). The revised number of exposures, 41 seals and seven sea lions, are based only on those animals observed within the acoustic “line of sight” of the T1 Tower, Temporary Tower C, YBITS2 test pile, and AE Foundation construction sites (Table 7). These exposures are less than the 50 harbor seal and 10 sea lion exposures permitted by NMFS (NMFS 2013; Table 6).
