Naval Base Kitsap-Bangor Explosives Handling Wharf 2

Year 2 Marine Mammal Monitoring Report (2013–2014)

BANGOR, WASHINGTON

April 2014

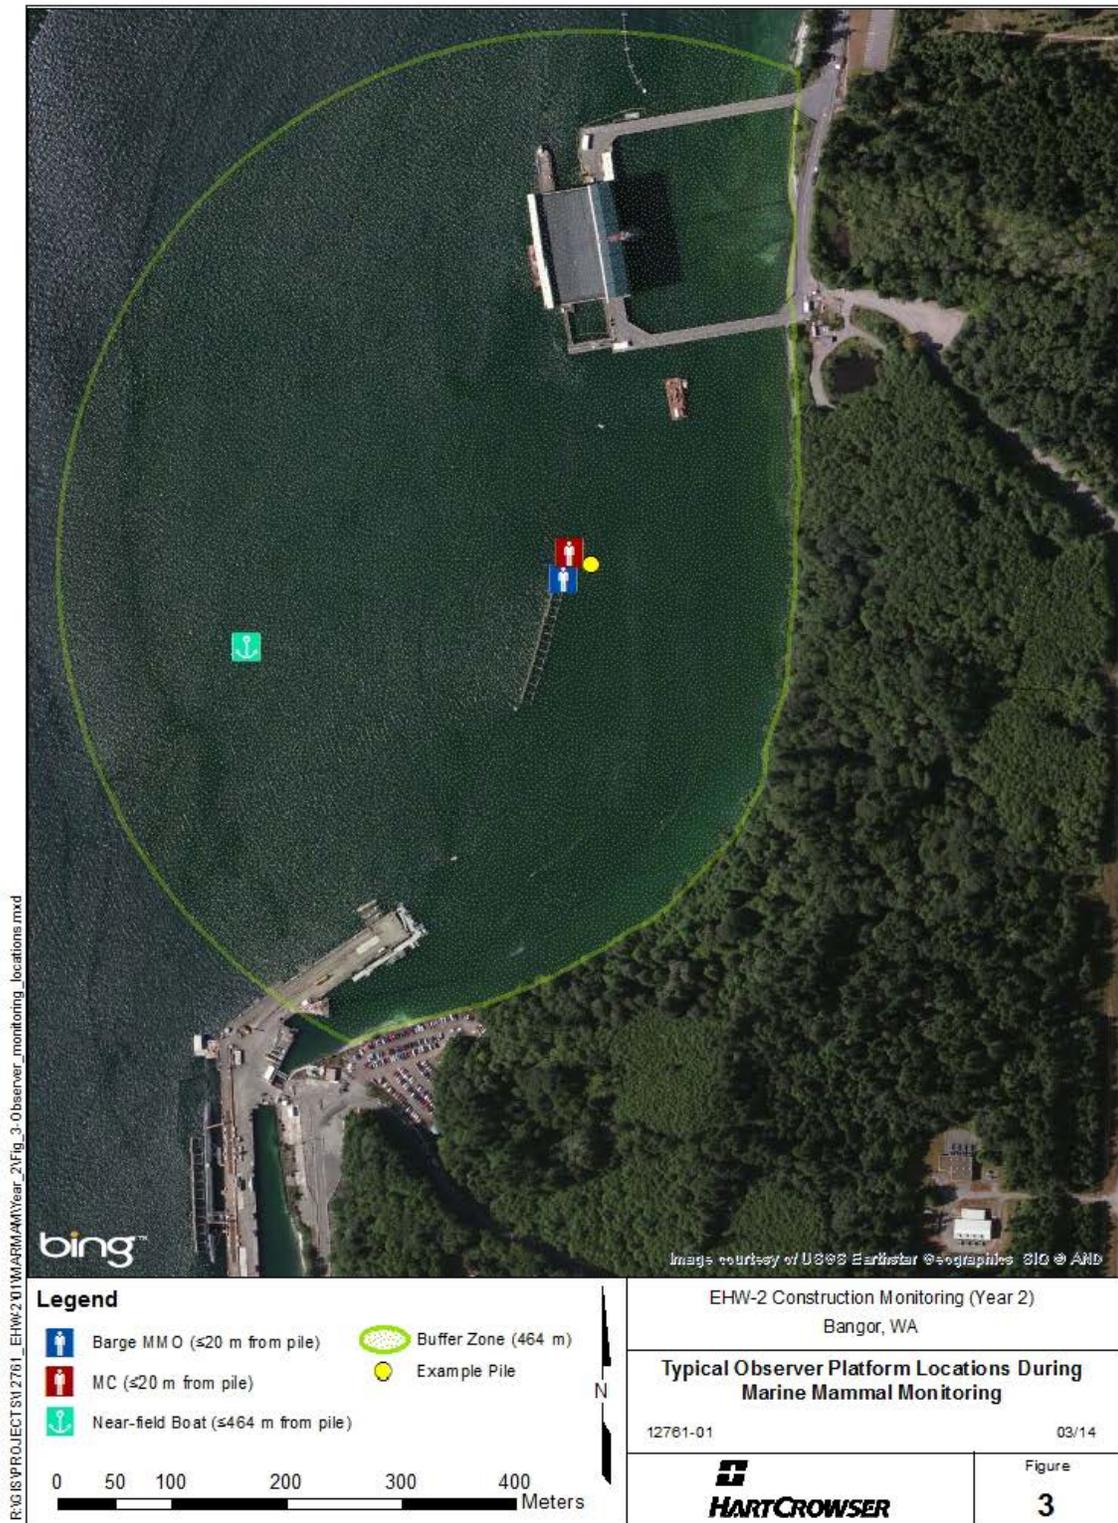
Figure 3. Typical Observer Monitoring Platforms during Marine Mammal Monitoring

Vessel-based Monitoring. Vessels were used as observation platforms and for transportation to pile driving barges. The year 2 EHW-2 CMP included one 32-foot (9.8-meter [m]) fiberglass-hulled Bayliner, which was used as the primary monitoring platform for the MMO conducting surveys of the buffer zone. A 26-foot tugboat and several other smaller vessels were used for transportation of personnel and equipment, and as monitoring platforms as needed. Vessels were equipped with VHF radios and depth sounders. All captains were United States Coast Guard-certified and were familiar with the Puget Sound waterways and the unique characteristics of the region. MMO monitoring vessels were equipped with elevated observation platforms, which provided maximum viewing capability. The MMO monitoring vessels' observation platforms were approximately 3 to 4 m (9.8 to 13.1 feet [ft]) above the water line.

Pier- and Barge-based Monitoring. The MC was typically located on the construction barge, and served as an additional marine mammal observer as needed from that relatively stationary location. The MC was typically 5–20 m (16–66 ft) from the pile, and at all times had a view of most of the shutdown zone. Since the MC typically served as an additional marine mammal observer to compliment the boat- and barged-based MMOs required by the protocol, the MCs were not required to have full observation of the shutdown zone at all times. However, in the event that the MC was the primary observer of the shutdown zone, the MC was positioned to provide full coverage of the shutdown zone. The MC was positioned in close proximity to the construction foreman or in the foreman’s line-of-sight, and each pile driving event was communicated between the foreman and MC. The MC would transmit the pile specifications and other details to the observers and vessel captains, all of whom monitored the same radio channel. The MC logged pile driving times and related construction activities for each pile (**Appendix B**). This served as the basis for data quality control of marine mammal sightings.

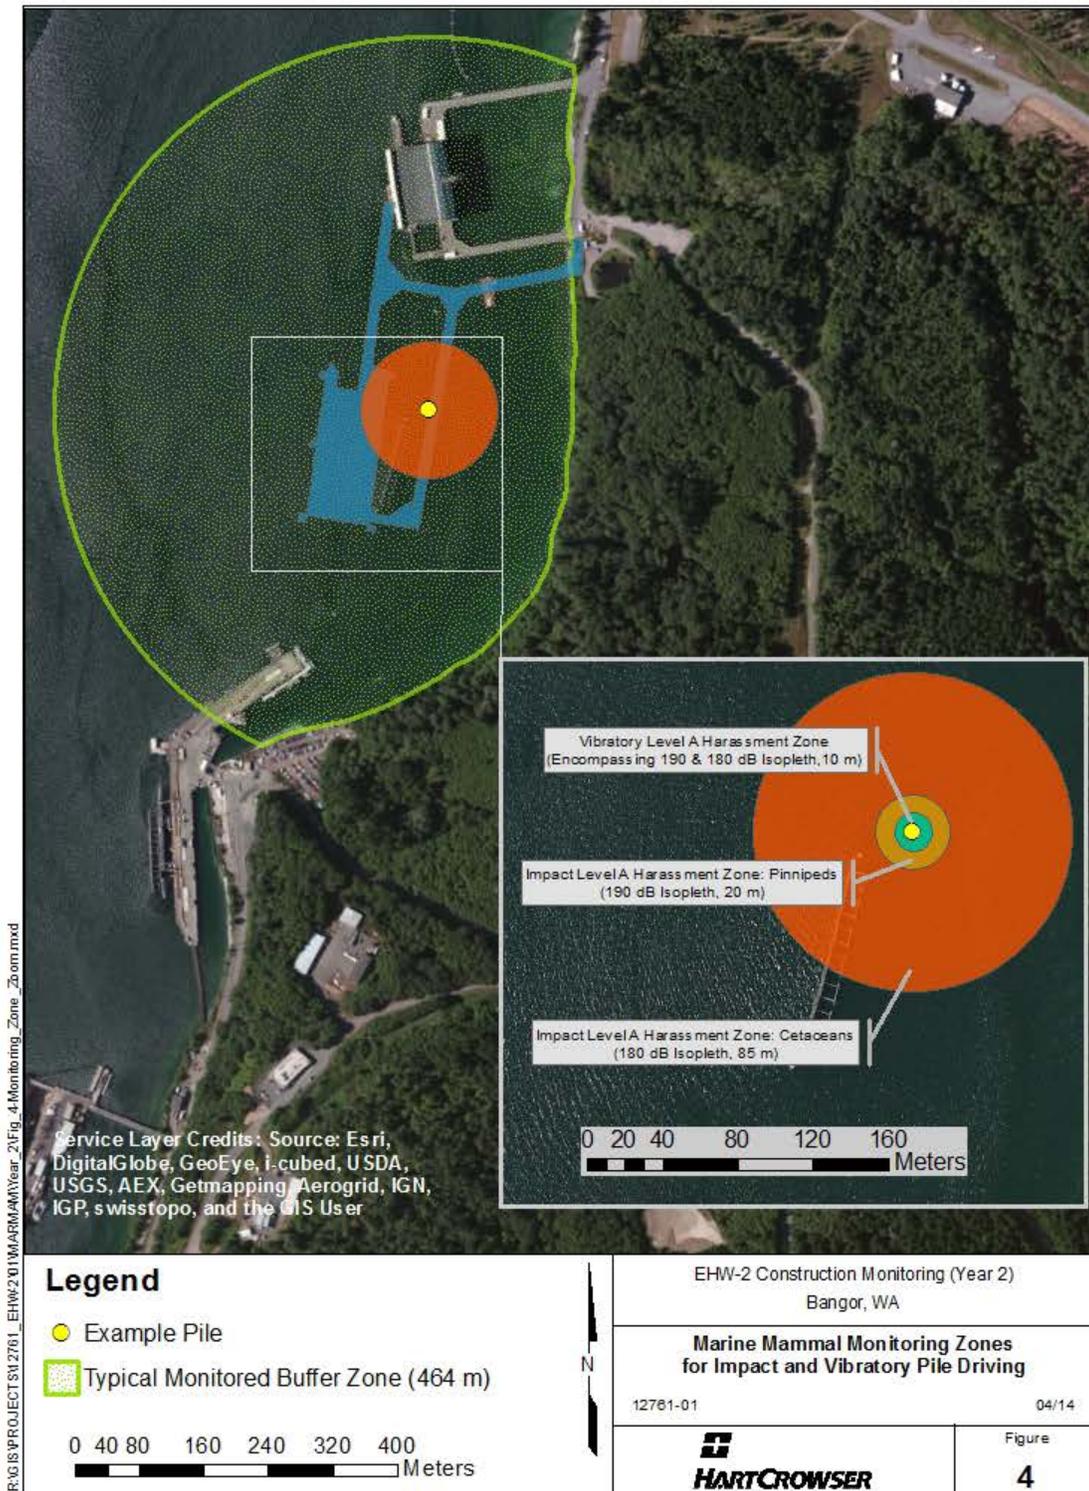
Figure 4. Marine Mammal Monitoring Zones for Impact and Vibratory Pile Driving

Shutdown Zone. The shutdown zone included all areas where the underwater sound pressure levels were anticipated to equal or exceed the Level A (injury) Harassment criteria for marine mammals (180 decibels referenced to 1 micropascal [dB re 1 μ Pa] isopleths for cetaceans; 190 dB re 1 μ Pa isopleths for pinnipeds). For vibratory pile installation and removal, monitors enforced a 10-m (32.8-ft) shutdown zone, which encompassed the Level A Harassment zones for cetaceans and pinnipeds (**Figure 4**). For impact pile installation, monitors enforced a 20-m (65.6-ft) shutdown zone for pinnipeds and an 85-m (278.9-ft) shutdown zone for cetaceans (**Figure 4**). The 10-m shutdown zone was also monitored during other activities with the potential to affect marine mammals, including movement of a barge to the pile location, and the removal or insertion of a pile from the water column via a crane (“dead pull” and “stabbing,” respectively).

Buffer Zone. Although a buffer zone (Level B harassment, 120 dB isopleth) for vibratory pile removal was predicted to have an area of 41.4 square kilometers (km²; 16.0 square miles), monitoring an area of that size would have been impractical (**Figure 5**). Instead, MMOs used the NMFS-approved 464-m (1522-ft)-radius buffer zone (160 dB isopleth) as a guideline for placement of marine mammal monitoring platforms during vibratory pile driver activity (**Figure 4**; DoN 2012). However, all identifiable marine mammals, regardless of whether inside or outside the 464-m zone, were recorded.

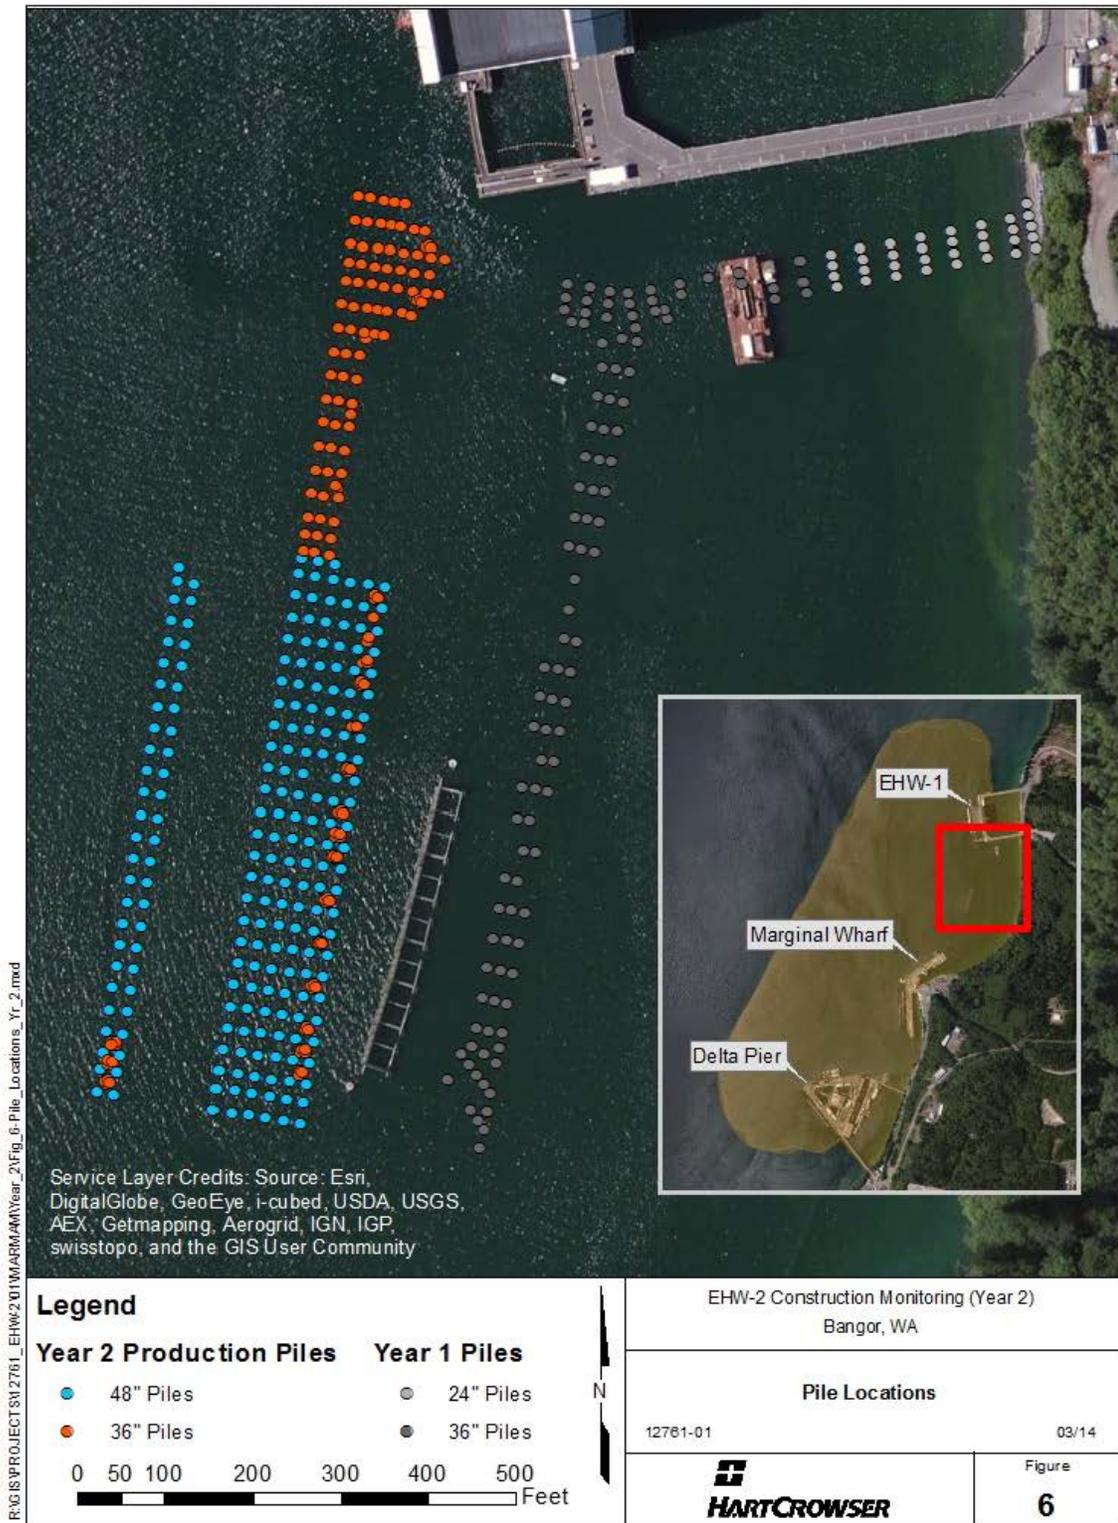
Figure 6. Year 2 Production Pile Locations

Pile Descriptions. During the EHW-2 CMP, 411 production steel piles (piles that will remain as part of the EHW-2 structure) were driven by vibratory and impact hammers. All 411 piles were driven by a vibratory hammer, and 383 of those piles were subsequently driven by an impact hammer. Piles impacted consisted of 299 plumb piles and 84 batter piles. Production piles ranged in diameter from 36 to 48 inches (0.92 to 1.22 m) (**Figure 6; Appendix D**).

During Year 2 of the EHW-2 CMP, template pin piles and falsework (referred to as “temp” piles in **Appendix D**) were also installed and removed with vibratory hammers. These temporary piles ranged in size from 24 to 48 inches (0.61 to 1.22 m) in diameter (**Figure 6; Appendix D**).

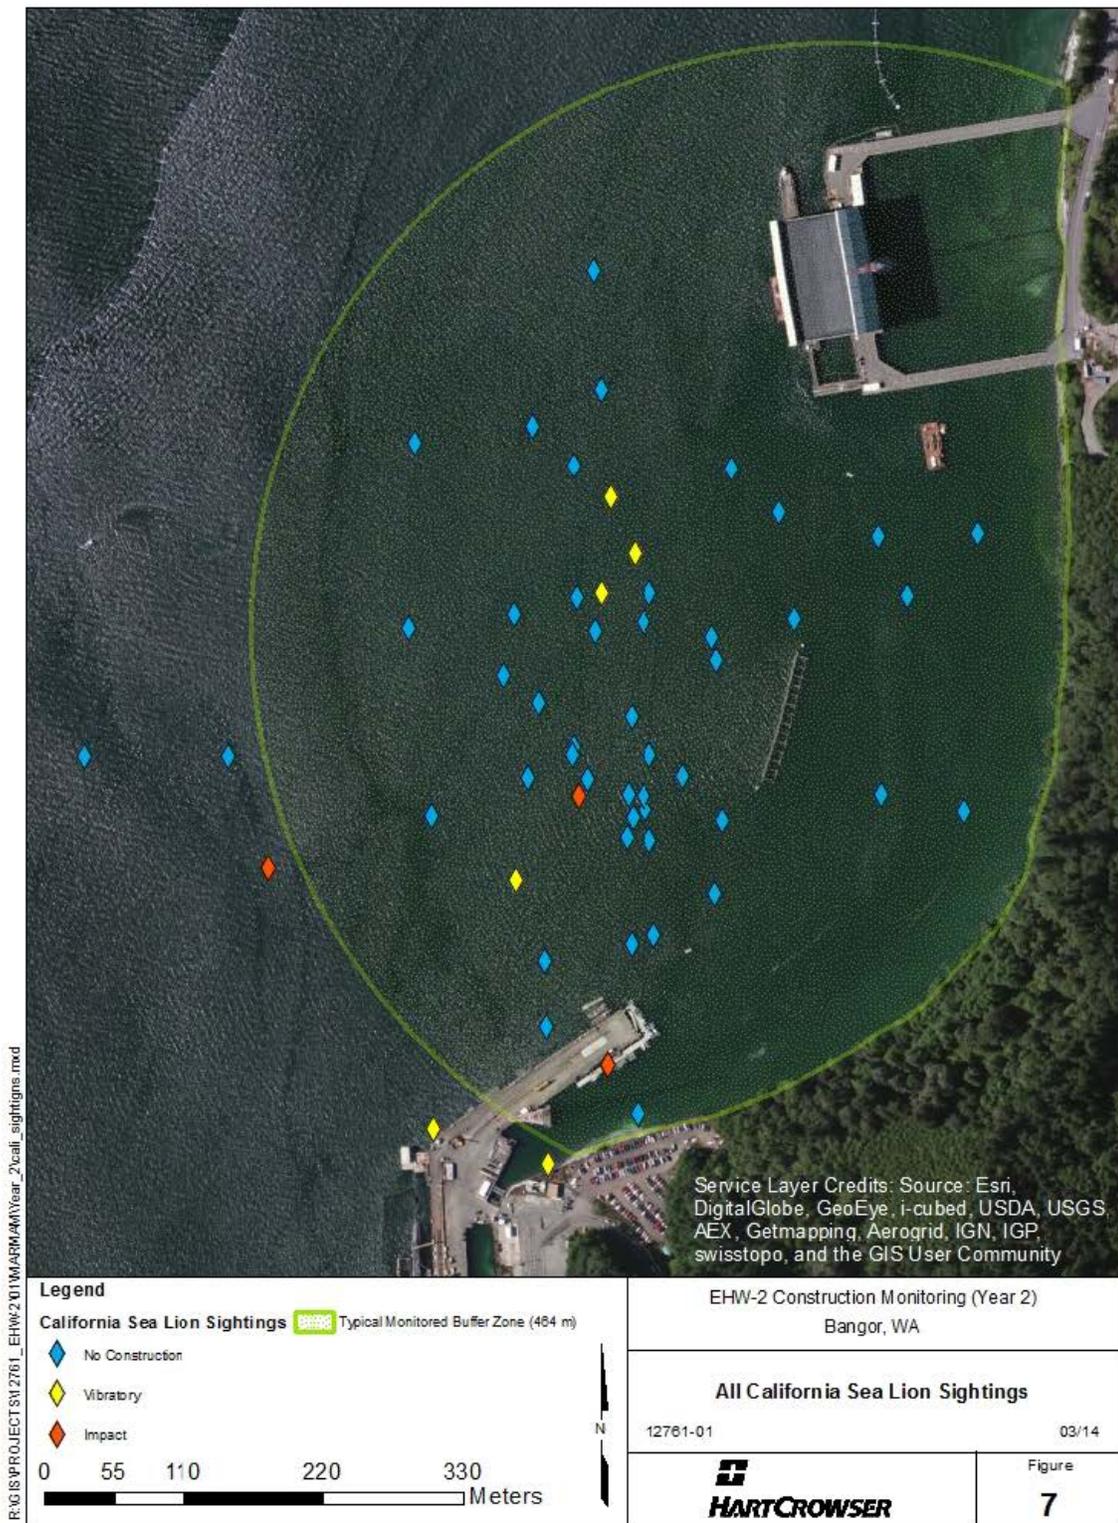
Figure 7. All California Sea Lion Sightings

Primary Surveys. A total of 697 sightings of 723 marine mammals were observed during primary marine mammal surveys of pile installation and removal activities (impact and vibratory pile driving; **Table 5; Figures 7 and 8**). There were 10 California sea lion sightings, all of which were of individual animals. Harbor seals were by far the most frequently sighted species during impact and vibratory pile driving, accounting for 98% of all sightings. Although harbor seals were observed in pairs, most often they were seen individually (98% of sightings).

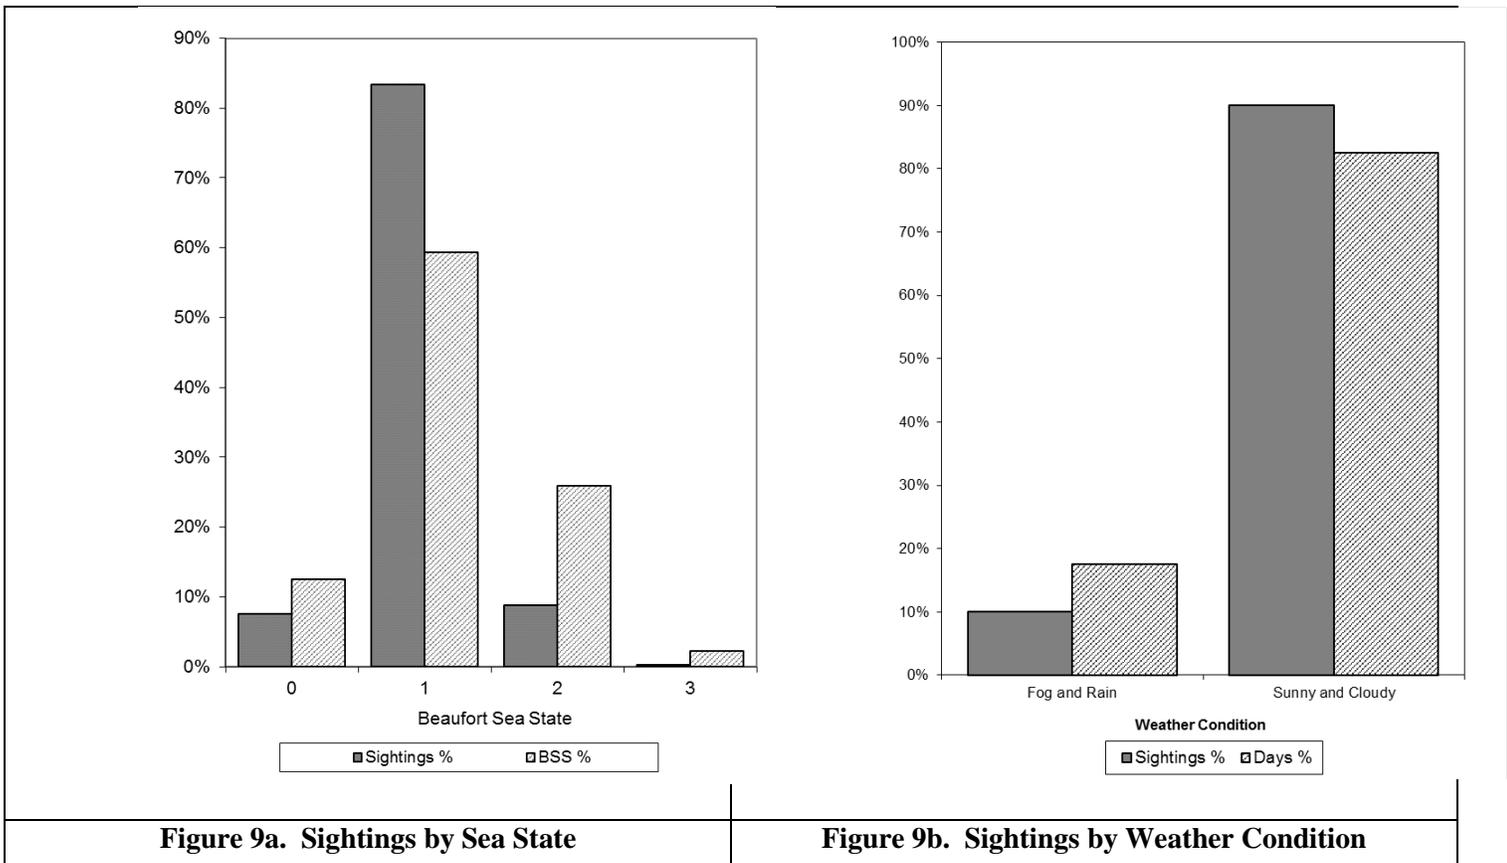
Most marine mammal sightings were made in calm conditions with low wave height (**Figures 9a** and **9b**). All marine mammal sightings (including resightings) were made during Beaufort sea state (BSS) conditions of 0–3 (winds at or below 16 knots; see **Appendix C** for the Beaufort scale). Sightings declined significantly at BSS 2 and above. This appeared to be due, at least in part, to reduced activity and movement by marine mammals, as the MMOs often reported good monitoring visibility at a BSS of 3. Favorable weather persisted throughout construction and shutdowns due to reduced visibility were not required at any time. All construction and marine mammal surveys occurred during sea states of BSS 3 or below.

Favorable weather conditions (cloudy and sunny) occurred on 82% of construction days; 90% of all sightings occurred under those conditions. Weather that produced reduced visibility (fog and rain) occurred on 18% of construction days; 10% of all sightings occurred under those conditions.

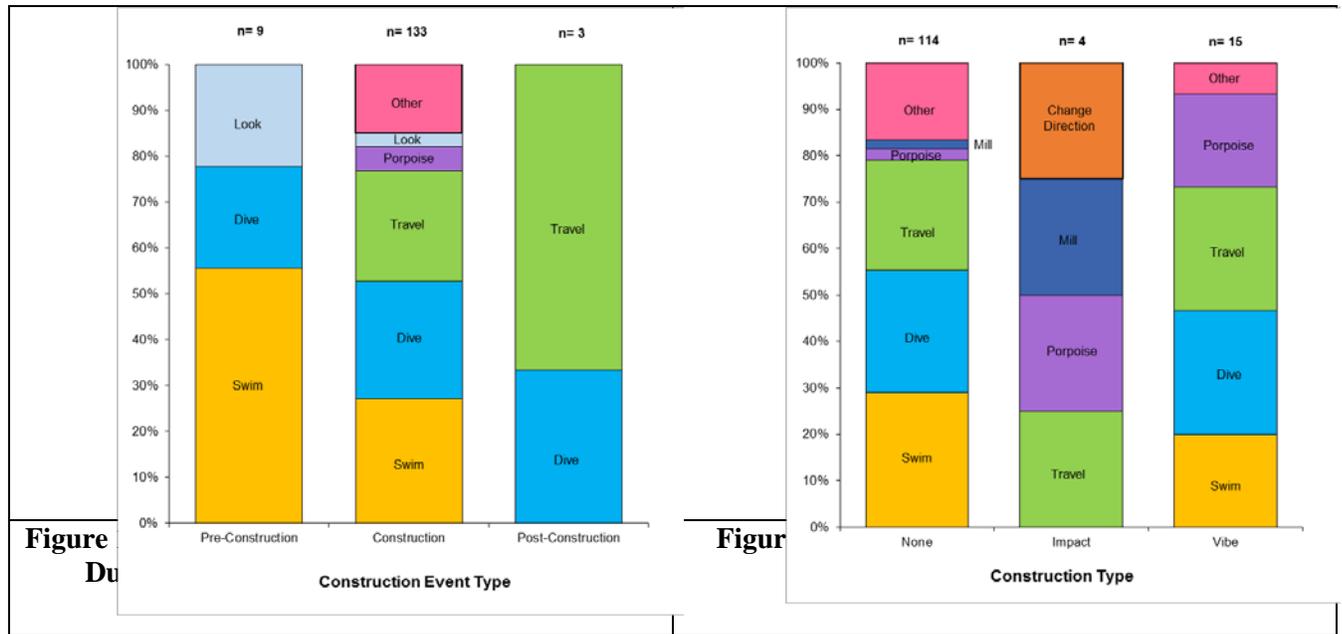
California Sea Lion. During pre-construction monitoring, California sea lions were observed “swimming” (56%, n=5), and “diving” and “looking” (each 22%, n=2) (**Figure 10a**). During construction, California sea lions were frequently observed “swimming” (27%, n=36), “diving” (26%, n=34), and “traveling” (24%, n=32). In addition to these dominant behaviors observed during construction, California sea lions also exhibited a range of other behaviors (e.g., porpoise, look, mill, and spyhop), but less frequently, with only 2 to 3 animals demonstrating. In the table, these behaviors were collectively grouped under “other” during construction. During post-construction monitoring, California sea lions were frequently observed “diving” (33%, n=1) and “traveling” (66%, n=2).

When analyzed by construction event type, California sea lions were frequently observed “traveling” (24%, n=27), “swimming” (29%, n=33), and “diving” (26%, n=30) during construction events other than pile driving (**Figure 10b**). The four California sea lions observed during impact driving were seen “traveling”, “porpoising”, “milling” and “change direction” (each 25%, n=1). During vibratory pile driving, California sea lions were most frequently

observed “diving” and “traveling” (each 27%, n=4), in addition to “porpoising” and “swimming” (each 20%, n=3).

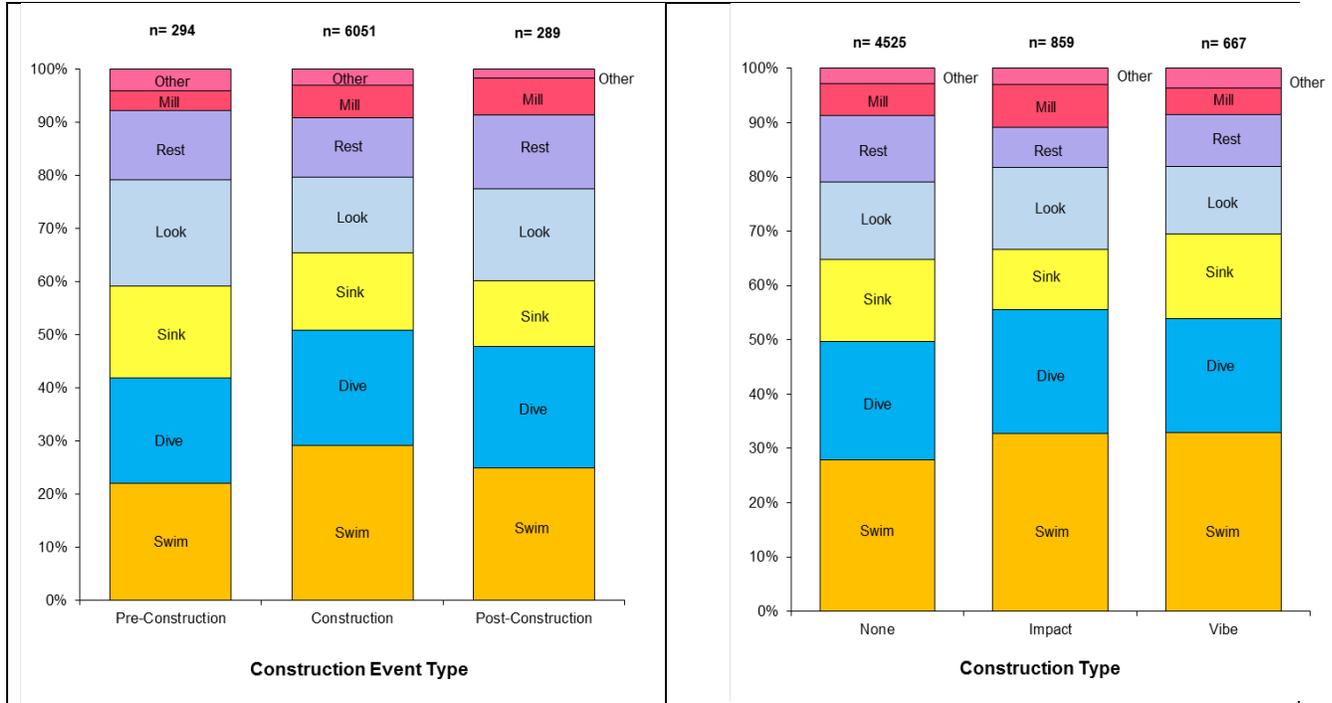
Figure 11a. Harbor Seal Behaviors Before, During and After Construction: Primary

Harbor Seal. During pre-construction monitoring, harbor seals were most frequently observed “swimming” (22%, n=65), “diving” (20%, n=58), “sinking” (17%, n=51), and “looking” (20%, n=59) (**Figure 11a**). During construction, harbor seals were frequently observed “swimming” (29%, n=1766), “diving” (22%, n= 1311), “sinking” (15%, n=884), “looking” (14%, n=858), and “resting” (11%, n=684). During post-construction monitoring, harbor seals exhibited similar behaviors as observed during construction. Of these behaviors “swimming” (25%, n=72), “diving” (23%, n=66), and “looking” (17%, n=50) were most common.

When analyzed by construction event type, harbor seals were frequently observed “swimming” (28%, n=1265), “diving” (22%, n=981), and “sinking” (15%, n=686) during construction other than pile driving (**Figure 11b**). During impact pile driving, harbor seals were most frequently observed “swimming” (32%, n=281), “diving” (23%, n=197), and “looking” (15%, n=131). During vibratory pile driving, harbor seals were most frequently observed “swimming” (33%, n=220), “diving” (21%, n=140), and “sinking” (16%, n=104).

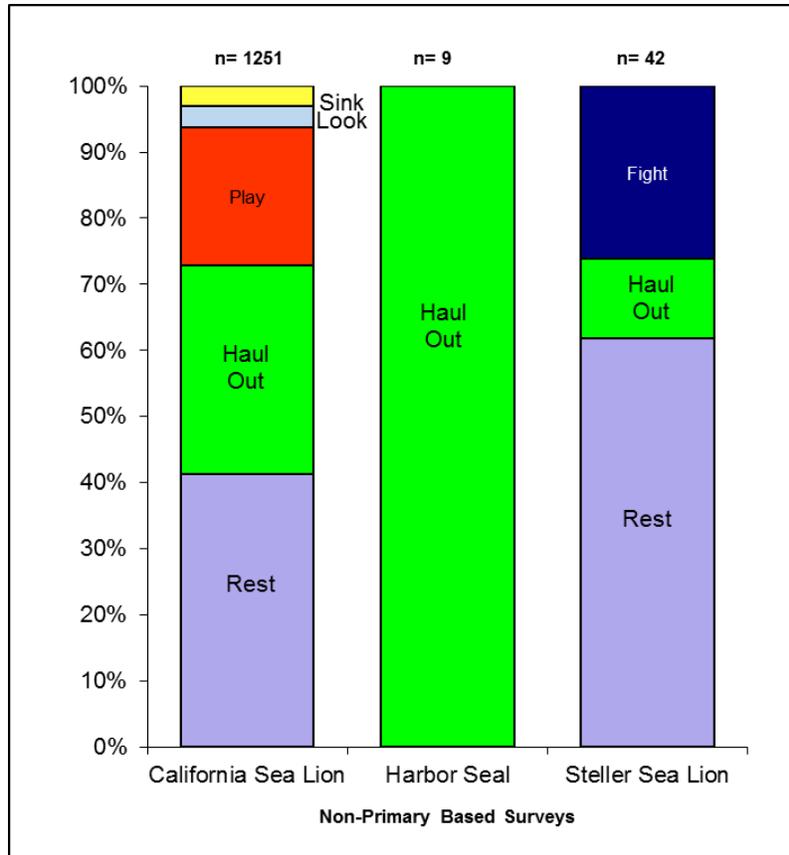
Figure 12. Marine Mammal Behaviors: Non-Primary Based Surveys

California sea lions were most often seen “resting” (41%, n=516), “hailed out” (32%, n=396), and “playing” (21%, n=260; **Figure 12**). Harbor seals were only observed “hailed out” (100%, n=9). Steller sea lions were seen “resting” (62%, n=26) and “fighting” (26%, n=11) while hailed out on the submarines (**Figure 12**).

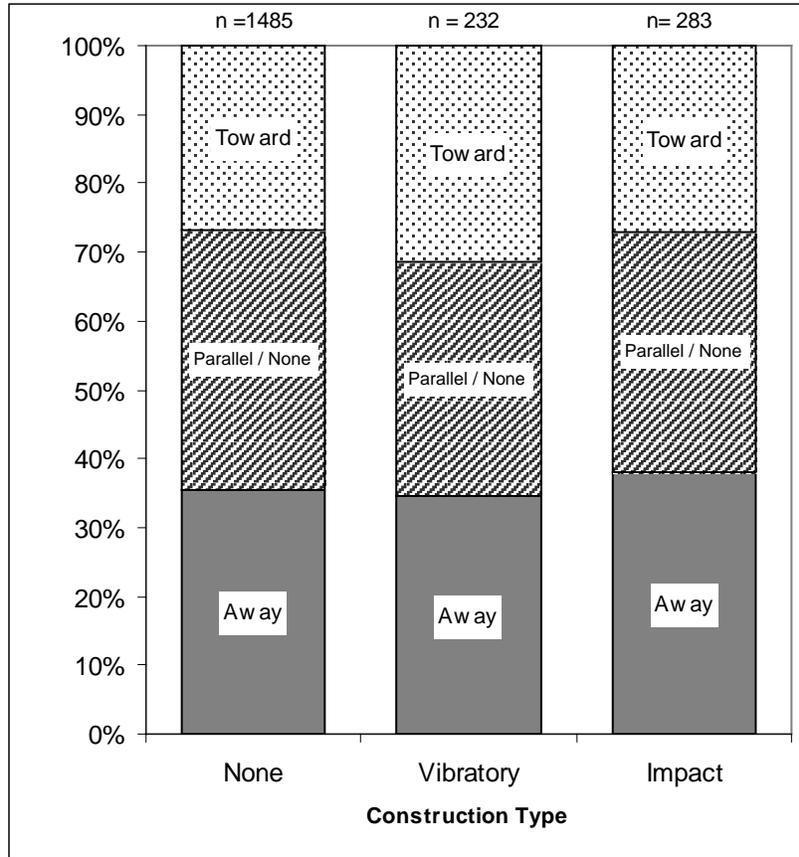
Figure 13. Relative Motion of Marine Mammals by Construction Event

Summary of Quantitative Analysis. During periods of construction other than pile driving events, marine mammals were most frequently observed swimming parallel or having no relative motion to the construction area (38%, n=561; **Figure 13**). During vibratory pile driving, marine mammals were equally observed moving away from the pile or having no relative motion (each 34%, n=80). There was also a slight increase in the percentage of animals that moved toward the pile during vibratory pile driving (31%, n=73) compared to non-pile driving periods (27%, n=397; **Figure 13**). During impact driving events, animals were most frequently observed moving away (38%, n=108) and moving parallel to or having no relative motion to the pile (35%, n=98). Marine mammals moved toward the pile as frequently during impact pile driving (27%, n=77) as during periods of no construction (27%, n=397).

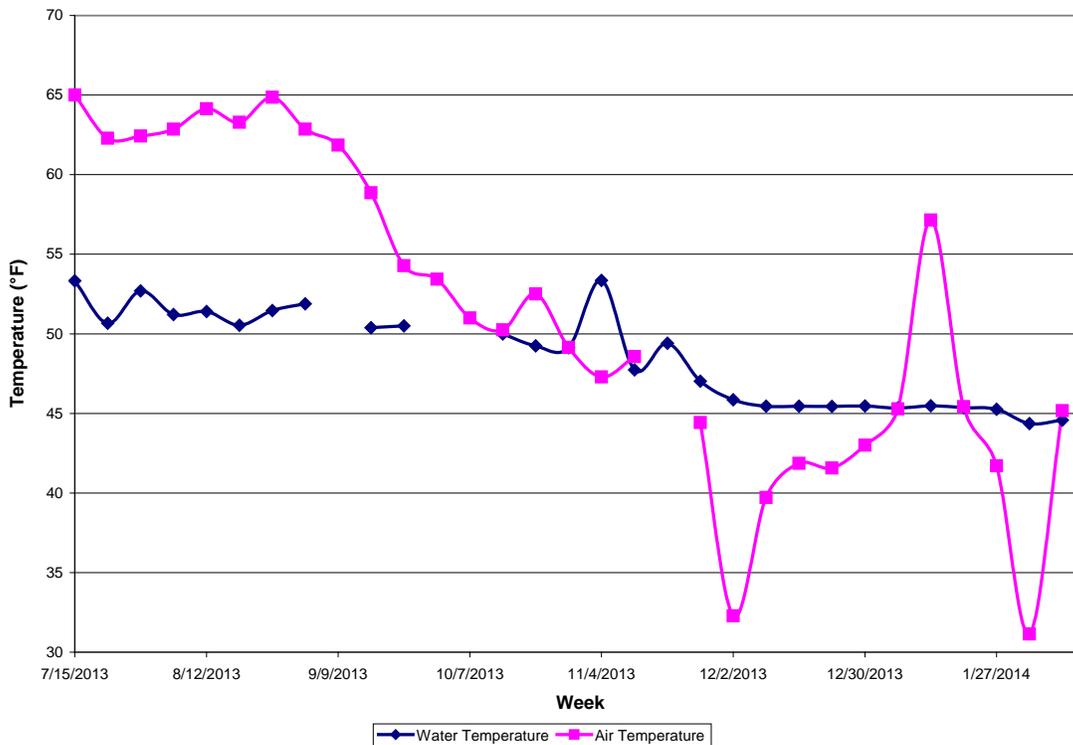
Figure 14. Average Air and Water Temperatures in the WRA

Environmental data can be found in **Appendix G** and are summarized by week in **Figures 14** and **15**. Average weekly air temperatures fluctuated from 65 degrees Fahrenheit (° F) in July to the lowest recorded average temperature of 31° F in early February. Water temperatures steadily decreased from 53° F to 44° F by mid-February when monitoring ended. Neither air nor water temperatures had any effect on the observers’ ability to identify marine mammals within the WRA.

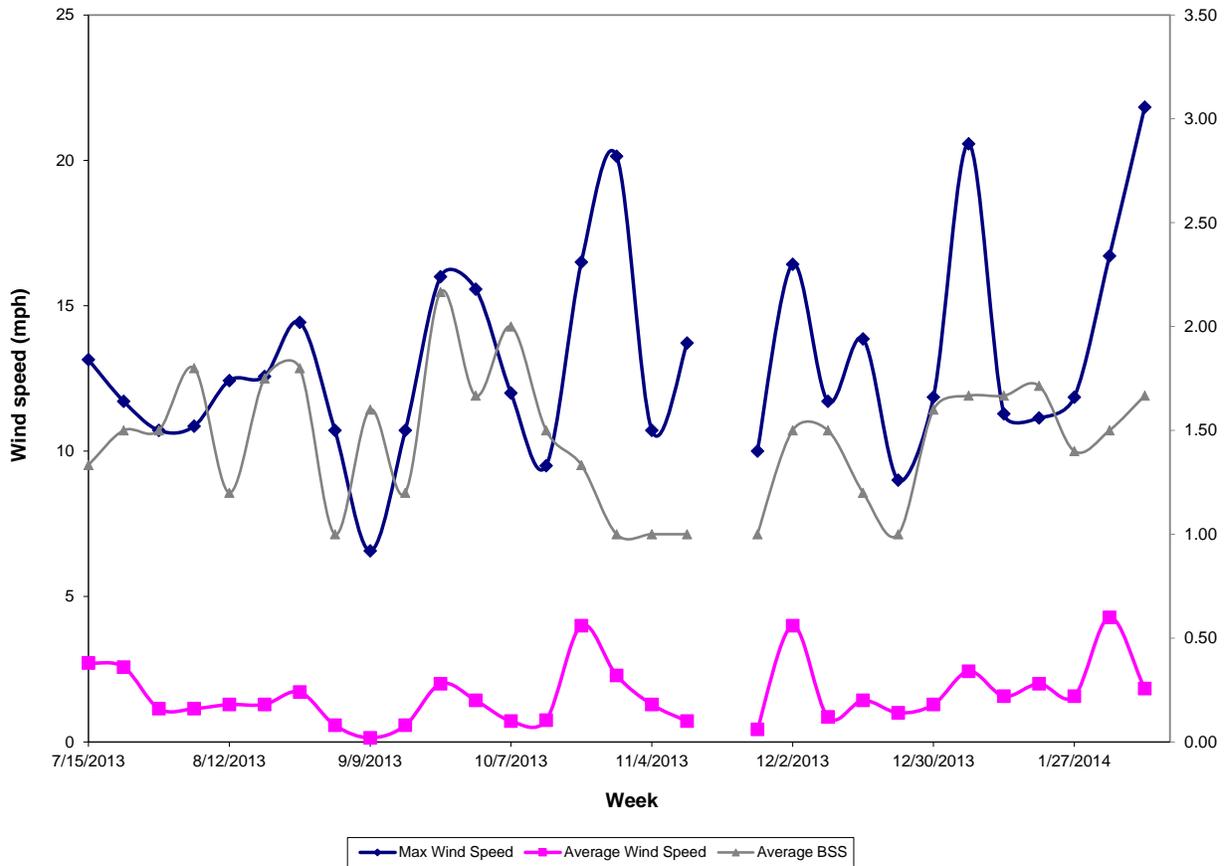
Figure 15. Wind Speed in the WRA

Average weekly wind speeds ranged from 0 to 4.3 miles per hour (mph), with the maximum wind speed of 29 mph on 19 December 2013 (no impact pile driving occurred during high wind periods due to the Marbled Murrelet Monitoring Plan protocol limiting sea state to less than BSS 3 during impact pile driving; **Figure 15**). Wind speeds did not result in unacceptable visibility ranges during pile driving activity, and resulted in a maximum BSS 3 (typically BSS 1–2). Observers found that localized wind “chop” was the primary determinant of the quality of viewing conditions. This benefited observers in the WRA as conditions in this area were generally calmer due, in part, to the location of the project area between EHW-1 and Marginal Wharf and in part, to the security fence, which provided a degree of shelter and dissipated wind and wave energy from the open waters of Hood Canal. Construction barges and boats also tended to reduce sea state in the vicinity of the construction work area.
