Final Report

Incidental Harassment Authorization

Issued June 28, 2013 – June 27, 2014 to the City of San Diego for  
La Jolla California Children's Pool Construction and Harbor Seal Monitoring

City of San Diego  
Public Works Department  
Engineering and Capital Projects Branch  
Architectural Engineering and Parks Division

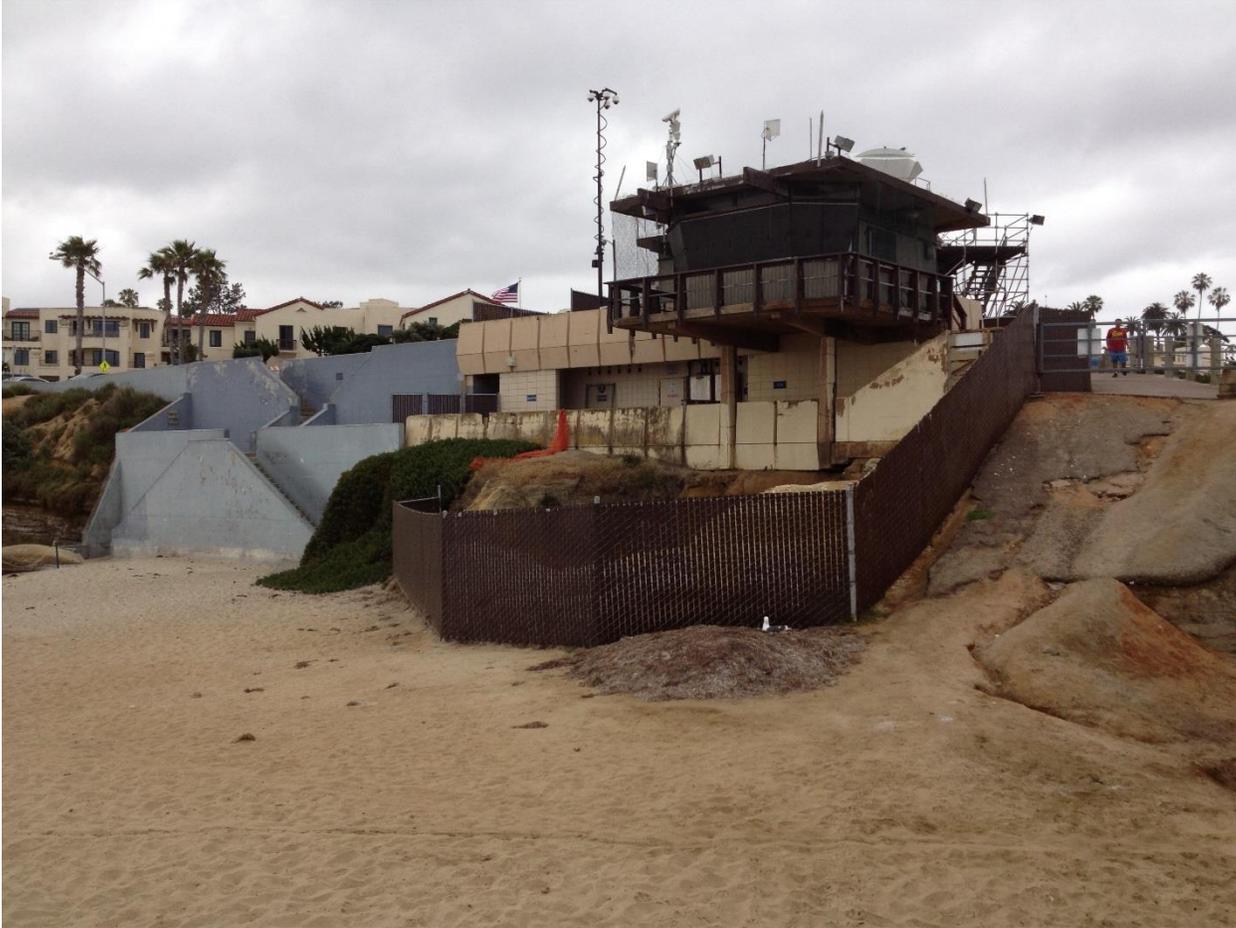
Figure 1. Old Lifeguard Station from beach level at Children's Pool, La Jolla, CA.

The City of San Diego applied for and was granted Level B Incidental Harassment Authorization (IHA) by National Marine Fisheries Service (NMFS) on June 28, 2013 through June 27, 2014, for demolition of the existing and construction of a new lifeguard station immediately above Children's Pool (CP), at 827 ½ Coast Boulevard, La Jolla, California (32° 50'50.02"N 117° 16'42.8"W; Figures 1, 7, and 8).

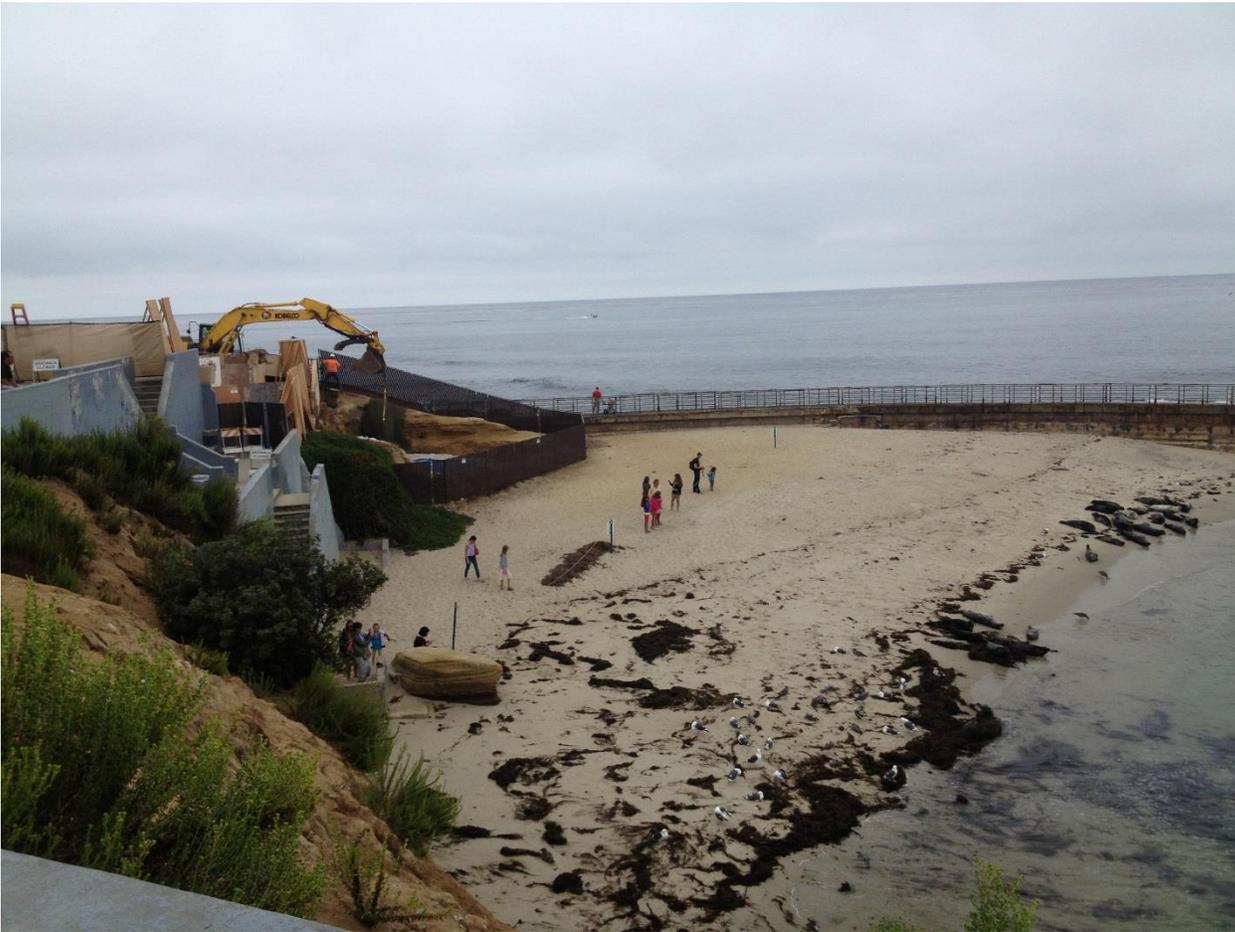
Figure 2. Excavator removing debris from beach level and over visual/acoustic barrier. Note seals at water's edge and visitors behind rope barrier at monitoring location: Mid-Rope. Note monitoring location: Top of Stairs at far left of photo (at end of tan fence screening material and gray wall) as well as location: Bottom of Stairs at corner of small gray wall to left of large rock on beach.

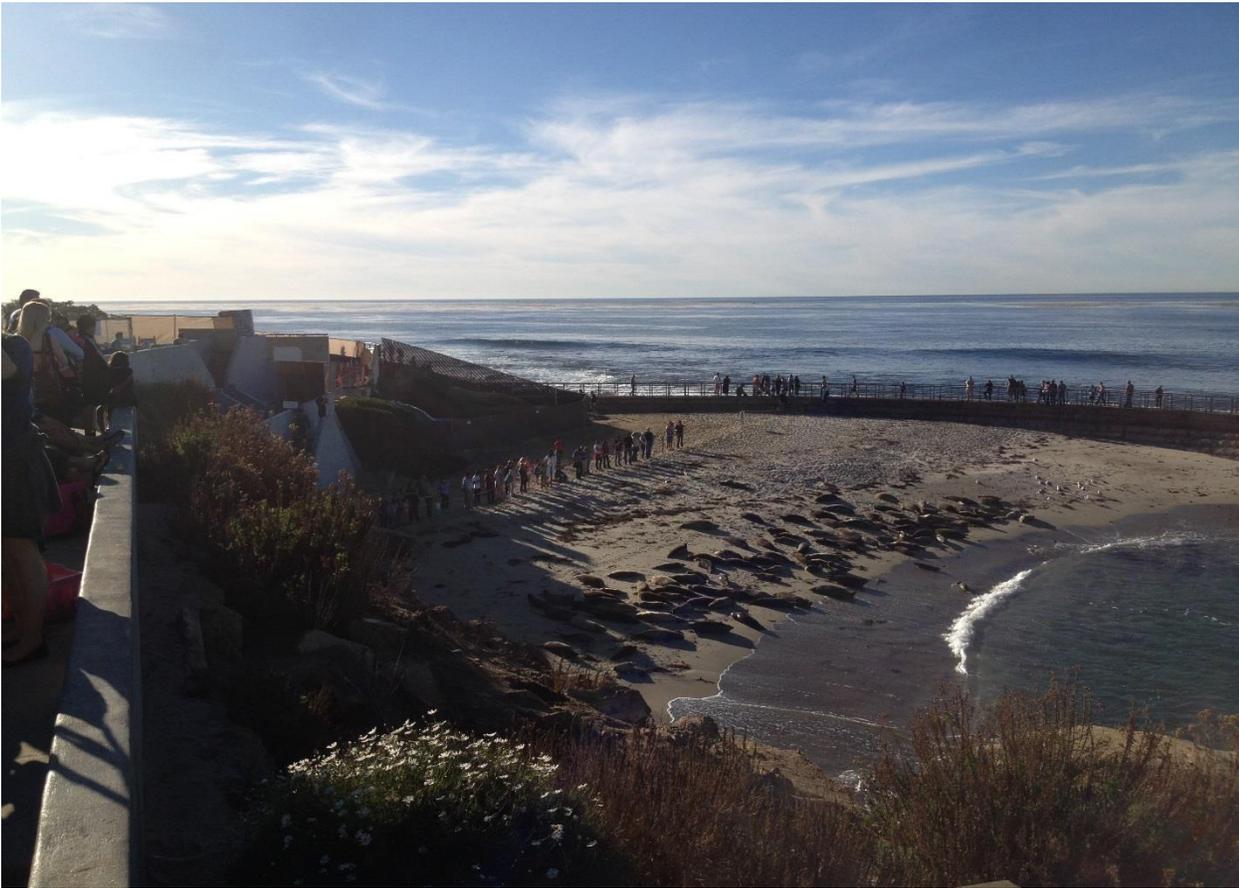
Figure 3. Children’s Pool visitors viewing seals during pupping season construction moratorium. To date CP docents have documented over 60 seal births this pupping season.

-Three Hanan & Associates, Inc. personnel (Zachary D. Hanan, Jonathan R. Sweeney, Jane E. Lithopoulos) and Dr. Hanan performed all observations by eye and with binoculars. PSO resumes were sent to NMFS and each was approved; additionally, each PSO was specifically trained at CP by Dr. Hanan for this project. A monitoring plan and observation sheets were developed and used for recording sound and observations (see Appendices I, II, III). This plan and observation sheets included hourly collection and count paradigms for: environmental data, recoding locations relative to the buffer zones (Figure 3 and Table 8), sound recording, all marine mammal observations, and public presence documentation.

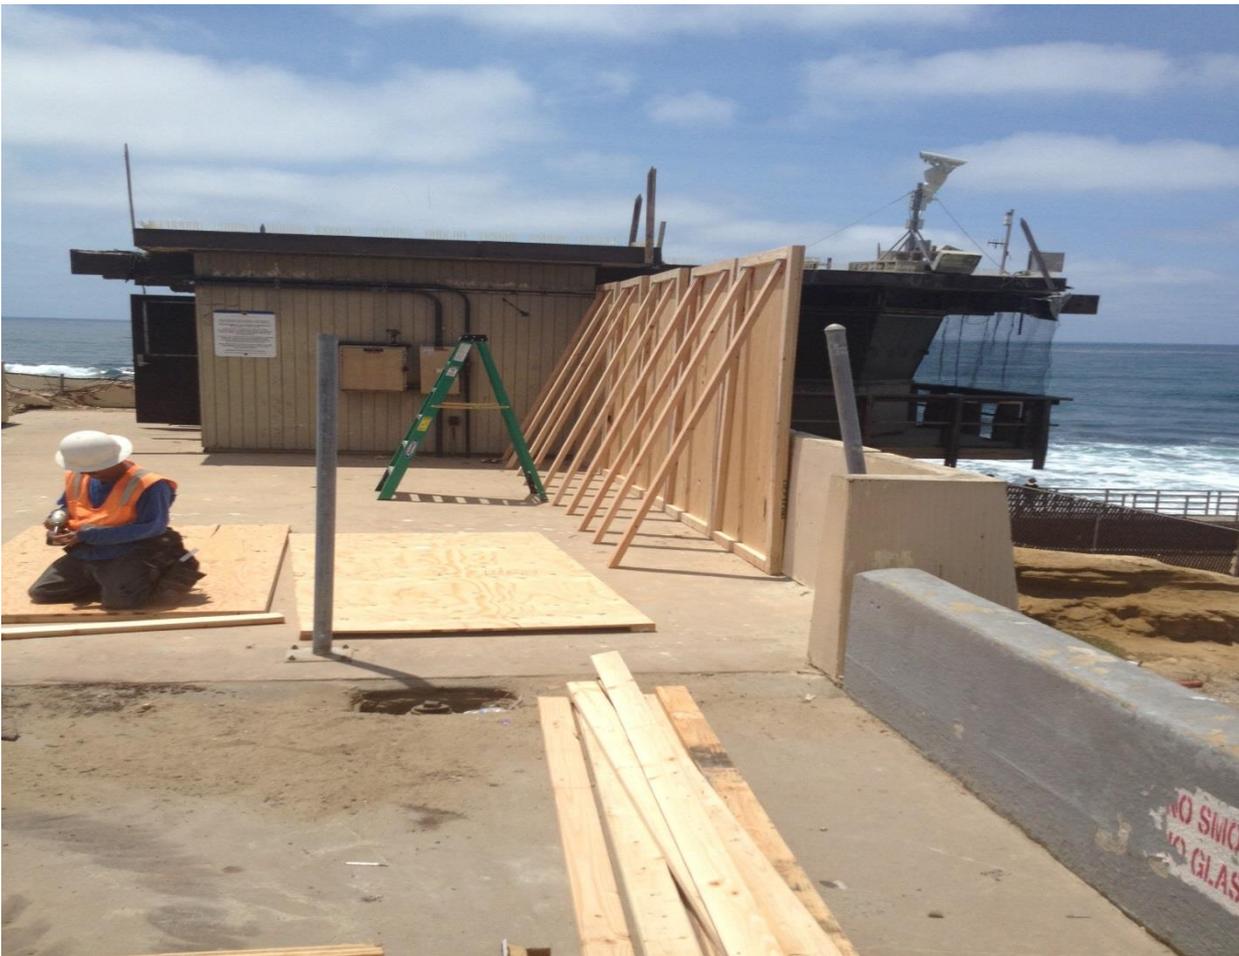
Figure 4. Building visual/acoustic barrier as seen from monitoring location: Top of Stairs (at juncture of tan and gray walls) next to construction site. Also note WAN video camera on top of lifeguard station.

-Sheets of 4 ft. by 8 ft. by 5/8<sup>th</sup> inch plywood framed with wooden two by fours were used to create the visual/sound barrier. The sheets of plywood were stood upright (8 feet tall) and held up with two wooden two by fours hinged to the top of the frame, so they could be collapsed and be moved depending on equipment location and need for access by equipment (See figures 4 and 12).

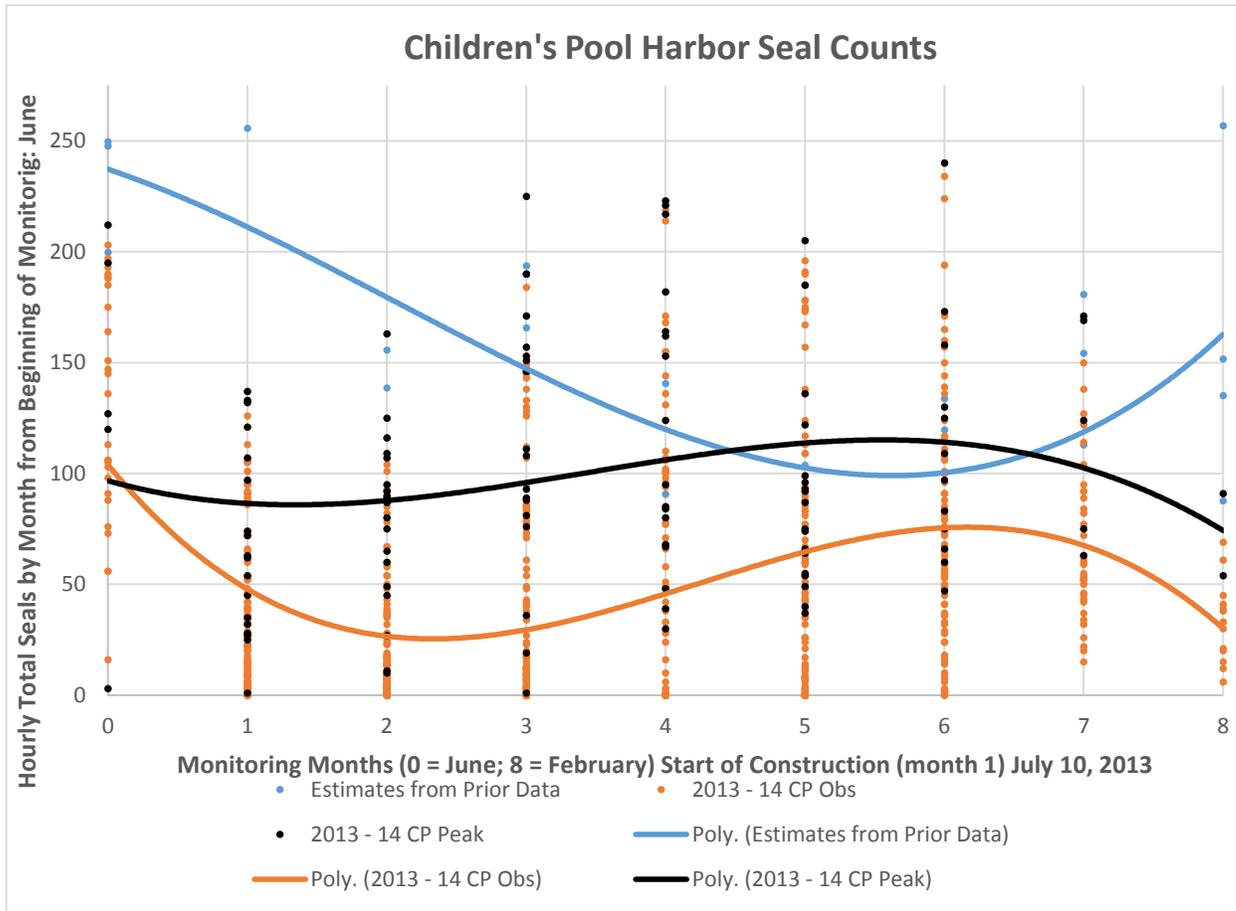
Figure 5. Harbor seal counts at CP June 3, 2013 (month 0) – February 12, 2014 (month 8) construction started in month 1 (July 10, 2013). Trend line for predicted counts from prior data (blue), and hourly counts/trend line for CP peak counts per day (black), and counts/trend line for all CP hourly counts by month (orange).

- After the first two months of monitoring, H&A evaluated mean and peak counts of harbor seals at CP relative to historic and projected abundance estimates (see Figures 5, 13, and 15) and presented the findings to NMFS. Based on those data, it was determined that harbor seal numbers were increasing during the two-month period and therefore site abandonment was not likely.

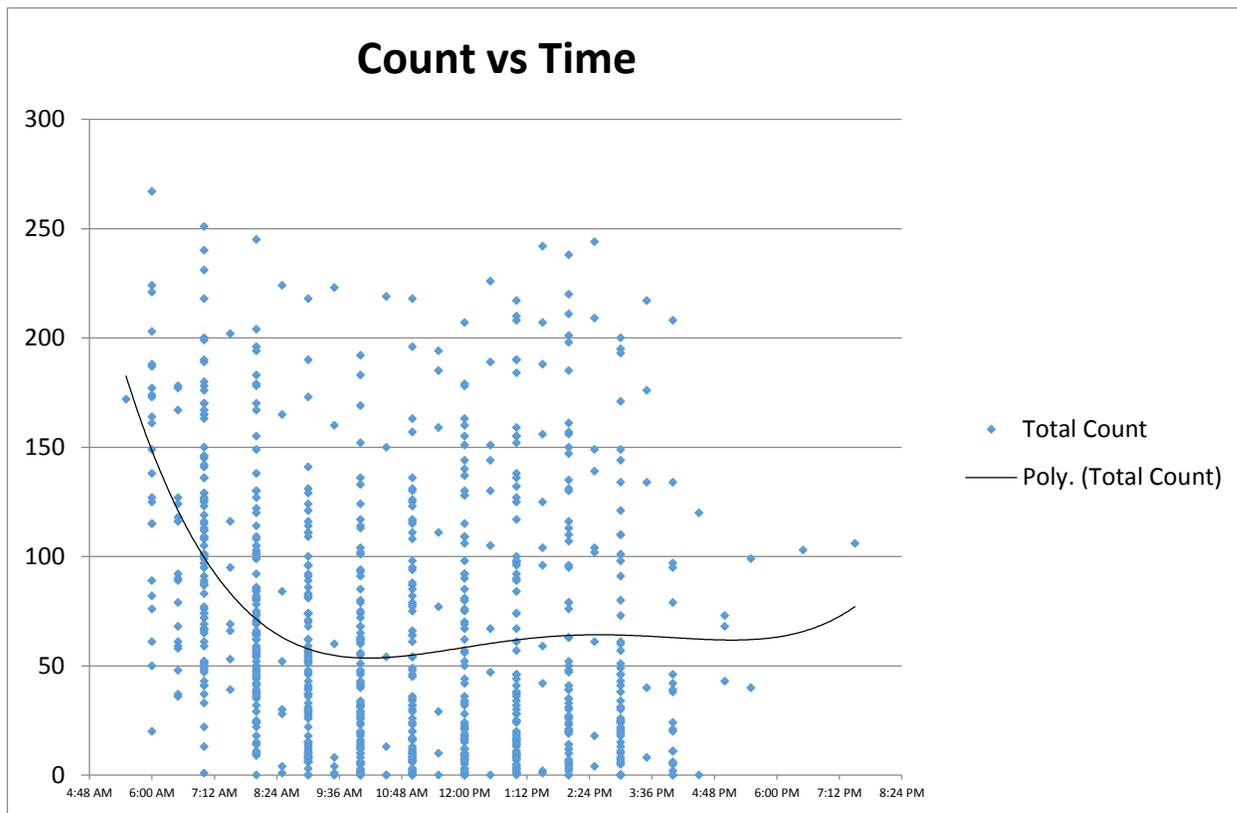
Figure 6. Harbor seal counts by time of day. Note the early morning declining trend line.

The trend line in Figure 6 shows a relationship which we noticed both before and during construction that the number of seals tend to decline as the city starts to awaken and the day progresses; people start arriving at CP for various activities not always related to seal watching: joggers and walkers, traffic passing by, maintenance of facilities and landscaping, trash trucks, lifeguard activities, storm water sampling, seal photographers, and seal aficionados.

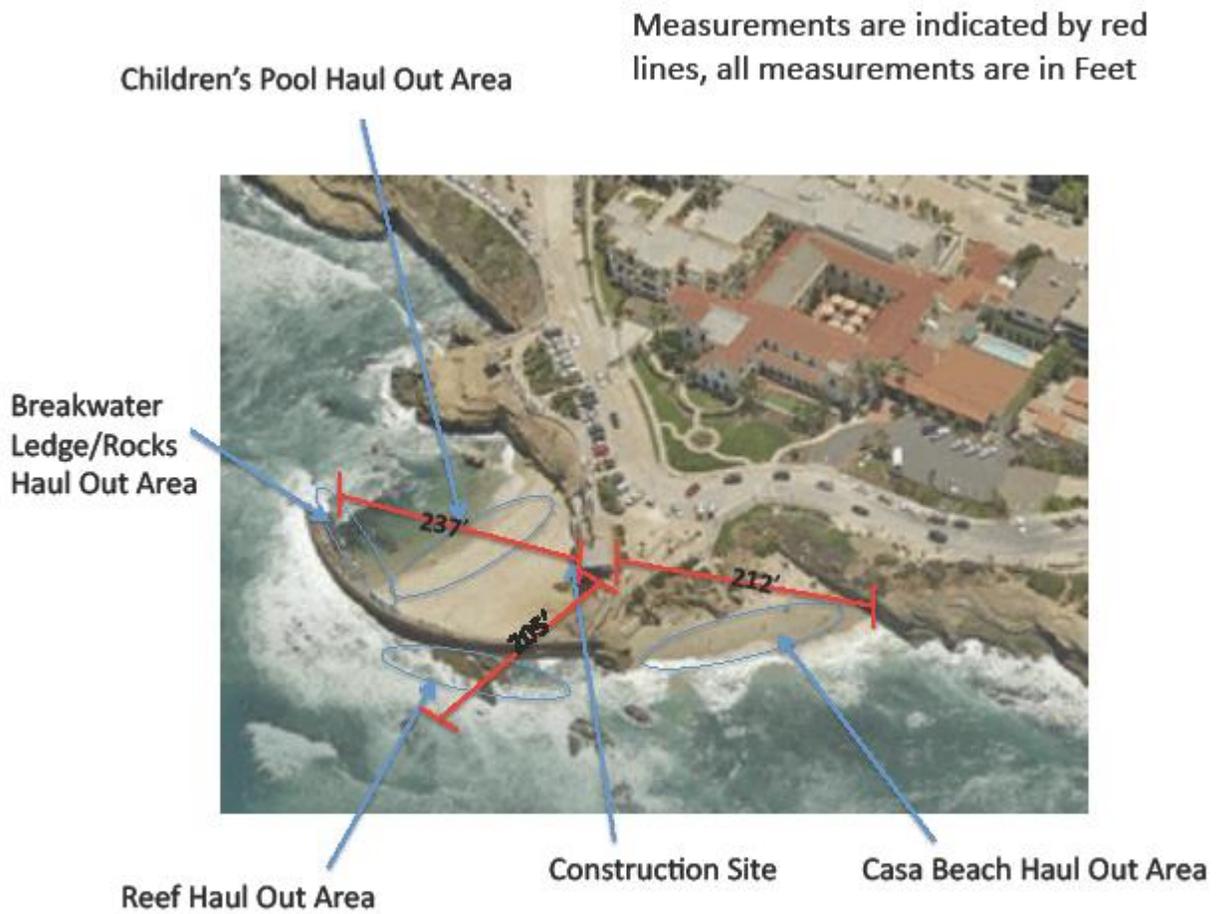
Figure 7. Children's Pool construction site and measurements away from construction site.

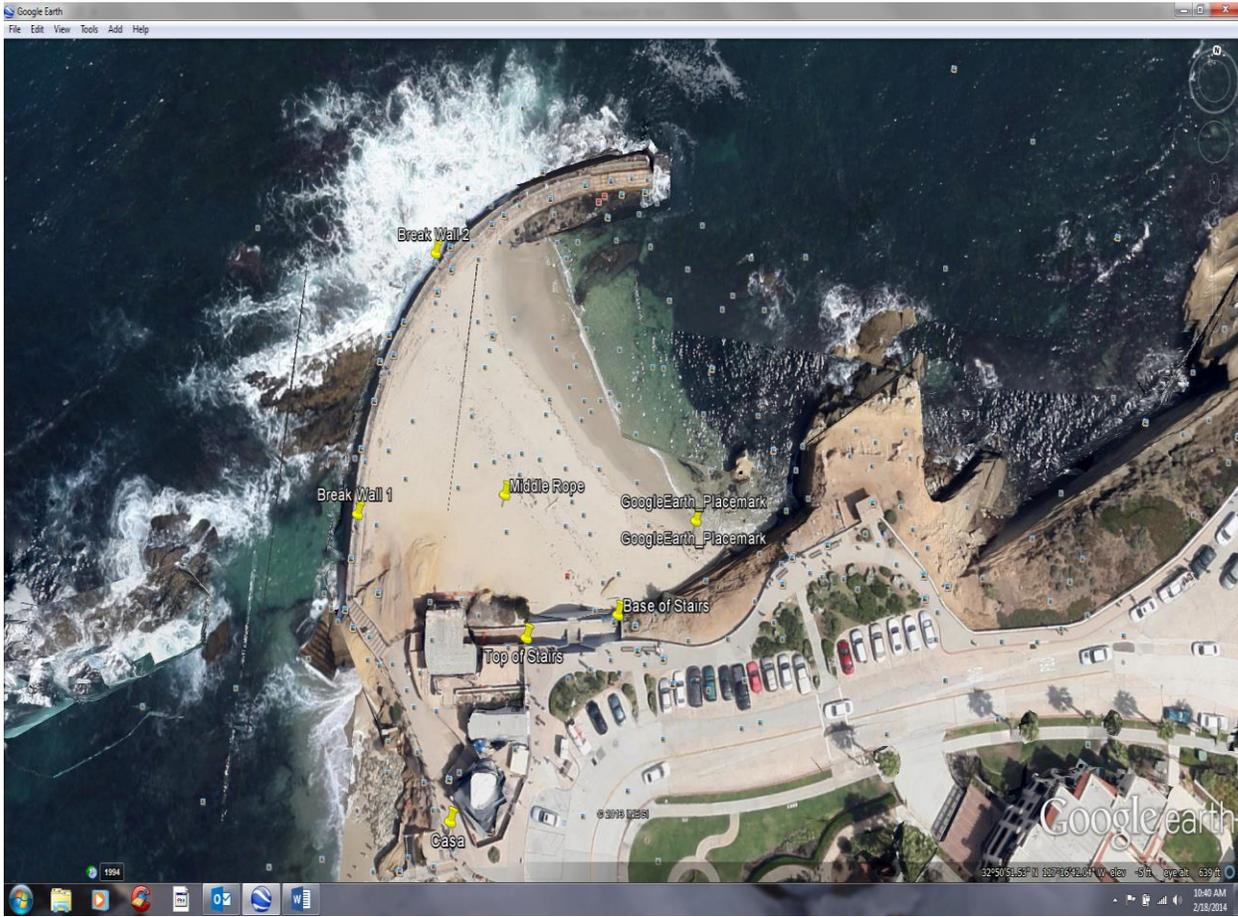
Figure 8. Location of monitoring stations (Top of Stairs, Bottom of Stairs, Middle Rope, Casa, Breakwall 1, and Breakwall 2) at Children’s Pool, La Jolla, CA.

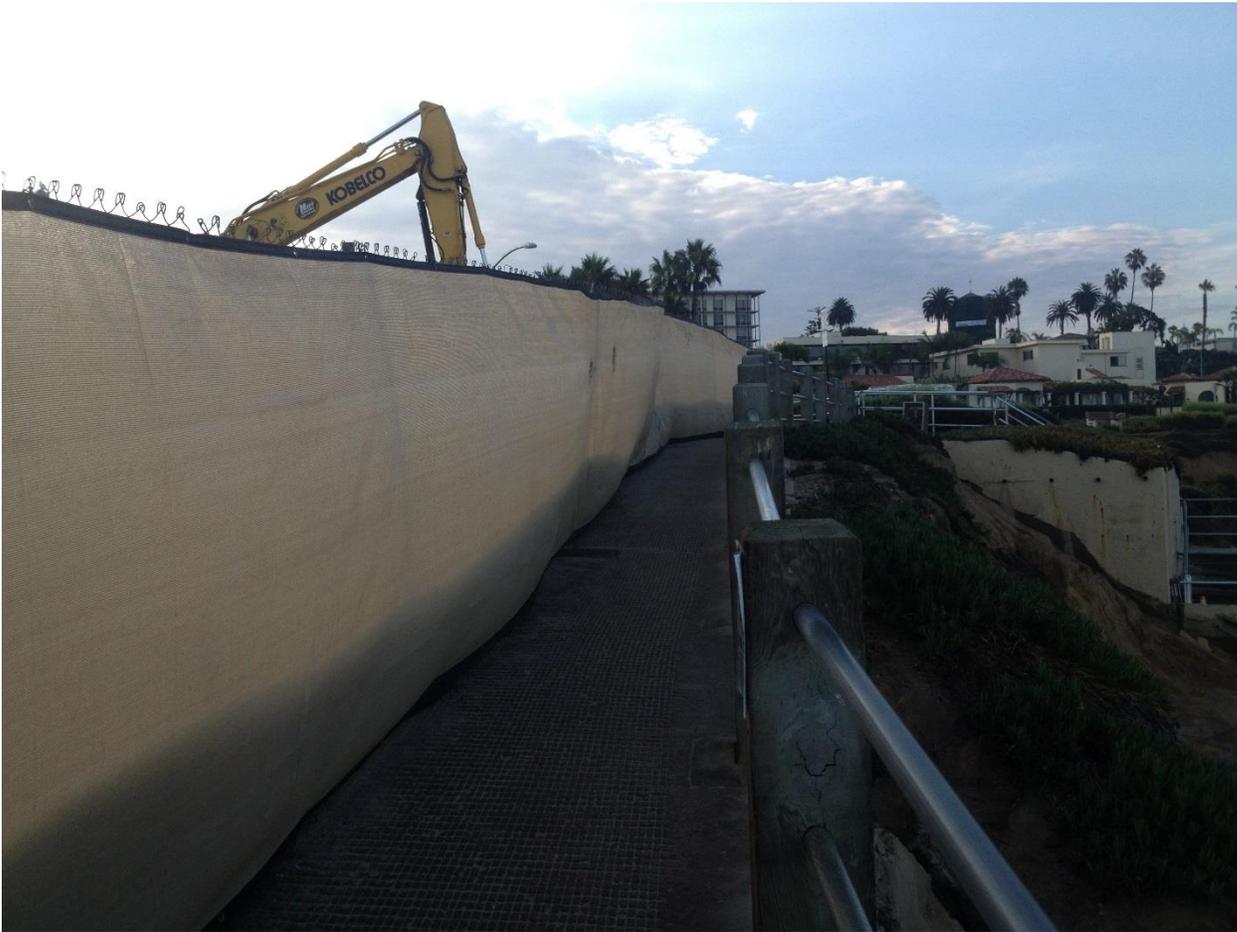
Figure 9. Monitoring location: Casa (above Casa Beach and next to construction site).

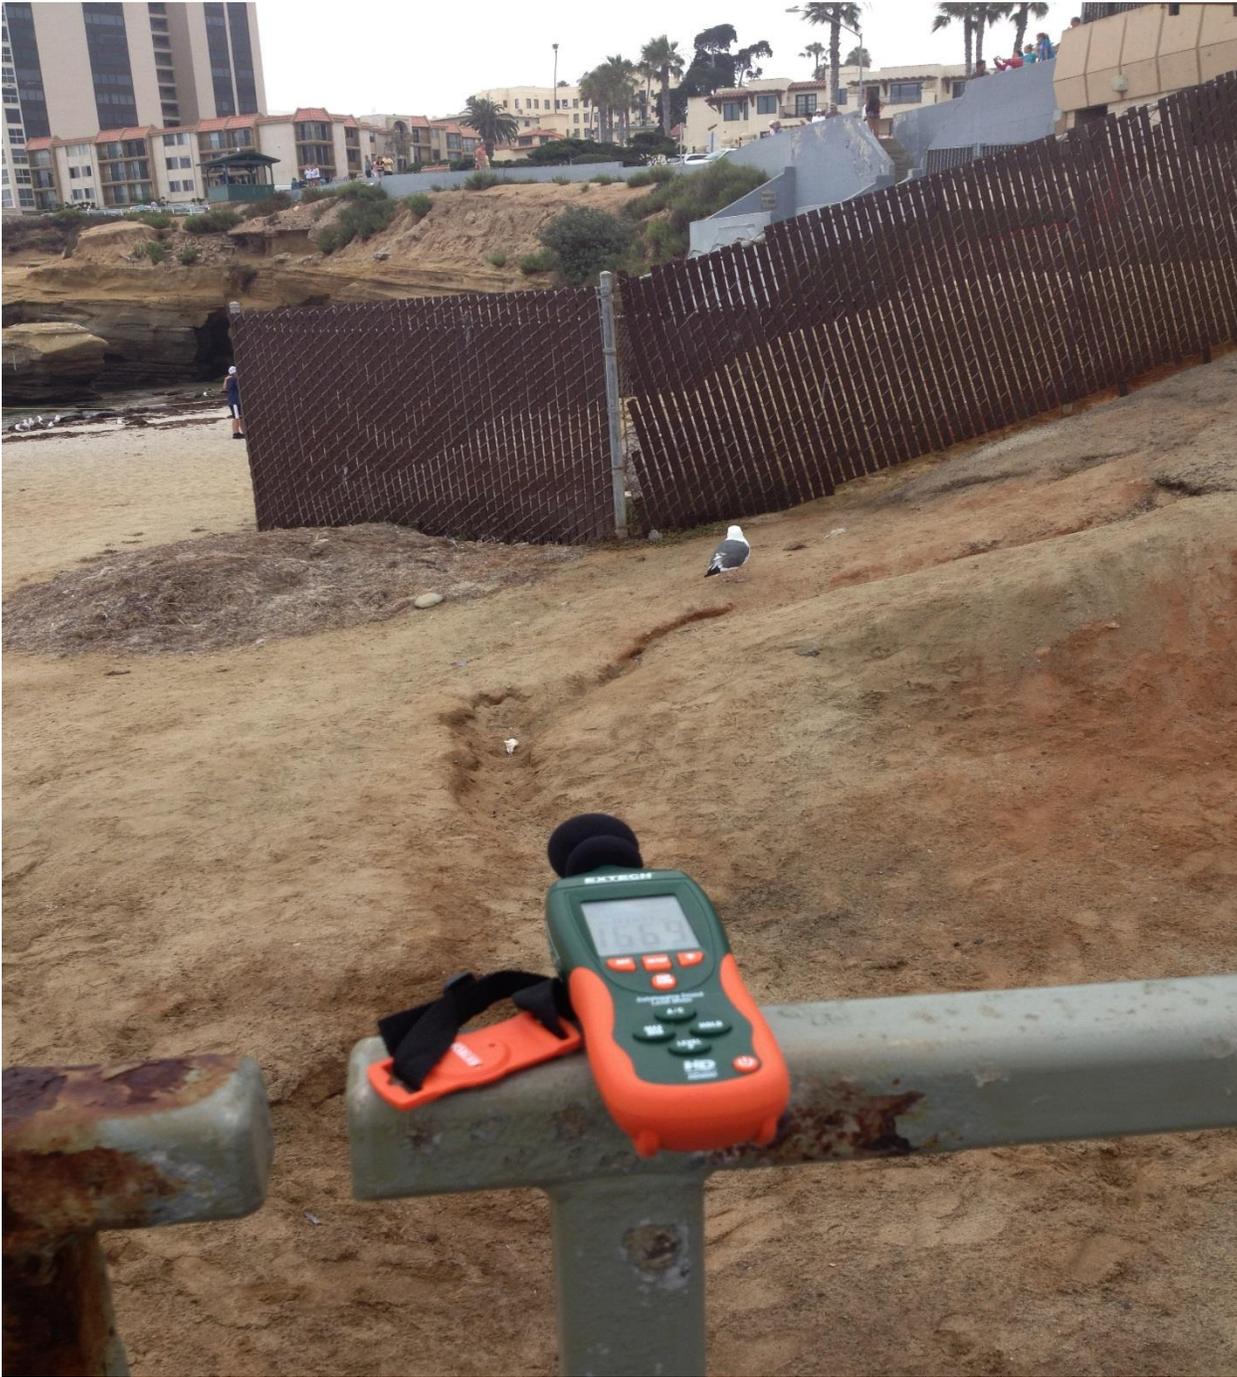
Figure 10. Monitoring location Breakwall 1 and sound meter on breakwater railing.

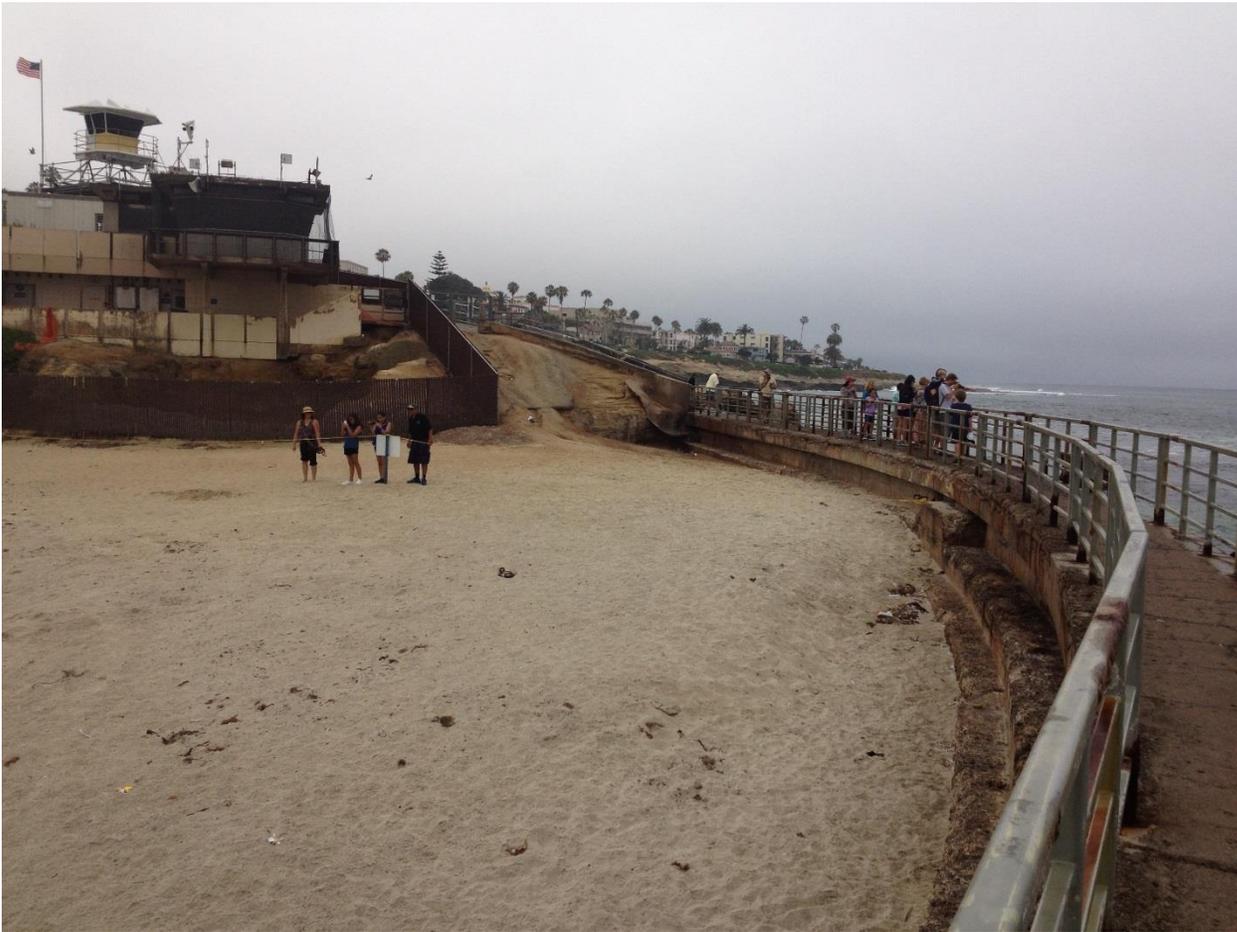
Figure 11. Monitoring location: Breakwall 2. Note Breakwall 1 located this side of second man on wall (tan shirt) and note yellow rope barrier on beach at white sign with four people standing on beach.

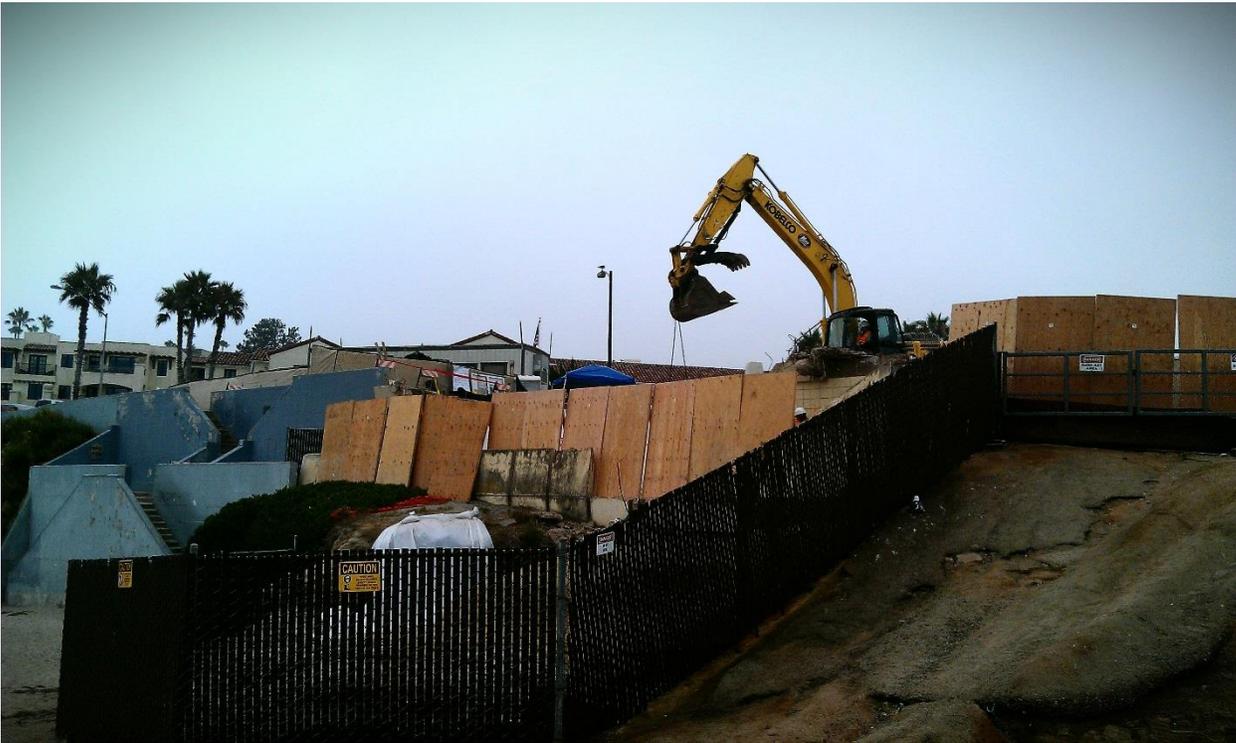
Figure 12. Moving visual/acoustic barrier to lower level of construction site after removal of old building.

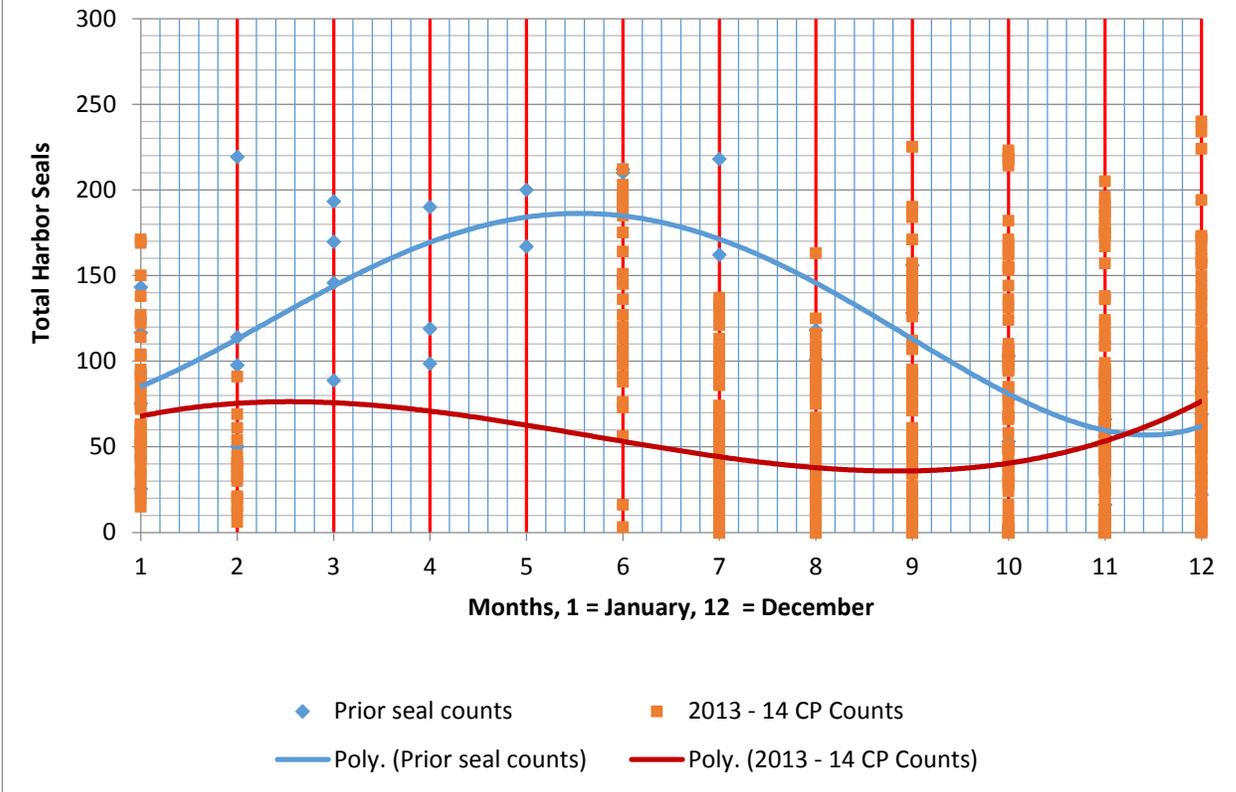
Figure 13. Estimated total seals by month based on counts at the site by Hanan & Associates, Yochem and Stewart, and Children’s Pool docents. Polynomial curve fit to counts by month was used to estimate harbor seals expected to be hauled out by day (blue). CP counts for 2013 – 14 are shown in red with trend line.

Actual counts and mean trends of seals observed during the period authorized by the 2013 IHA are shown in Figures 13, 14, and 15 fit with 3<sup>rd</sup> degree polynomial trend lines; predicted harbor seals hauling out by day as projected from previous studies at CP with upper and lower 95% confidence intervals included in Figure 15. Also shown on Figure 14 are juvenile harbor seals present which was added into the CP total. The third data set is displayed as the hourly totals by day for CP, Seal Rock, and Casa Beach added together as the Area Total with a trend line (Figure 14). We note that CP Total and Area Total showed declining trends prior to start of construction. We observed that public interactions seemed to be increasing during that time and also noted that there were large numbers of seals hauling out at night and into early morning hours (Figure 6). Because of these observations, H&A started randomly estimating numbers of seals hauled out at various times of the night using the WAN camera; which was set up for night vision (Figure 15, red trend line) and we moved our daily monitoring start time to just before dawn, frequently an hour or more before start of construction. During this time period, our peak count for monitoring was often during the first or second count of the day (Figure 6), before people/visitors started arriving at CP. Once the camera was removed (it

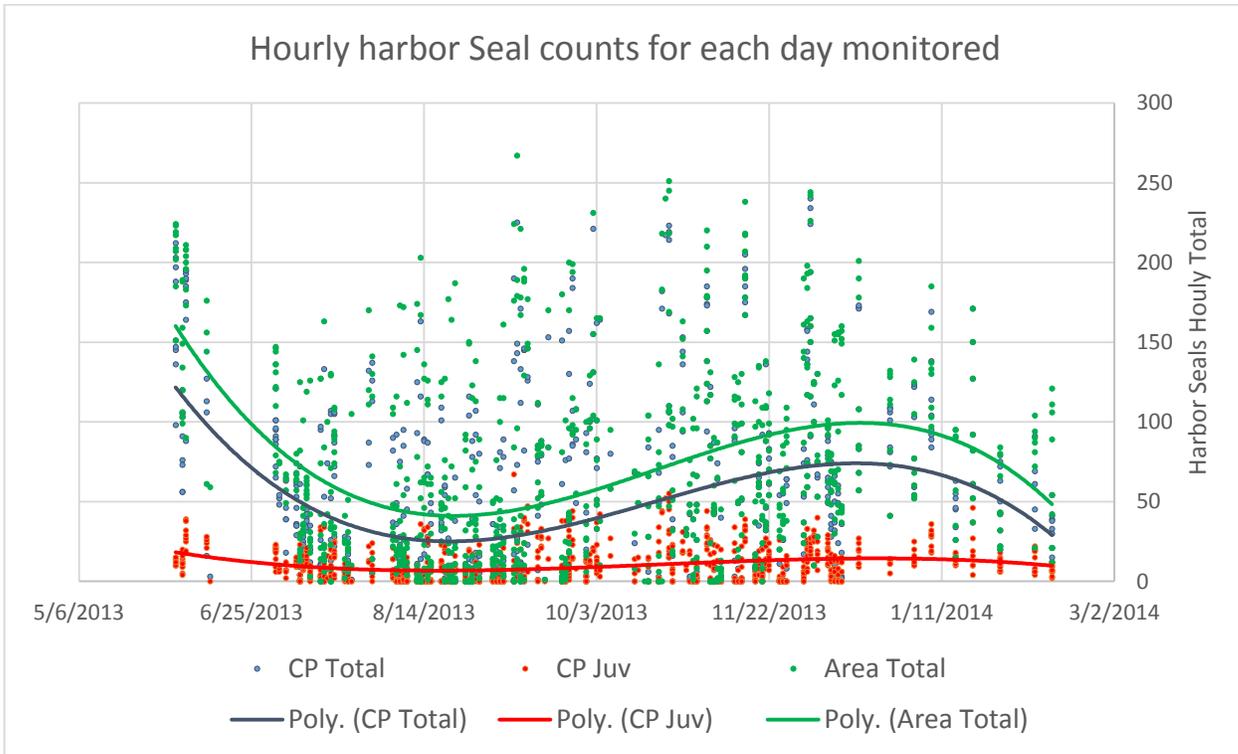
Figure 14. All counts of harbor seals 6/3/2013 – 2/12/2014 and third degree polynomial trend lines. Area Total includes CP Total; CP Juveniles included in both totals.

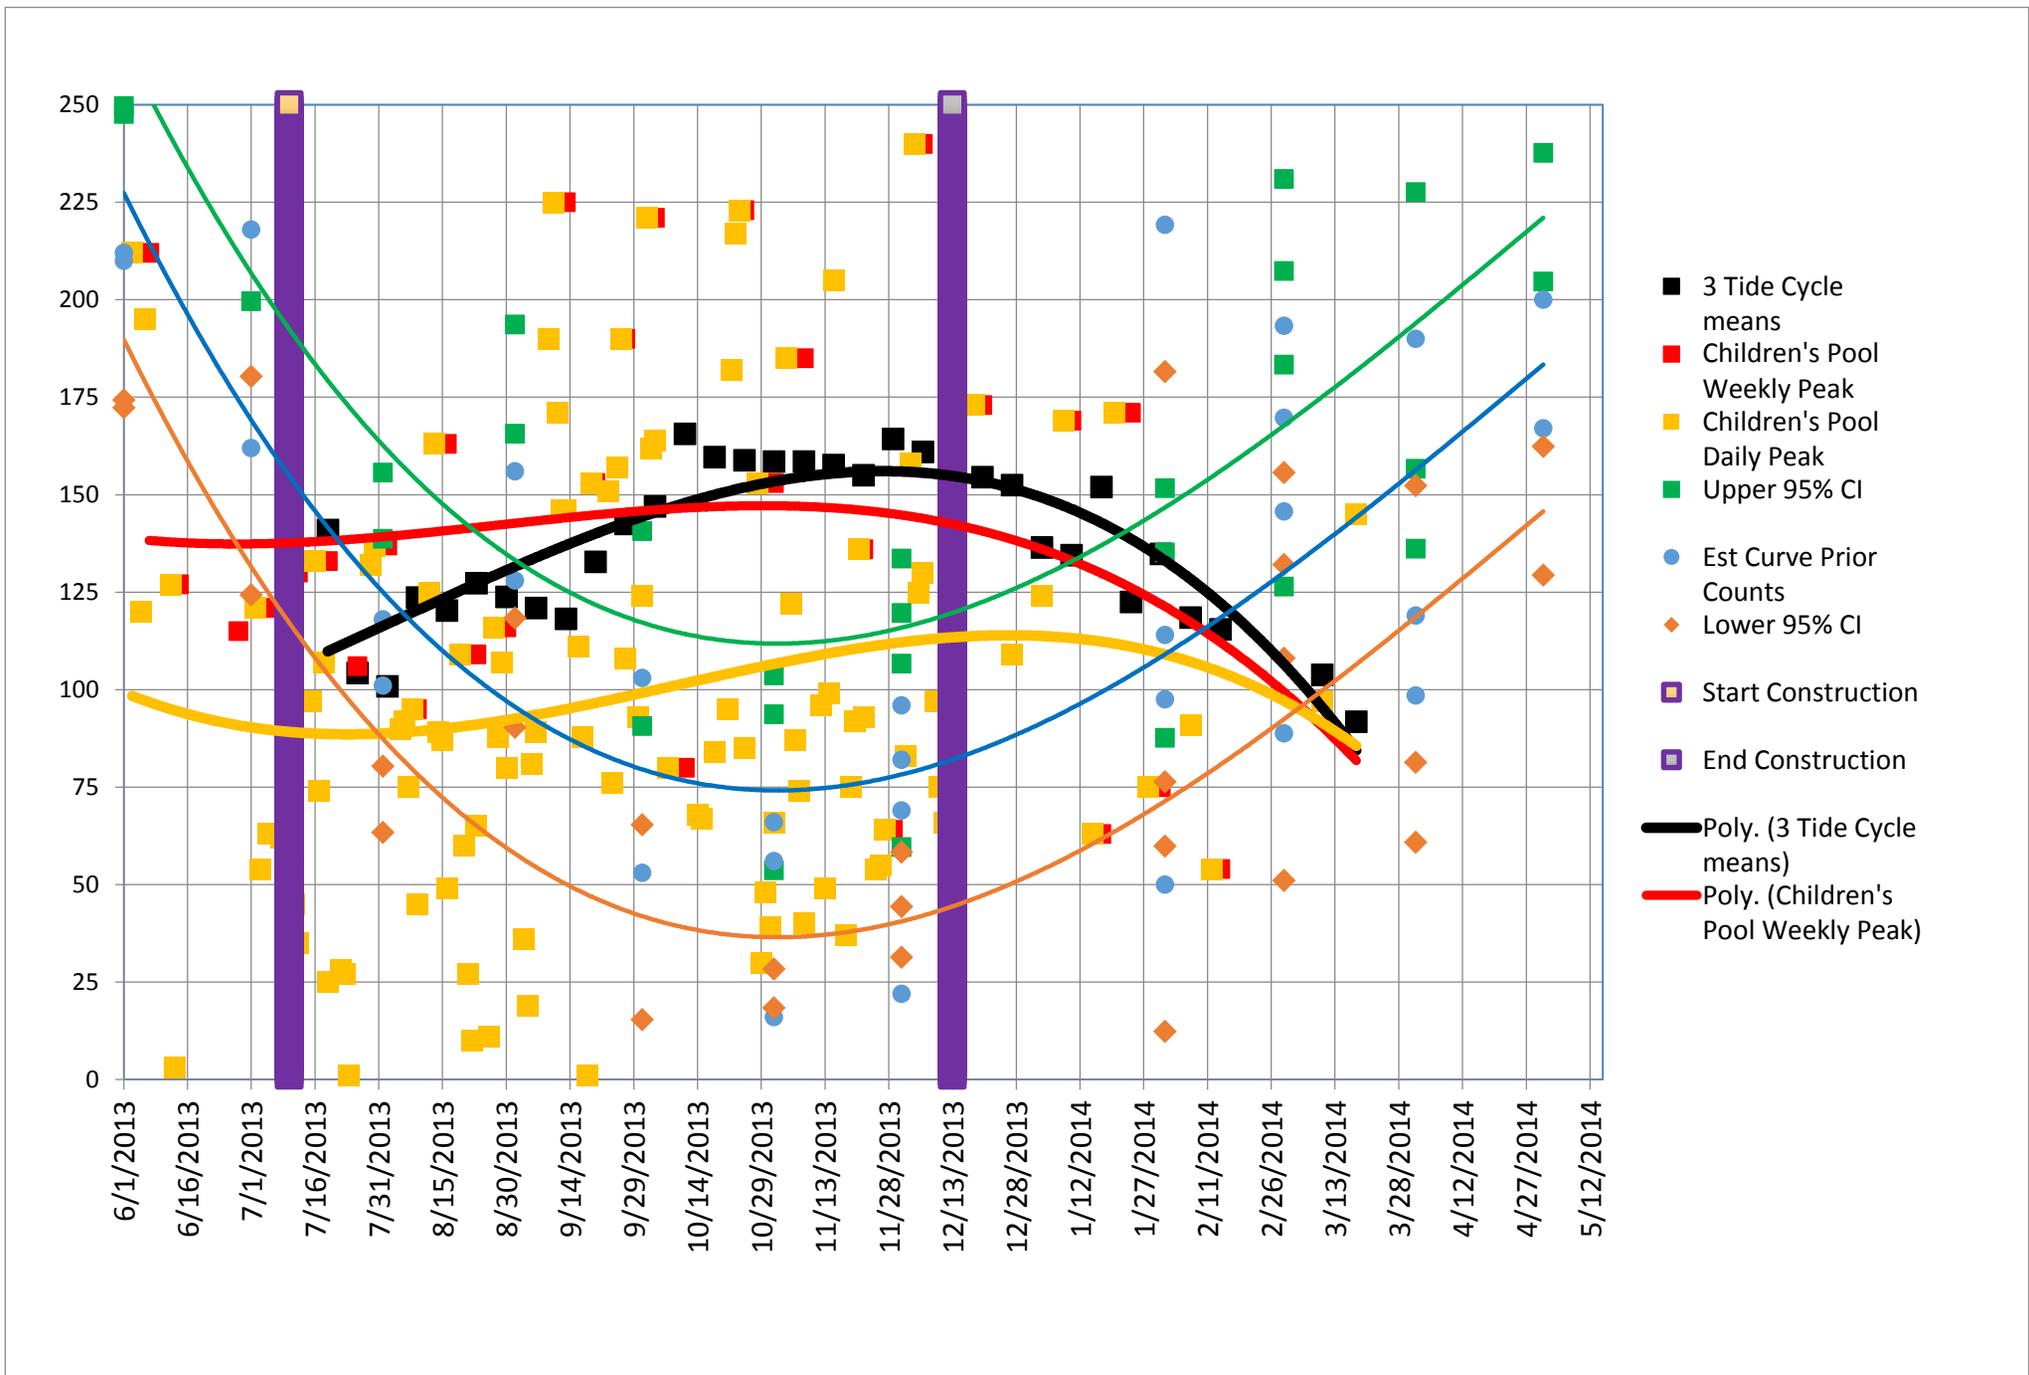
Figure 15. Children's Pool Harbor Seal Daily counts, Weekly Peak Haulout Counts, and running mean of counts during three tide cycles; Predicted haul out curve with upper and lower 95% Confidence Levels and solid vertical lines for Start (7/10) and End (12/13) of construction.

- regarding weekly mean comparisons to the previous three tide cycles please see Figure 15 which has a running six week mean for CP. This mean is well above the lower 95% confidence interval for the predicted CP mean based on previous CP studies. In fact the running mean is above the previous mean for most of the construction period and even above the upper 95% confidence interval for the latter two thirds of the construction period. All three 2013 curves decline following construction and converge mainly because of reduced sample size including two points in March which were opportunistic single counts by Dr. Hanan, which increased the likelihood of missing daily and weekly peak counts.
