Final Report  
Incidental Harassment Authorization  
for June 28, 2014 – June 27, 2015 to the City of San Diego for  
La Jolla California Children’s Pool Construction and Harbor Seal Monitoring

City of San Diego  
Public Works Department  
Engineering and Capital Projects Branch  
Architectural Engineering and Parks Division

by  
Doyle A. Hanan, PhD  
Hanan & Associates, Inc.

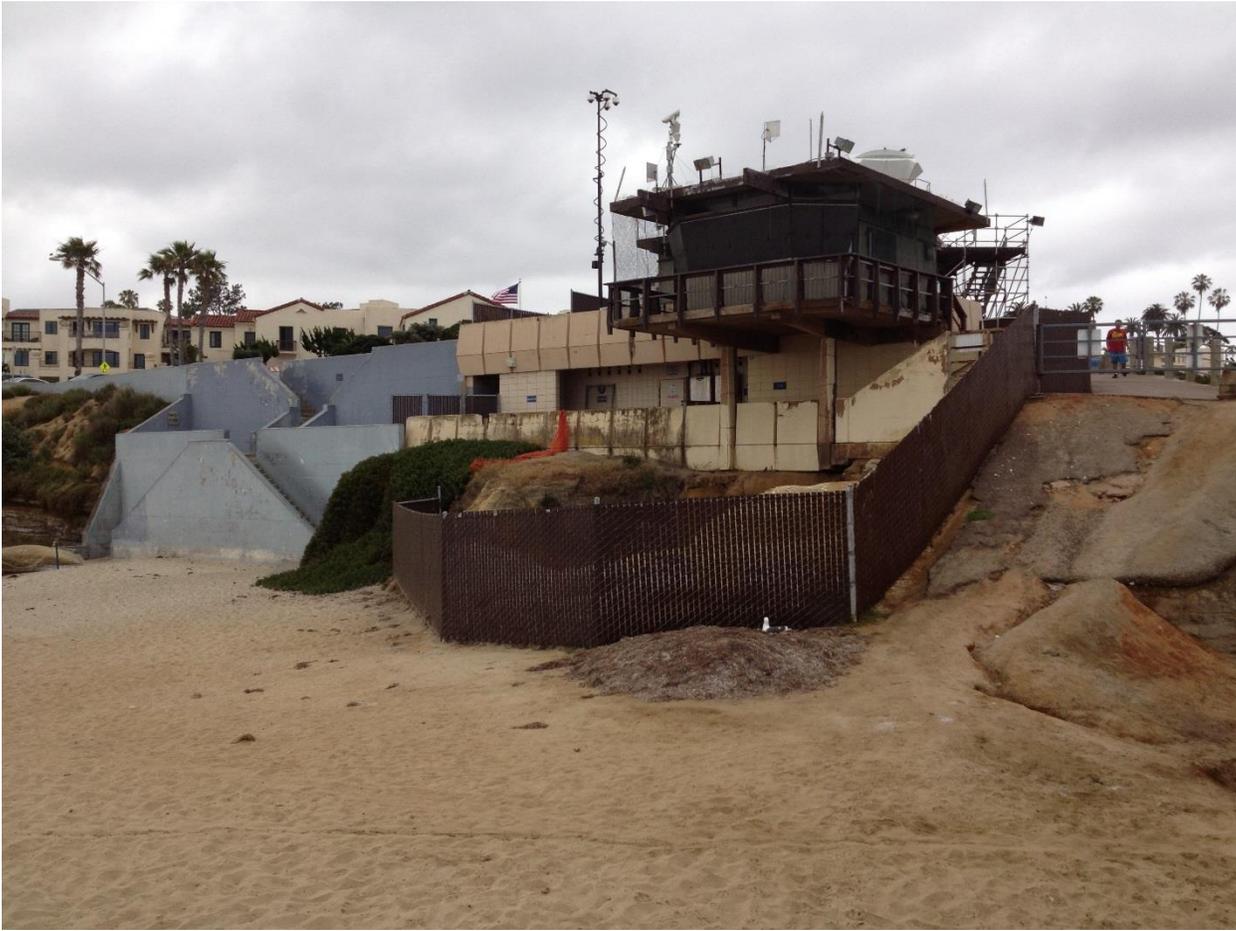
Figure 1. Old Lifeguard Station from beach level at Children's Pool, La Jolla, CA.

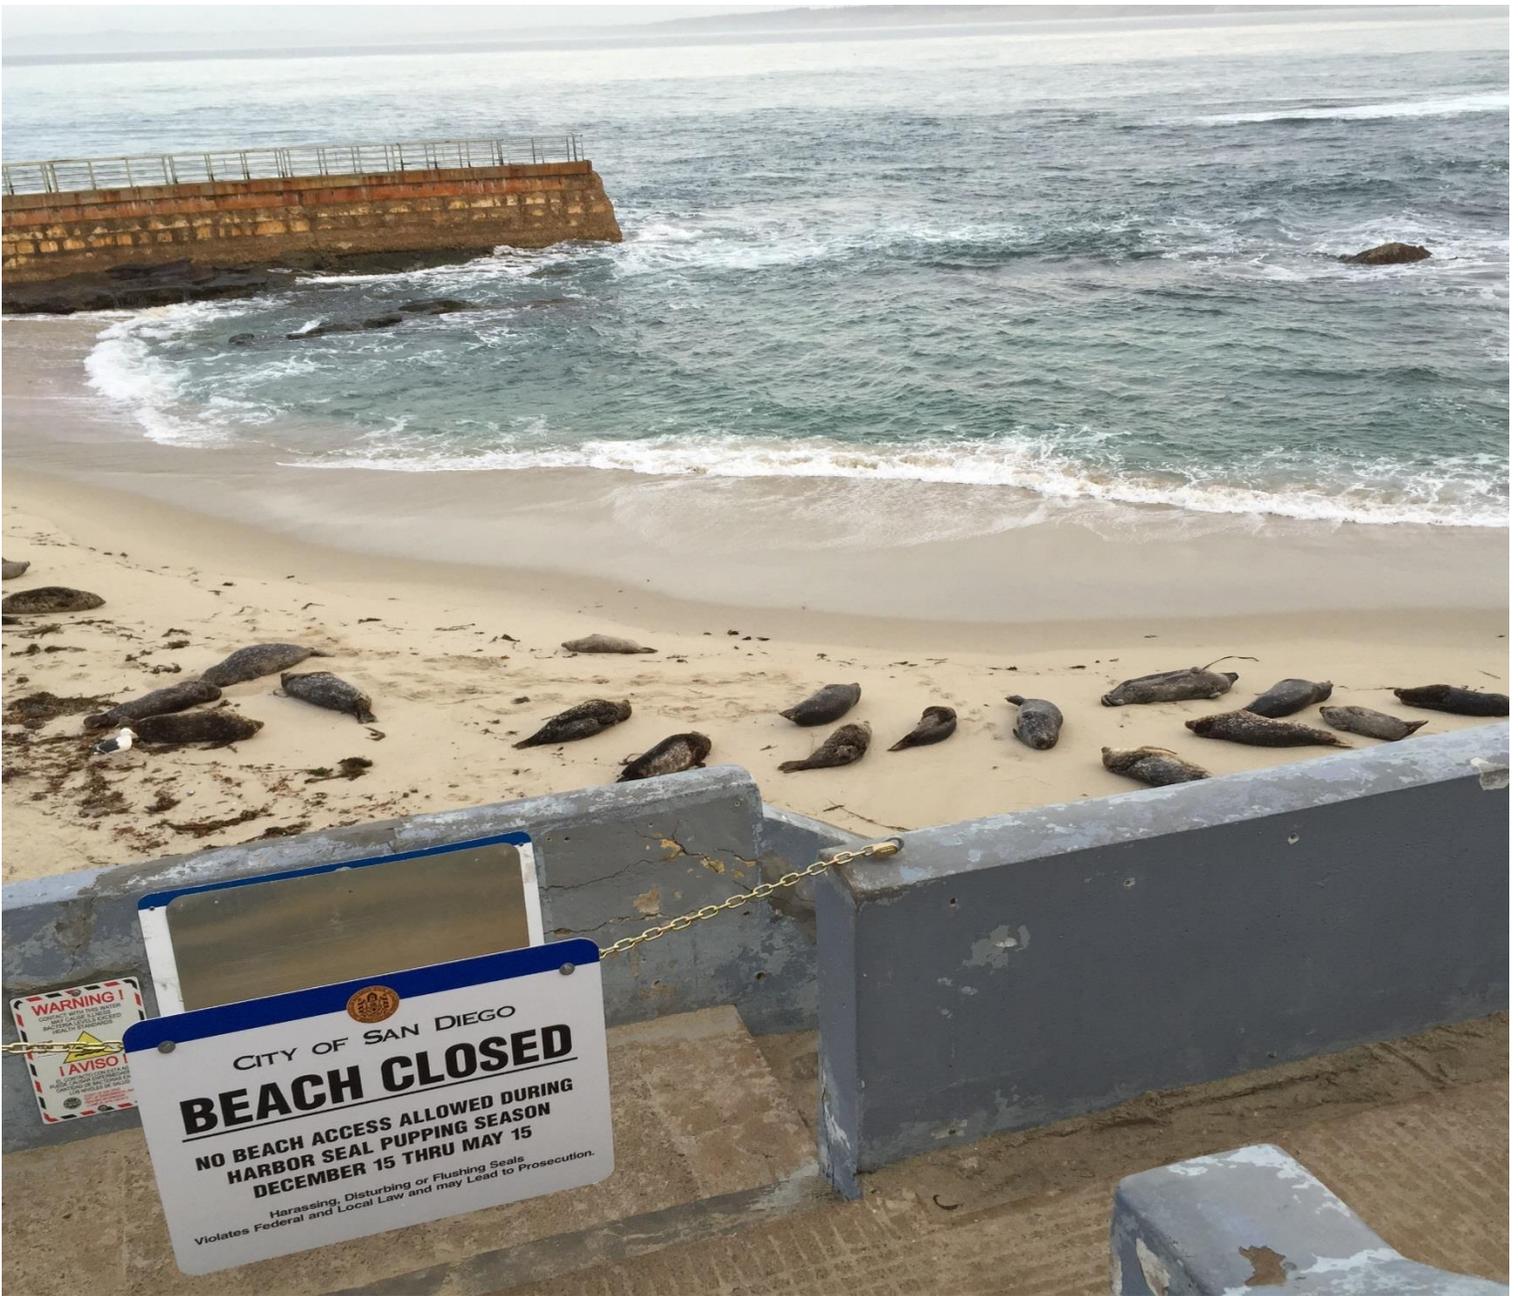
Figure 3. Children's Pool Beach closure sign installed by the City of San Diego December 15, 2014.

As an additional protective management measure for the seals at CP, the City of San Diego closed CP Beach to the public during pupping season, December 15 through May 15, 2015. This measure has been effective in keeping most people off the beach although we did record instances of violations and noted the likelihood of people on the beach at night based on footprints observed in early morning (Figures 3 and 4).

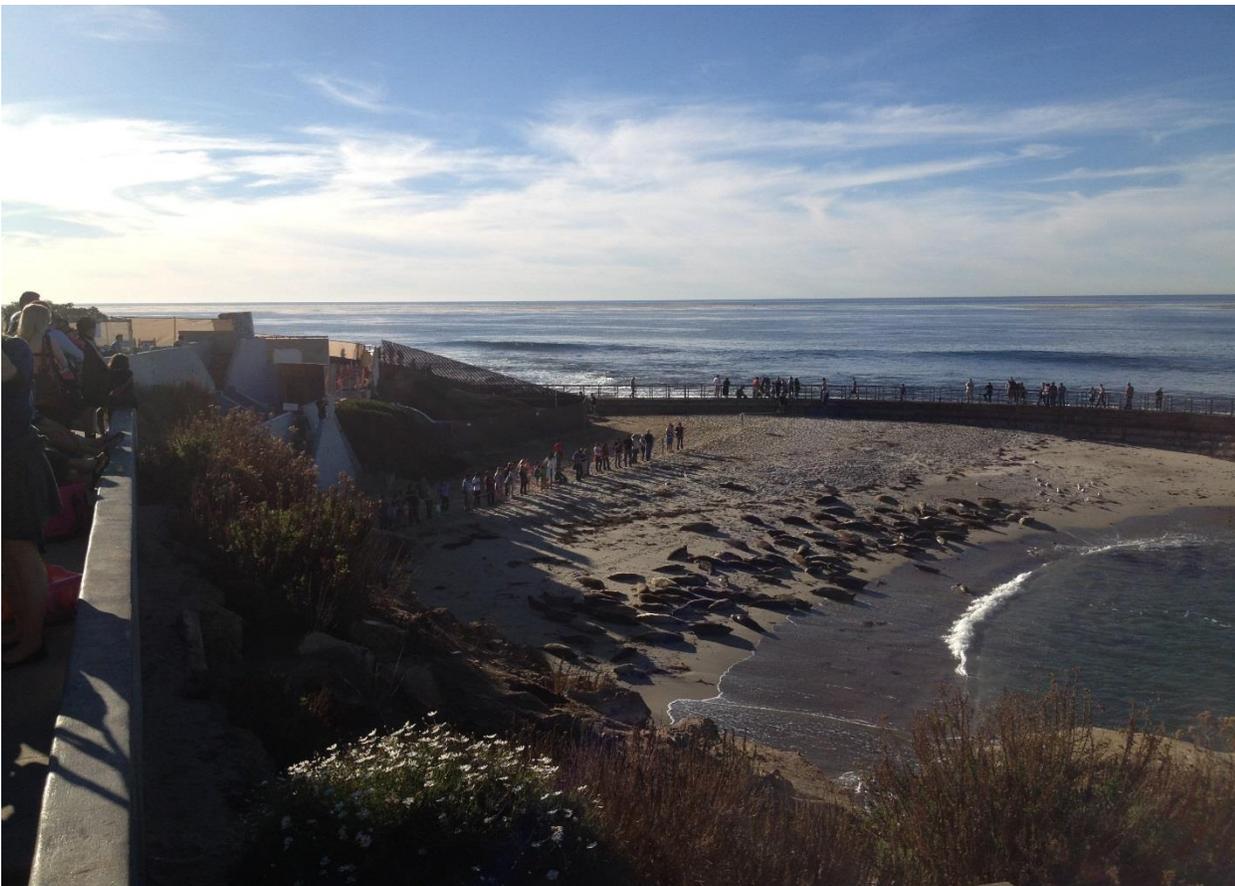
Figure 4. Children’s Pool visitors viewing seals during the 2013-4 pupping season construction moratorium. During the 2013-14 pupping season, docents documented over 60 seal births; this 2014-5 season on March 13, 2015 we observed 60+ pups at Children’s Pool Beach therefore total births were higher this year.

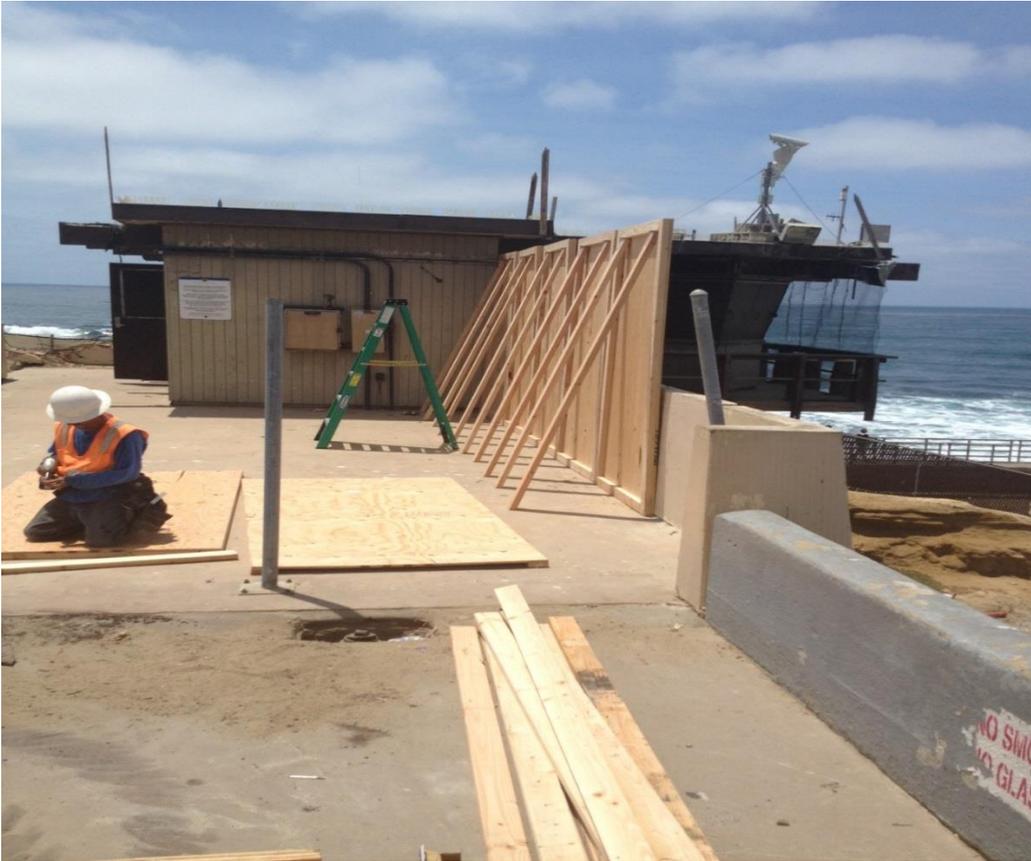
Figure 5. Building visual/acoustic barrier as seen from monitoring location: Top of Stairs (at juncture of tan and gray walls) next to construction site. Old station is in background with seal cam on top of building.

-Sheets of 4 ft. by 8 ft. by 5/8<sup>th</sup> inch plywood framed with wooden two by fours were used to create the visual/sound barrier. The sheets of plywood were stood upright (8 feet tall) and held up with two wooden two by fours hinged to the top of the frame, so they could be collapsed and be moved depending on equipment location and need for access by equipment (See figures 5 and 12).

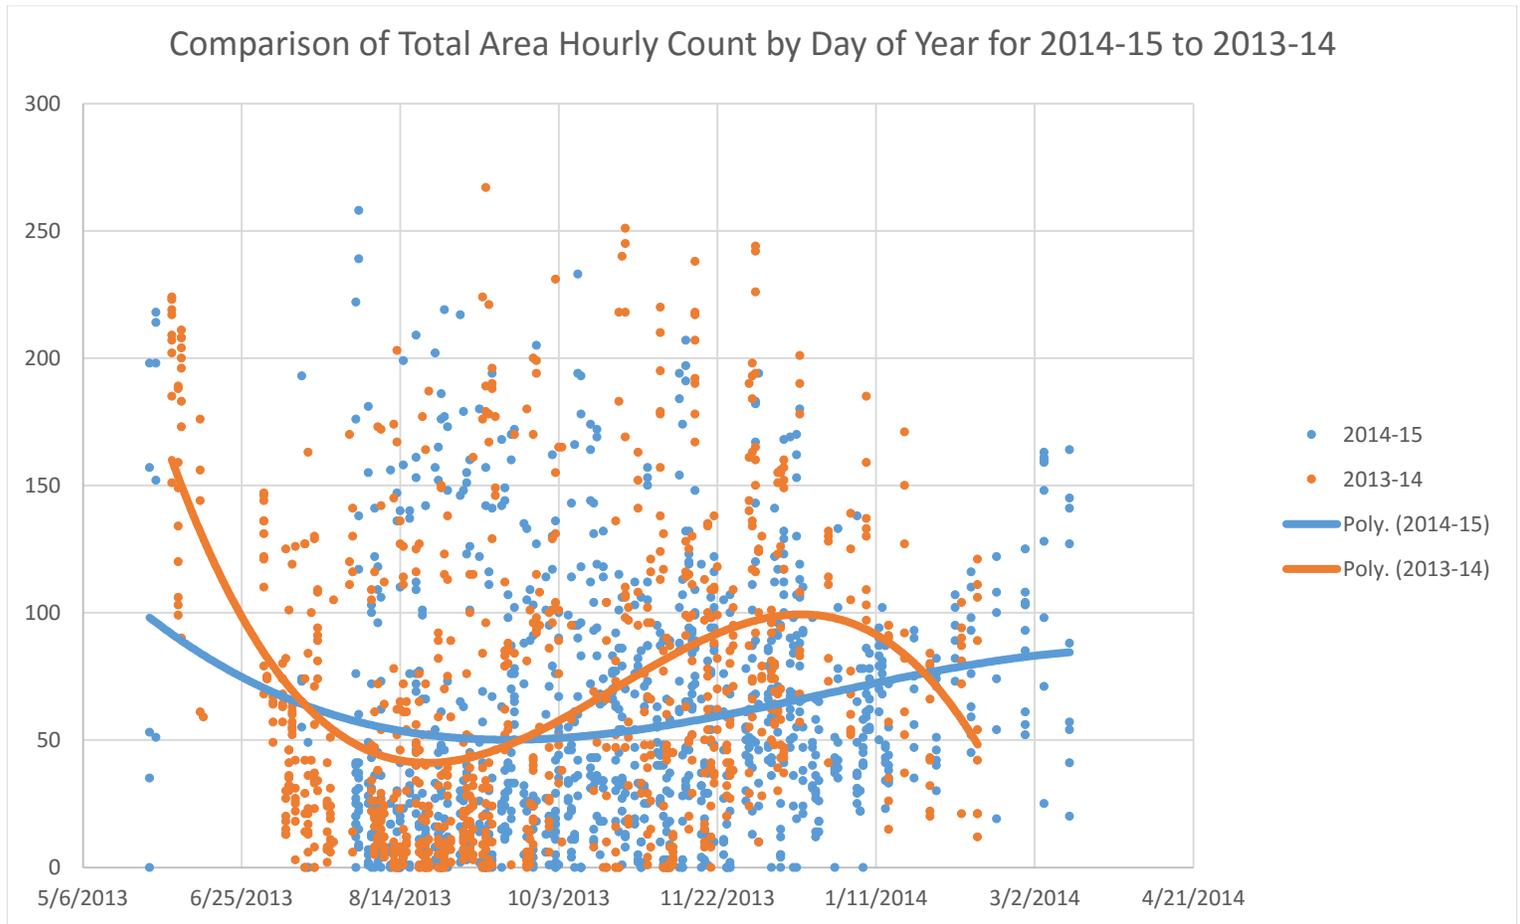
Figure 6. Harbor seal counts during most recent construction period (2014-15, blue trend line) compared to previous period (2013-14 red trend line) at Children’s Pool, La Jolla, CA. Counts include CP beach, South Casa Beach, Seal Rock, and reef area.

- After the first two months of monitoring, H&A evaluated mean and peak counts of harbor seals at CP relative to historic and projected abundance estimates (see Figures 6 and 7) and presented the findings to NMFS. Based on those data, we determined that harbor seal numbers were increasing during the two-month period and therefore site abandonment was not likely.

Counts and mean trends of seals observed during the period authorized by the 2014 IHA are shown in Figures 6 and 7 fit with 3<sup>rd</sup> degree polynomial trend lines; predicted harbor seals hauling out by day as projected from previous studies at CP with upper and lower 95% confidence intervals included in Figure 7. Also shown on Figure 14 are juvenile harbor seals present which were added into the CP total. The third data set is displayed as the hourly totals by day for CP, Seal Rock, and Casa Beach added together as the Area Total with a trend line (Figures 6 and 7). We note that CP Total and Area Total showed declining trends prior to start of construction. We observed that public interactions seemed to be increasing during that time and also noted that there were large numbers of seals hauling out at night and into early morning hours (Figure 9). We moved our daily monitoring start time to just before dawn rather than just before construction, frequently an hour or more before start of construction. During this time period, our peak

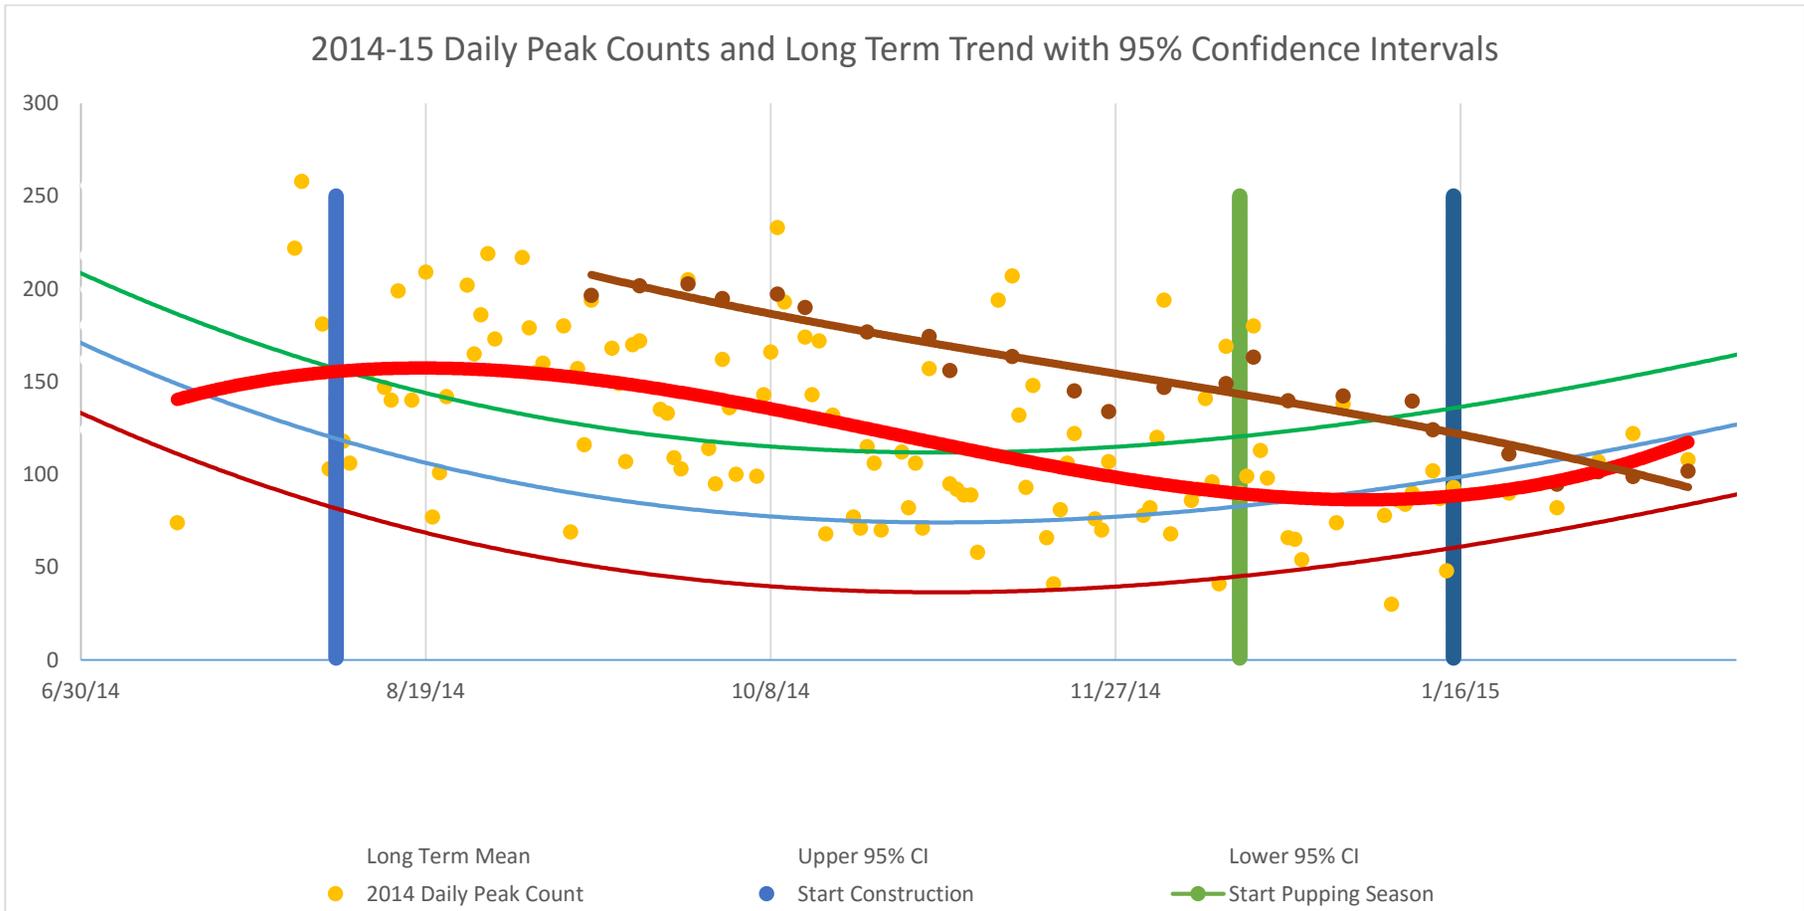
Figure 7. Children's Pool Harbor Seal Daily counts, Weekly Peak Haulout Counts, and running mean of counts during three tide cycles which stays above the lower 95% confidence level; Predicted haul out curve with upper and lower 95% Confidence Levels and solid vertical lines for Start (8/6/14) and End (12/15/15) of construction and finish of ramp South Casa Beach (1/15/15).

- regarding weekly mean comparisons to the previous three tide cycles please see Figure 7 which has a running six week mean for CP. This mean is well above the lower 95% confidence interval for the predicted CP mean based on previous CP studies. In fact the running mean is above the previous mean for most of the construction period and even above the upper 95% confidence interval for the latter two thirds of the construction period.

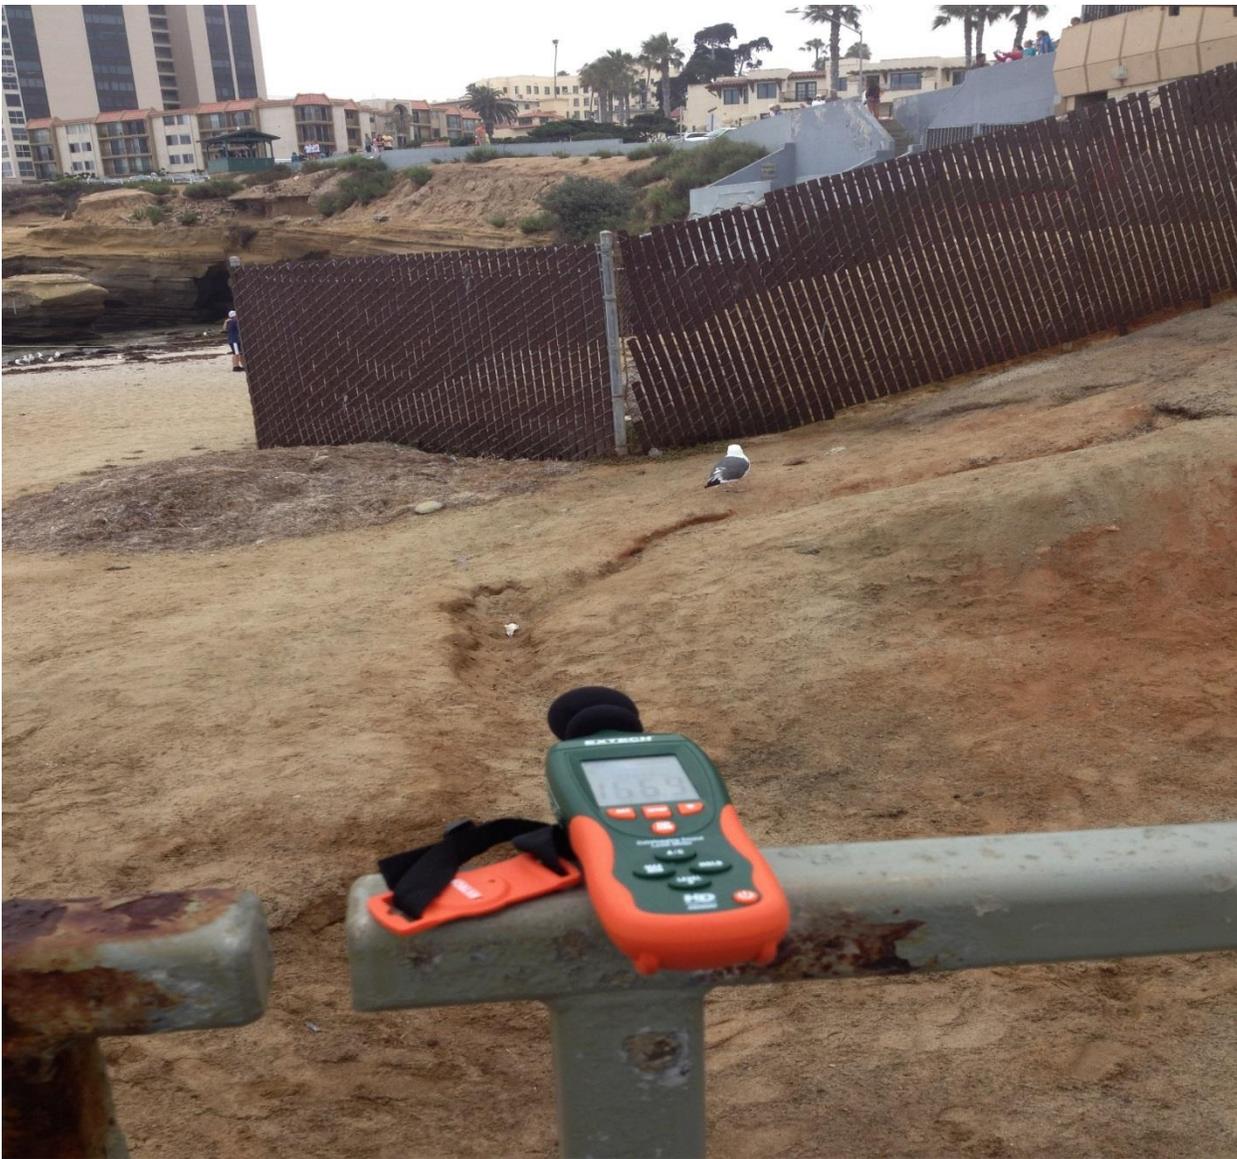
Figure 8. Monitoring location Breakwall 1 and sound meter on breakwater railing.

We recorded sound using an Extech® Instruments (model HD600) digital, handheld sound level meter recording in decibels. We recorded the maximum sound within a two-minute interval, fast (125 ms) response time, A-weighting, within a range of 30 - 130 dB as recommended by the manufacturer and distributor. When seals were above or very near the rope at the center of CP beach, we often did not go onto the beach to take recordings and possibly flush the seals. However, if members of public had already approached the seals at the rope, we proceeded with the recordings at all stations. For safety, no measurements were taken at Breakwall 1 or 2 when waves were breaking over the seawall. Mean ambient sound with no construction for all seven monitoring stations (n = 454) was 68.9 dB re 20 µPa (69.2 in 2013) with a range of 51.5 to 97.2 dB re 20 µPa (55.6 to 93.7 in 2013). This maximum recording (97.2 dB) represents screaming people on the sea wall about 0.5 meter from the monitor (Breakwall 1, Figure 8). Mean average sound during construction for all seven monitoring stations (n = 3,113) was 71.3 dB re 20 µPa (70.3 in 2013) with a range of 49.4 to 102.7 dB re 20 µPa (50.7 to 103.1 in 2013). This maximum recording was taken next to the construction fencing on the bluff above South Casa Beach (“Casa” monitoring site) and was recorded from a bobcat with jackhammer attached and the monitor was approximately 1 meter away. It did cause an alert of 5 seals about 10 meters from the source and 4 of them flushed into the water. We took another sound measurement on the beach below, 6 meters from the source and recorded 86.9 dB re 20 µPa. Thus the seals were not exposed to a sound level above 90.0 dB re 20 µPa. Please see Table 1 for summary results of recorded sound levels by individual type of equipment.

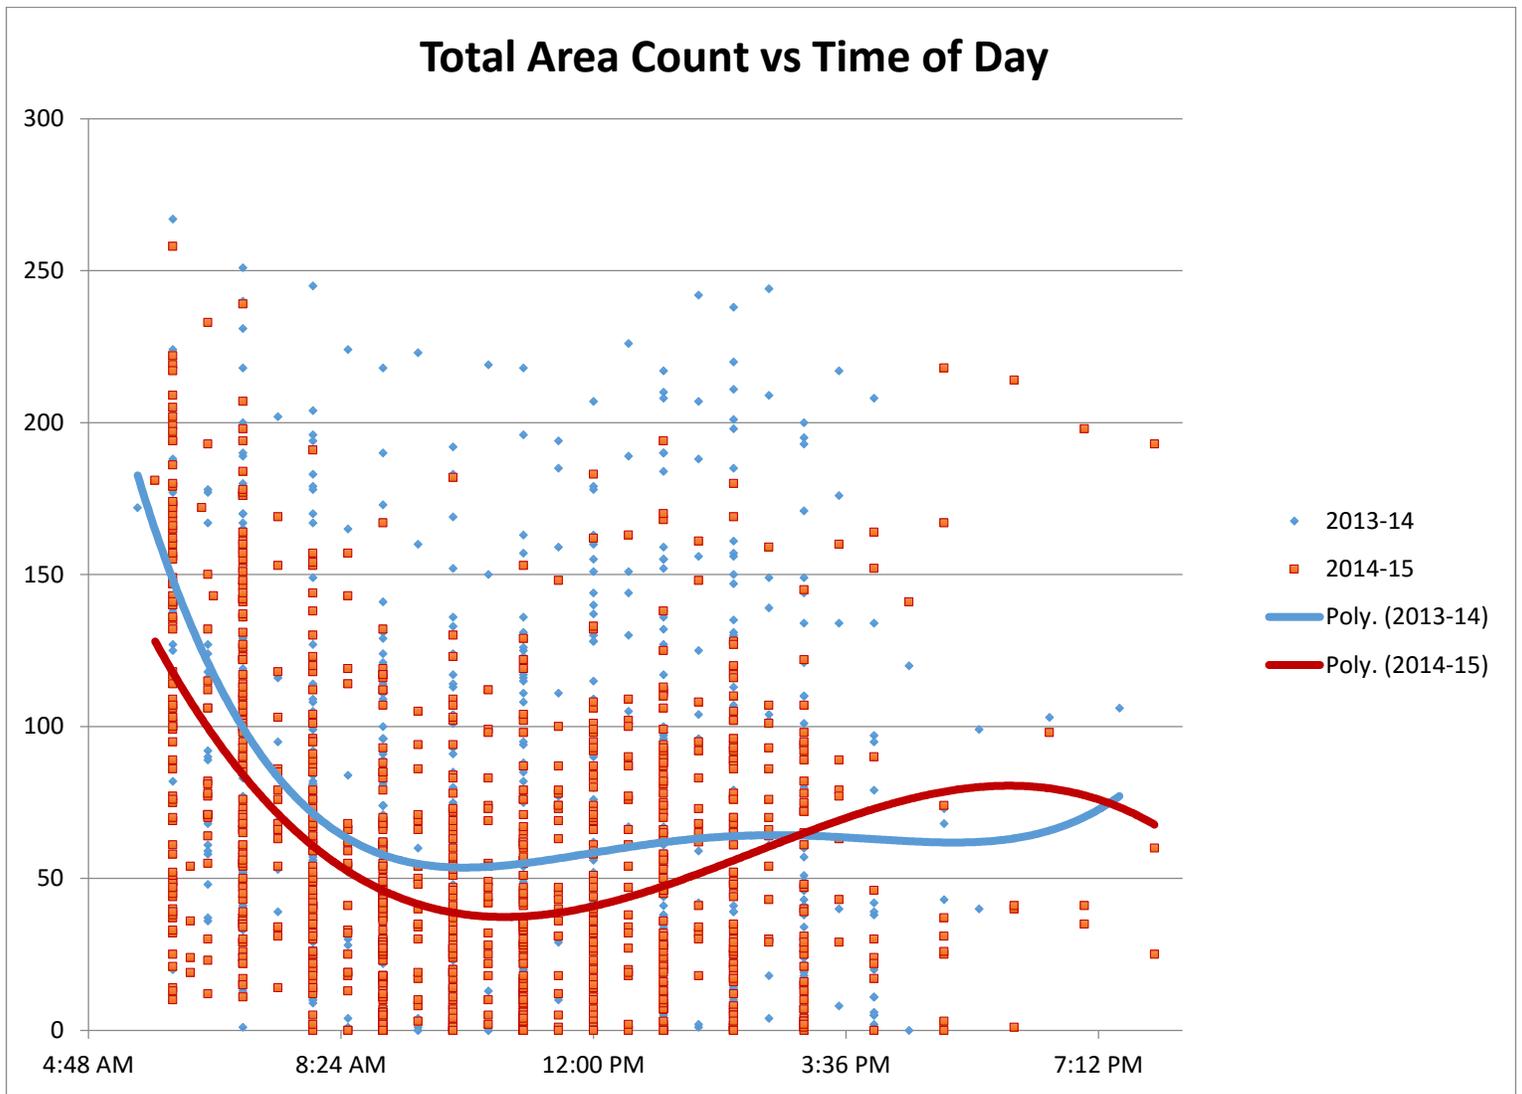
Figure 9. Comparison of 2013-14 to 2014-15 harbor seal counts by time of day. Note similarity and the early morning declining trend in both years.

count for monitoring was often during the first or second count of the day (Figure 9), before people started arriving at CP. Because of human disturbance at CP, daily peak counts (Figures 6 and 7) are likely better indicators of seals utilizing the area and the trend lines fit to peak counts better indicators seals present when comparing to other less disturbed seal hauling sites.

The trend line in Figure 9 below shows a relationship which we noticed both before and during construction that the number of seals tend to decline as the city starts to awaken and the day progresses; people start arriving at CP for various activities not always related to seal watching: joggers and walkers, traffic passing by, maintenance of facilities and landscaping, trash trucks, lifeguard activities, storm water sampling, seal photographers, and seal enthusiasts.

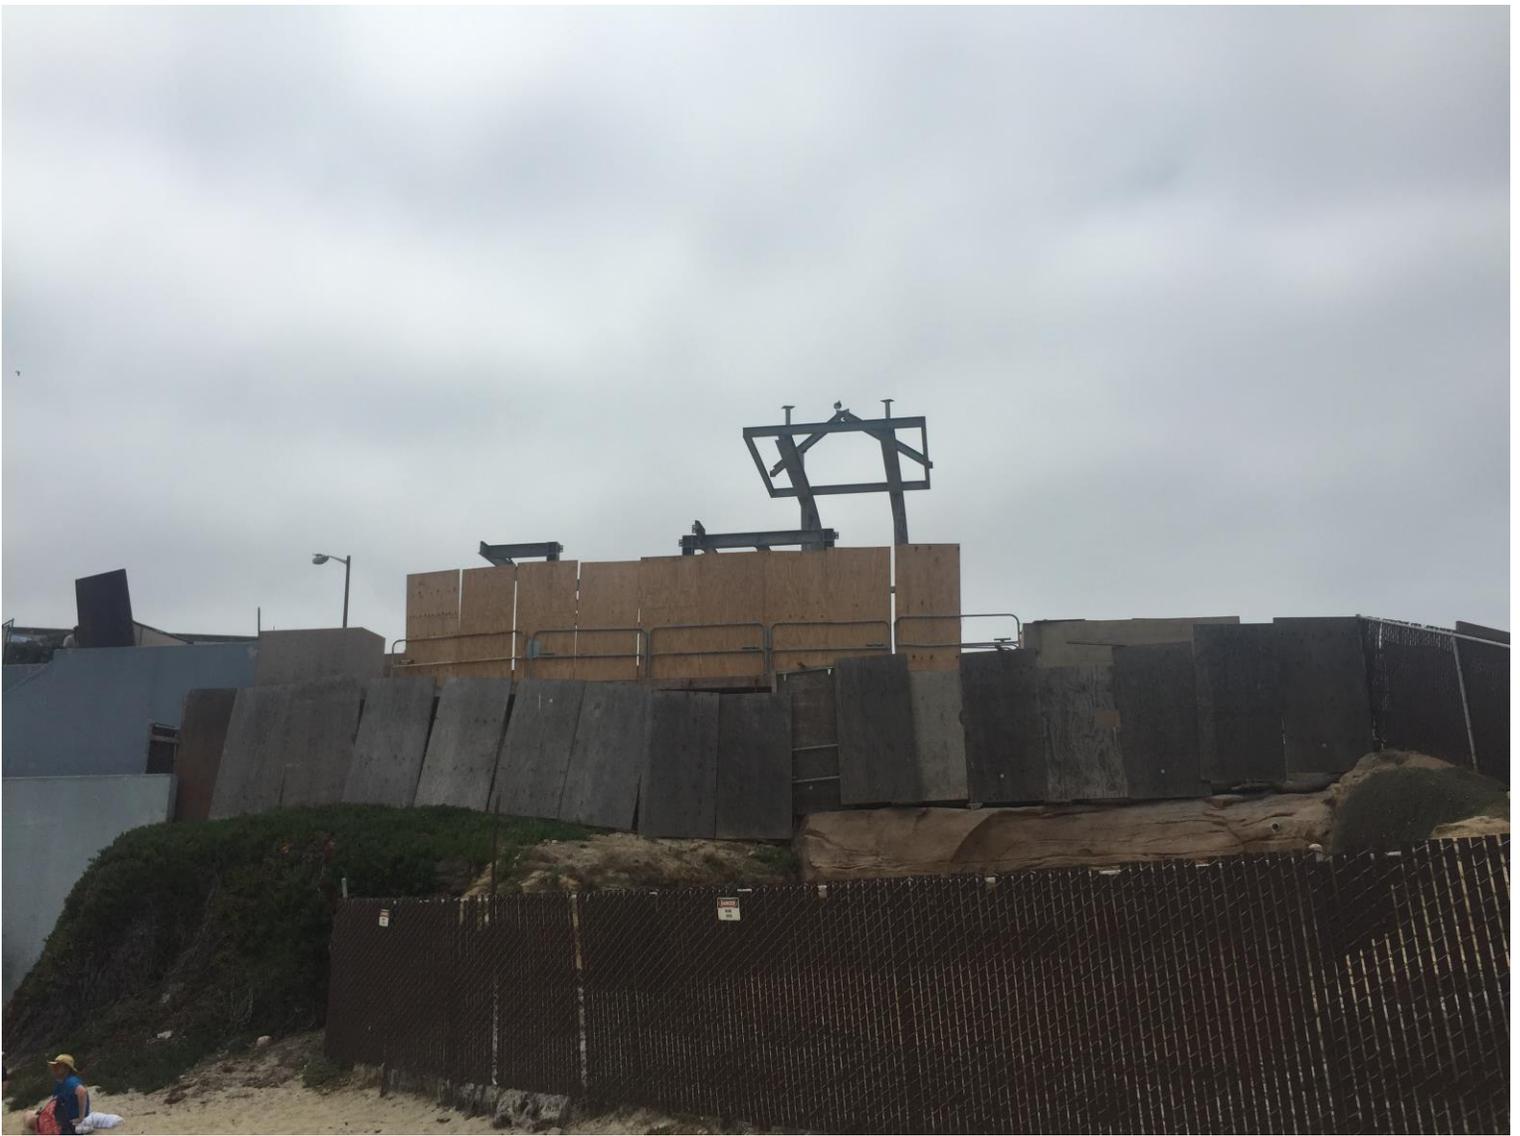
Figure 10. Children's Pool construction cite August 2015. Note two levels of sound and visual barriers plus chain link-visual barrier. Steel girders for life guard tower upper roof are in background.

June 1, 2015 was the beginning date for 2015-16 construction at CP; June was also the final month of the 2014-15 IHA. Because it was the beginning of construction we monitored for ambient sound and harbor seal behavior three days in May just prior to the new construction season. There were 18 days in June where actual construction activities occurred and during those days we documented 34 hours when equipment was being used on site and that equipment was almost exclusively hand tools for cleanup and building/placement of a second sound/visual barrier (see Figure 10).

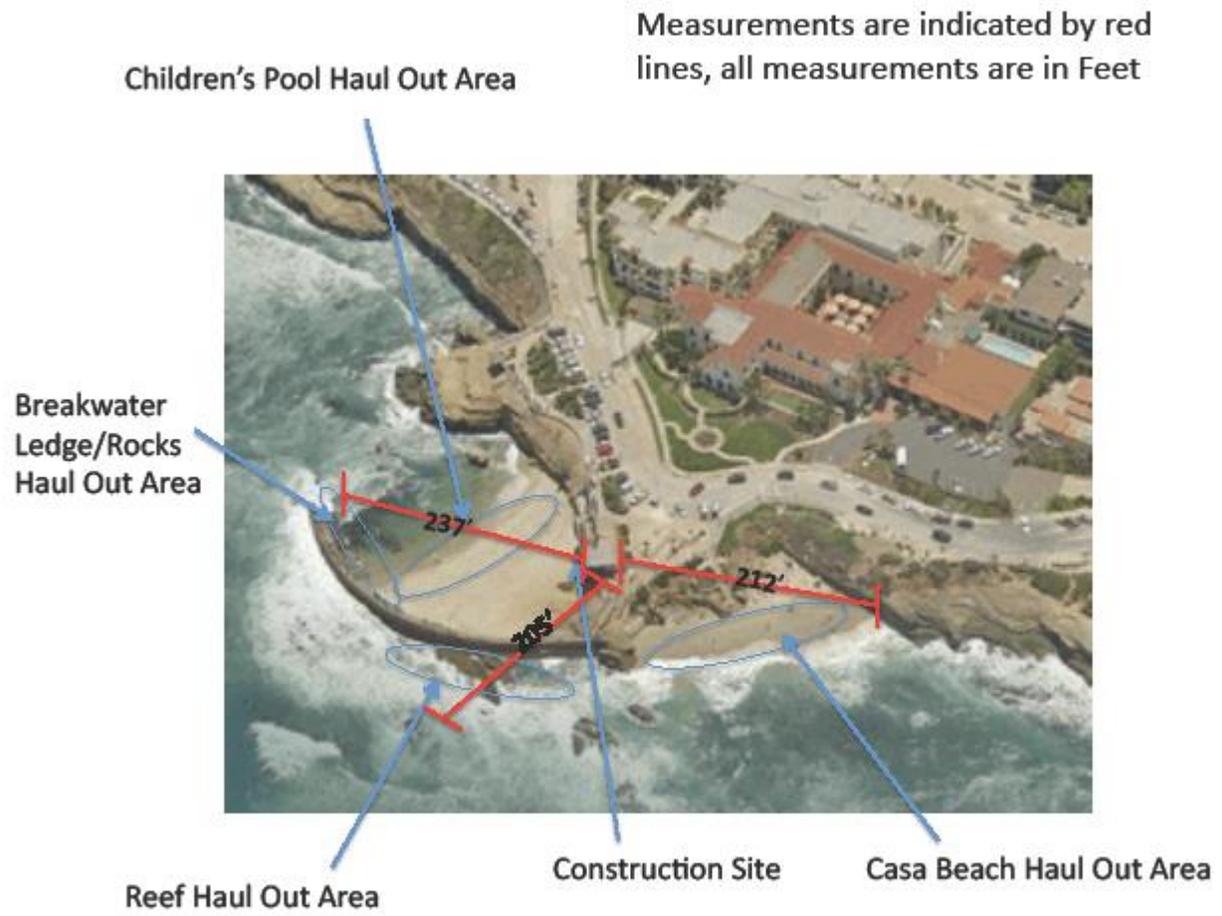
Figure 11. Children's Pool construction site and measurements away from construction site.

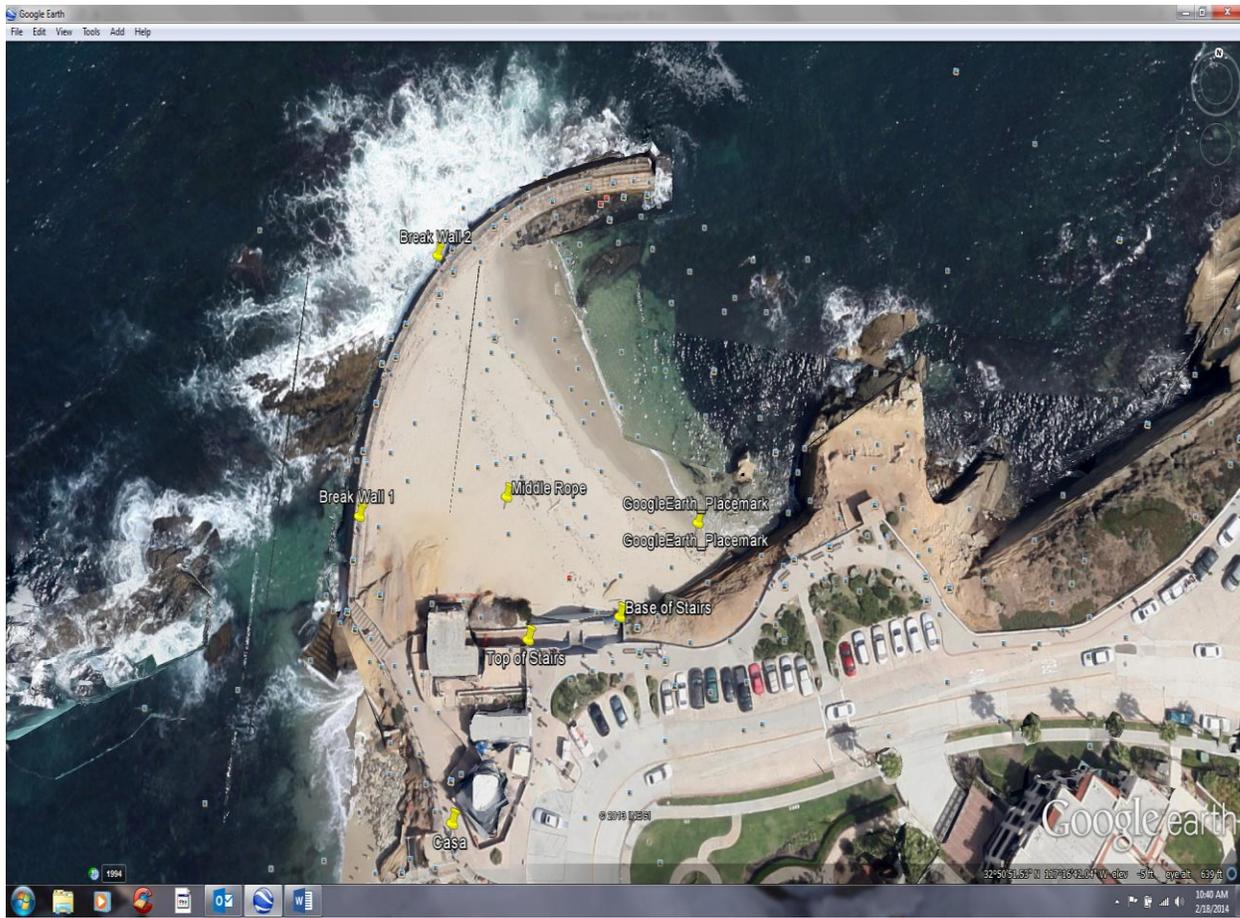
Figure 12. Location of monitoring stations (Top of Stairs, Bottom of Stairs, Middle Rope, Casa, Breakwall 1, and Breakwall 2) at Children's Pool, La Jolla, CA.

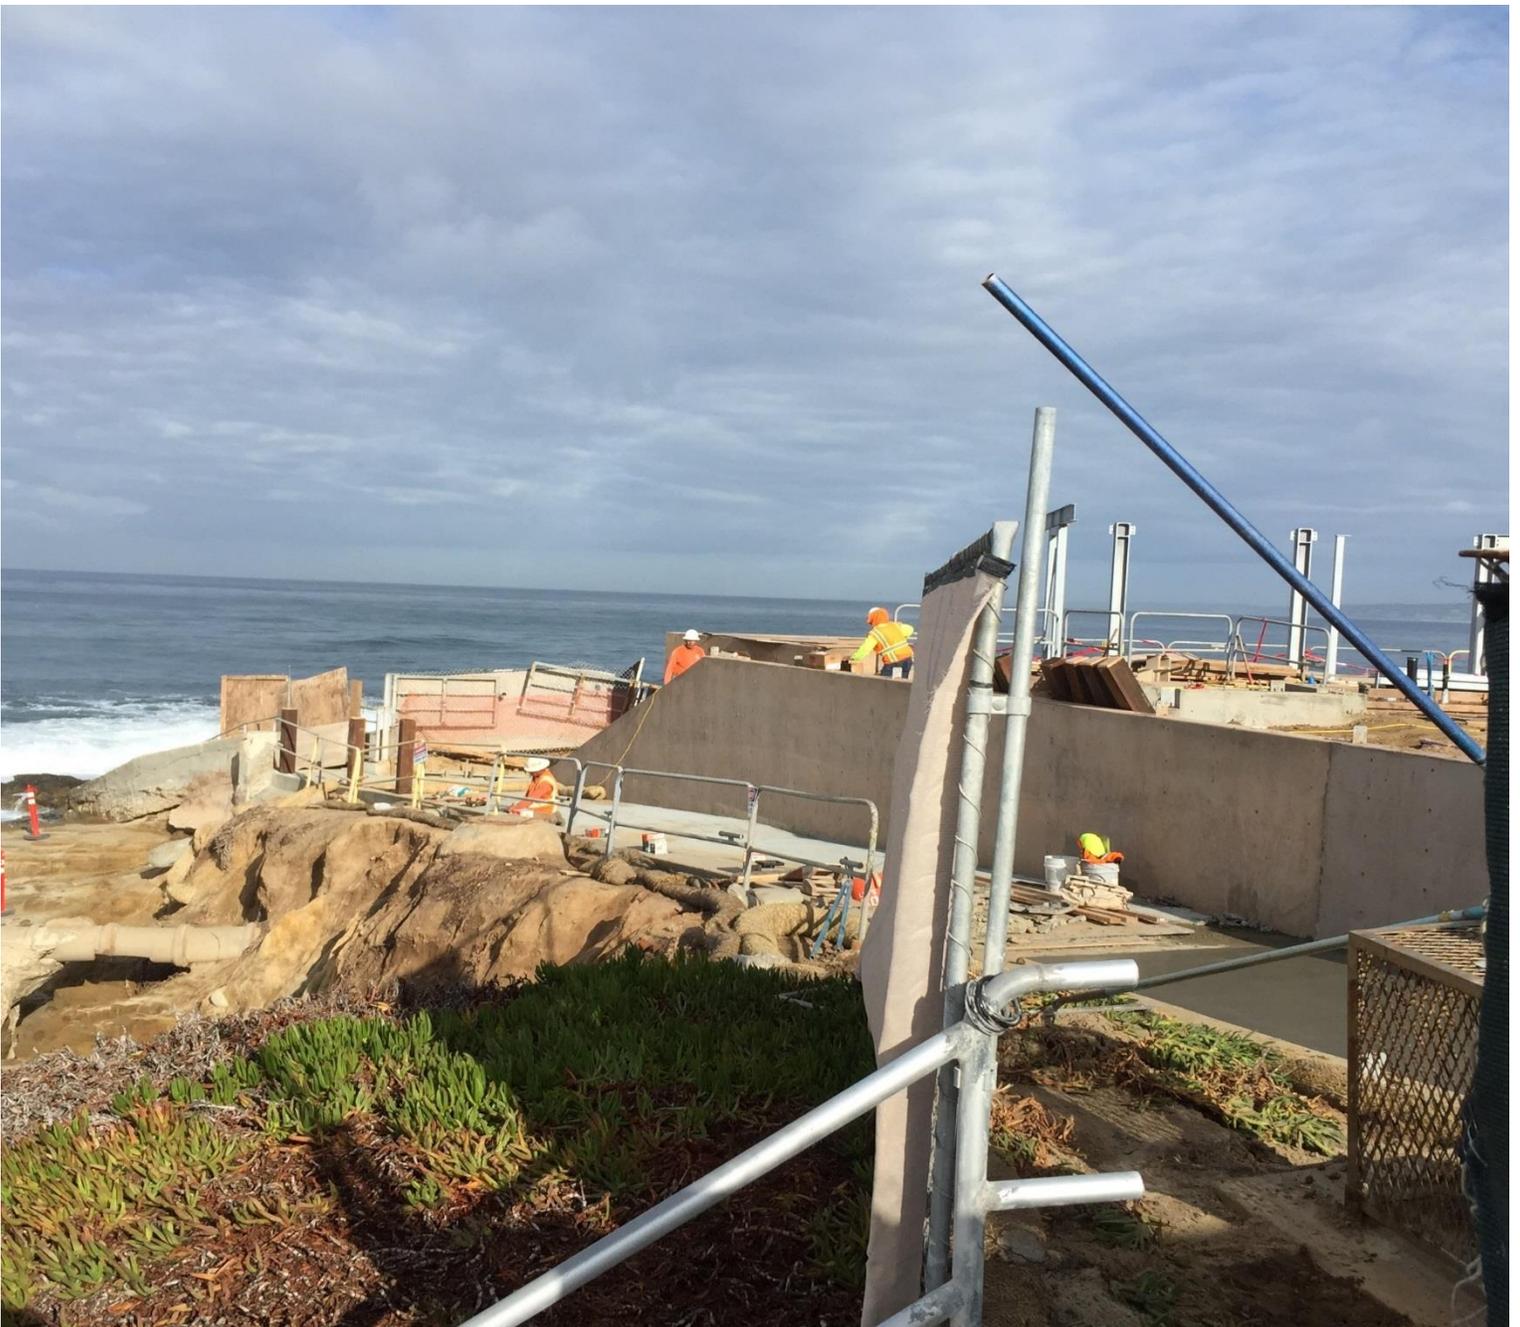
Figure 13. Monitoring location: Casa (above Casa Beach and next to construction site).

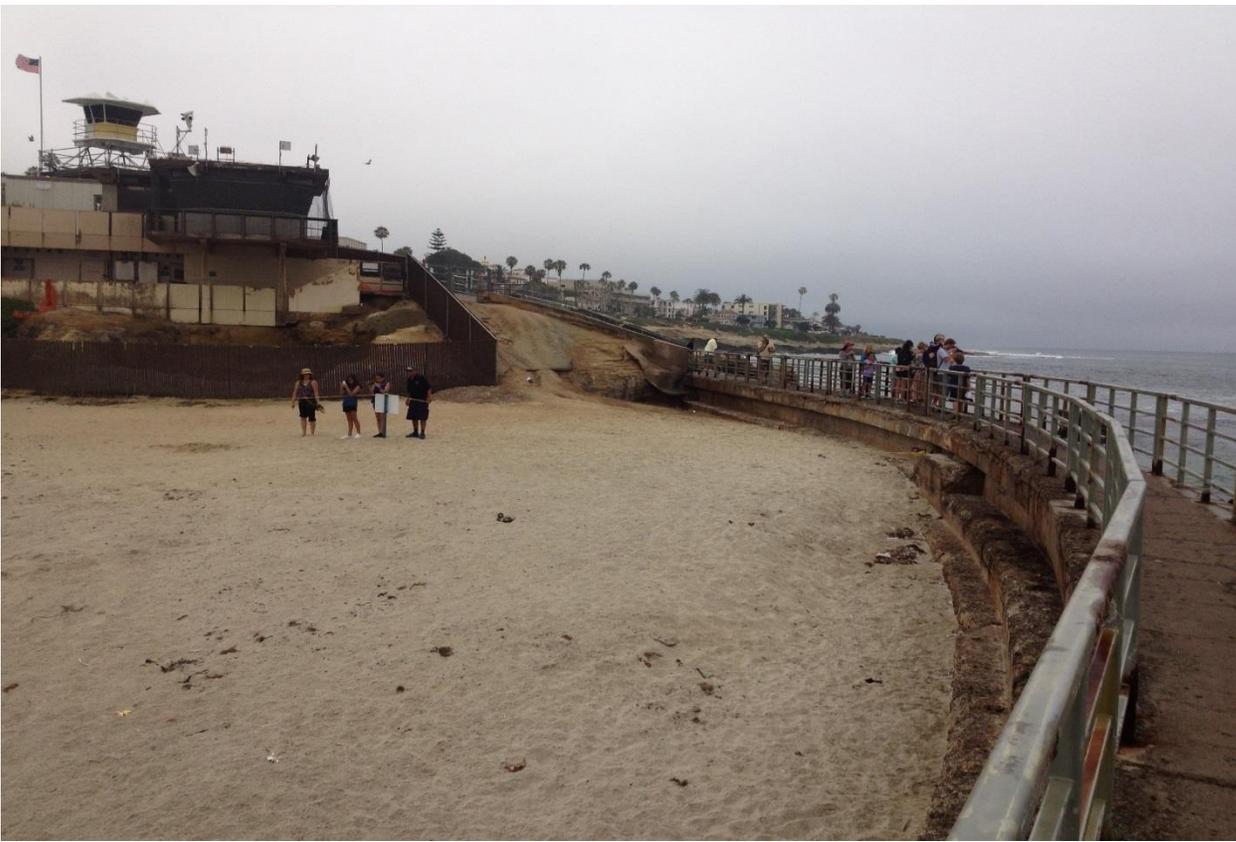
Figure 14. Monitoring location: Breakwall 2. Note Breakwall 1 located this side of second man on wall (tan shirt) and note yellow rope barrier on beach at white sign with four people standing on beach.

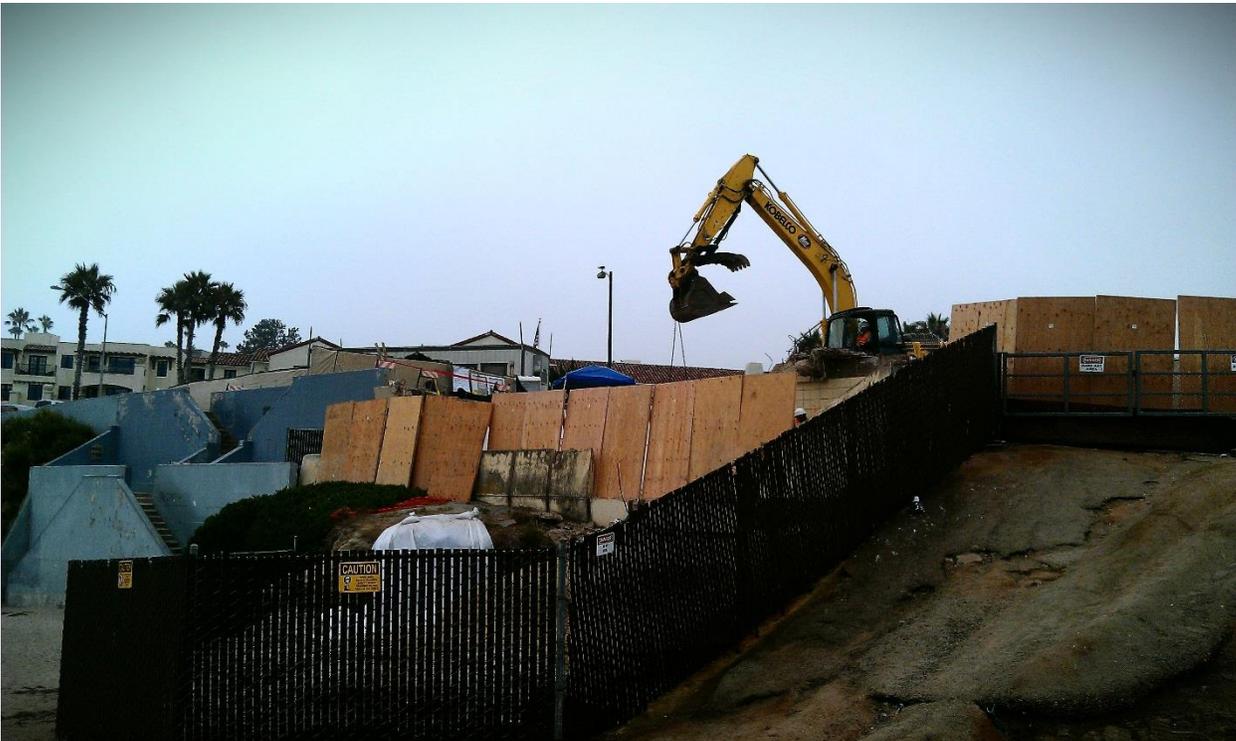
Figure 15. Moving visual/acoustic barriers to lower level of construction site after removal of old building.
