Marine Mammal Monitoring Report
**EHW-1 Pile Replacement
Project, 2015**
Naval Base Kitsap-Bangor, WA

Prepared by
Hart Crowser, Inc.

DoN 2016. Marine Mammal Monitoring Report, EHW-1 Pile Replacement Project 2015, Naval Base Kitsap-Bangor Washington. Prepared by Hart Crowser, Inc. for Naval Facilities Engineering Northwest, Silverdale, Washington. US Department of the Navy. April 2016.

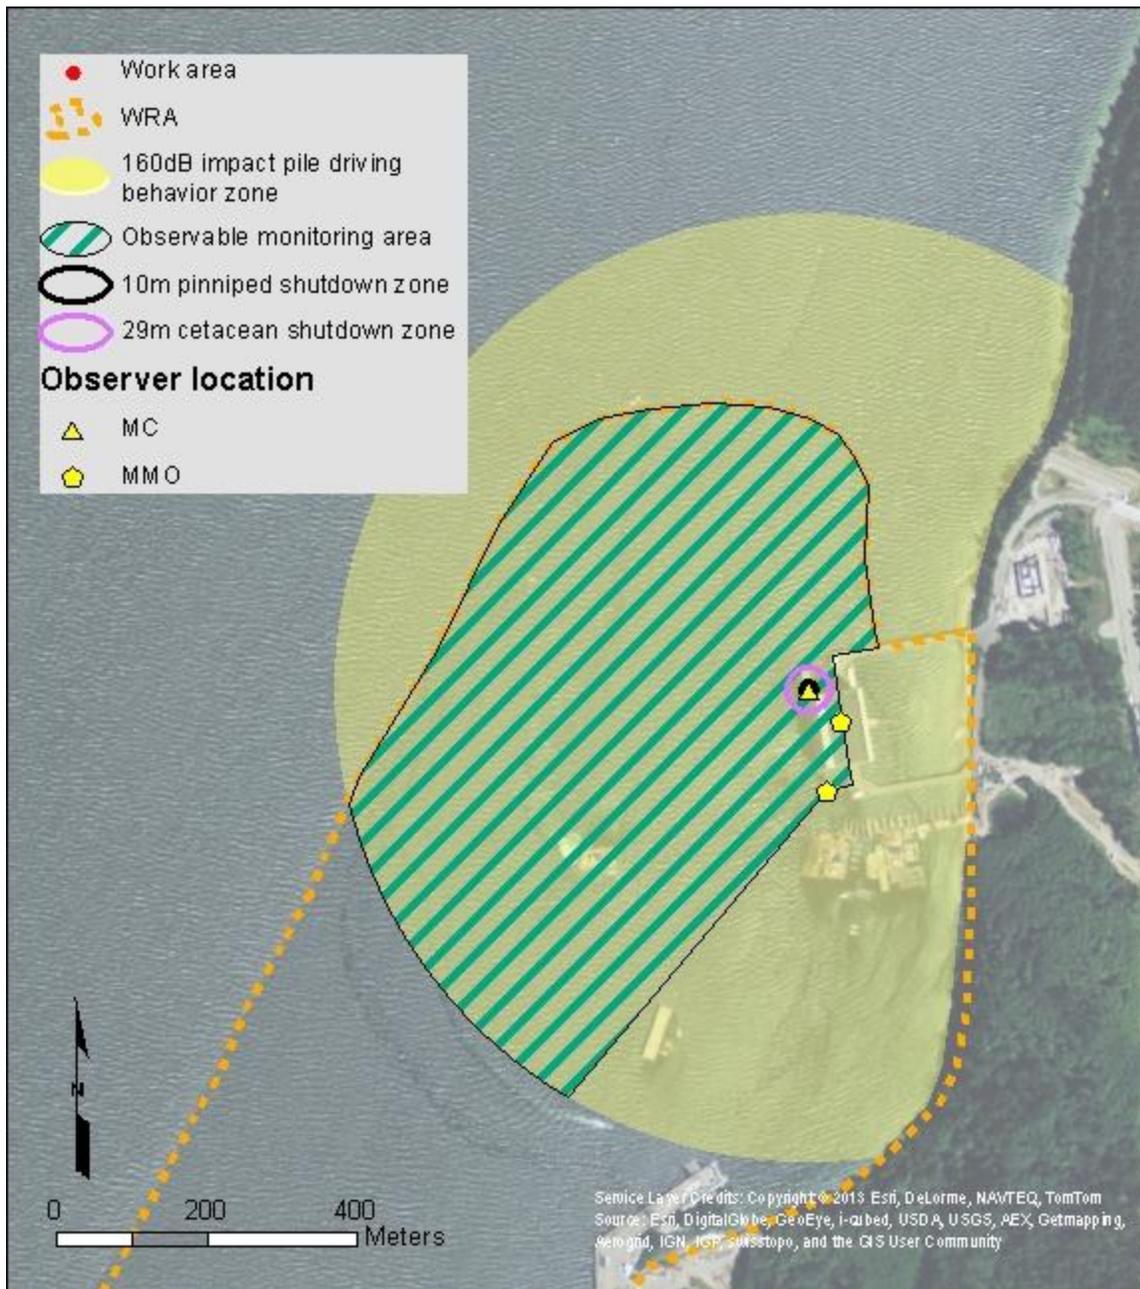
Figure 2 – EHW-1 PRP project area and observer platforms

MMOs used observation platforms on the EHW-1 pier. EHW-1 monitoring platforms were located approximately 33 to 525 ft (10 to 160 m) from the work area. Platform locations were chosen to provide the MMO with the best view of the project area, while maintaining a safe distance from construction activities. The exact location of the MMO platform was adjusted to provide complete coverage of the shutdown zone during pile driving.

The MC was positioned on EHW-1 with a view of the shutdown zone, contiguous to the work area and within 33 ft (10 m) of the pile. This monitoring platform ensured direct, line-of-sight communication with the contractor, a partial view of the shutdown zone (which was fully covered by at least one other MMO), and views of the adjacent waters. The location of the MC platform was adjusted to provide the best combination of coverage of the shutdown zone, direct communication with the pile-driver operator, and safety from overhead hazards. Pile-driving events were communicated between the foreman and MC. Pile specifications, construction activity type, and other details were transmitted by the MC to the other observers, all of whom monitored the same radio channel.

The Monitoring Plan required that MMOs be positioned at the best practicable vantage points, taking into consideration security, safety, and space limitations on the waterfront. Three monitors were land (pier)-based. The MC and one MMO were dedicated to the monitor the shutdown zone, and one MMO focused observations on the behavioral disturbance (buffer) zone (Figure 2).

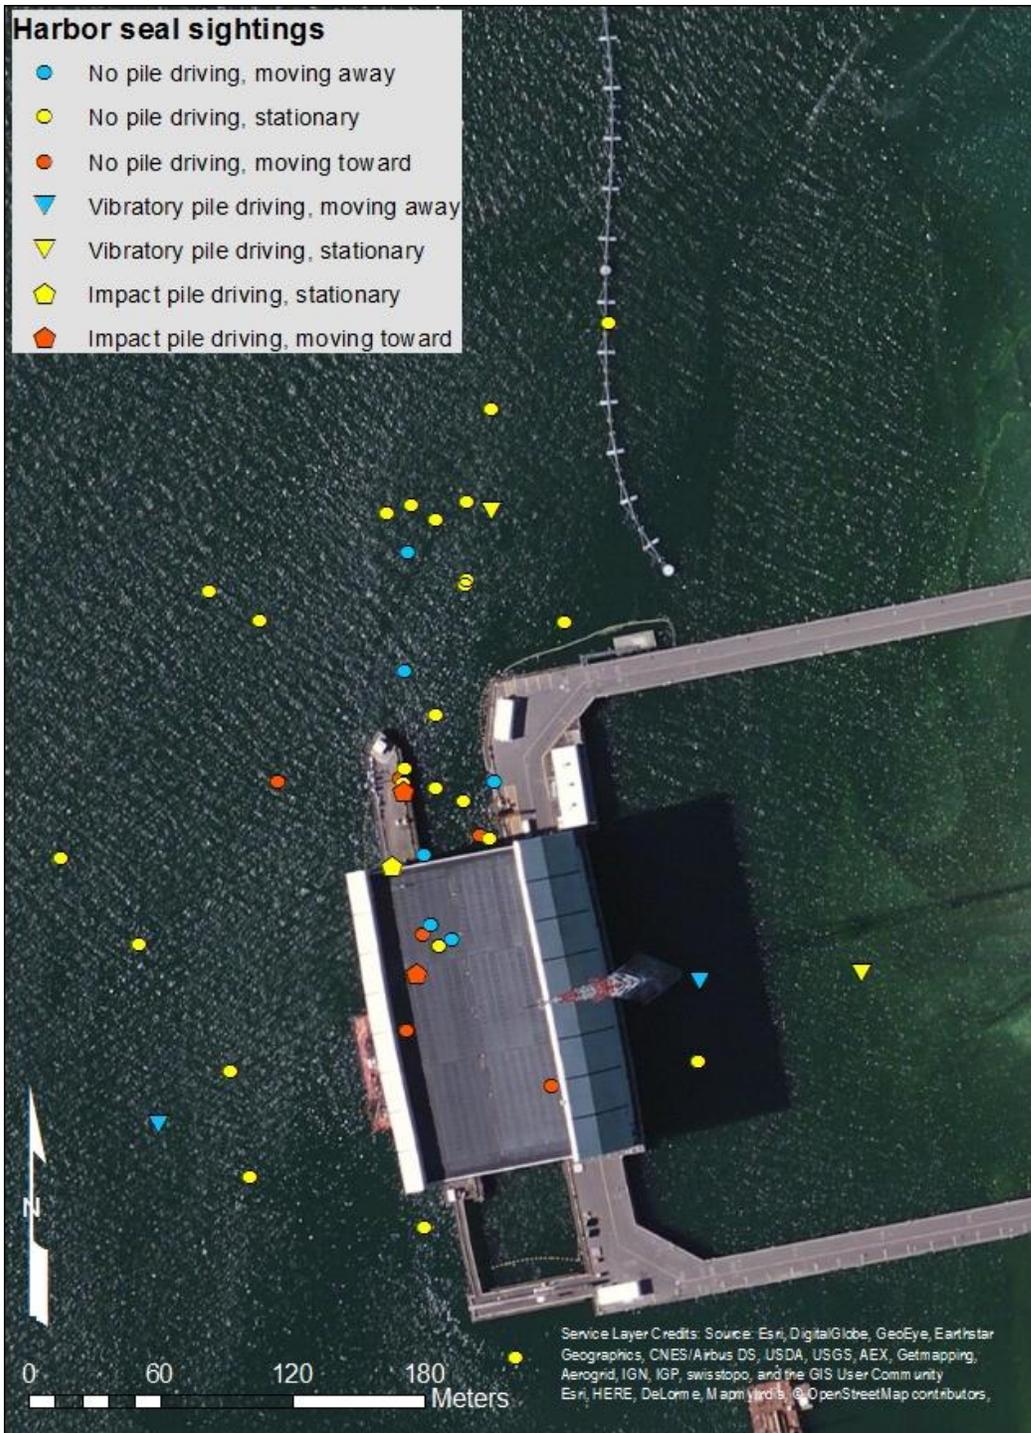
Figure 3 – 2015 EHW-1 PRP marine mammal sightings

A total of seven sightings of eight marine mammals were observed when pile driving was occurring. Of these, three harbor seal sightings (three animals) occurred during impact pile driving, and four harbor seal sightings (five animals) occurred during vibratory pile driving.

A total of 47 sightings of 57 individual animals were observed during marine mammal surveys of the 2015 EHW-1 PRP (Appendix D). A sighting could include more than one animal, which is why the total number of sightings is less than the total number of animals. Harbor seals were most commonly observed alone, but were also observed as an apparent mother-pup pair. Most harbor seal sightings occurred while the seals were in the water, but on occasion, harbor seals hauled out on the Navy's oil boom at EHW-1.

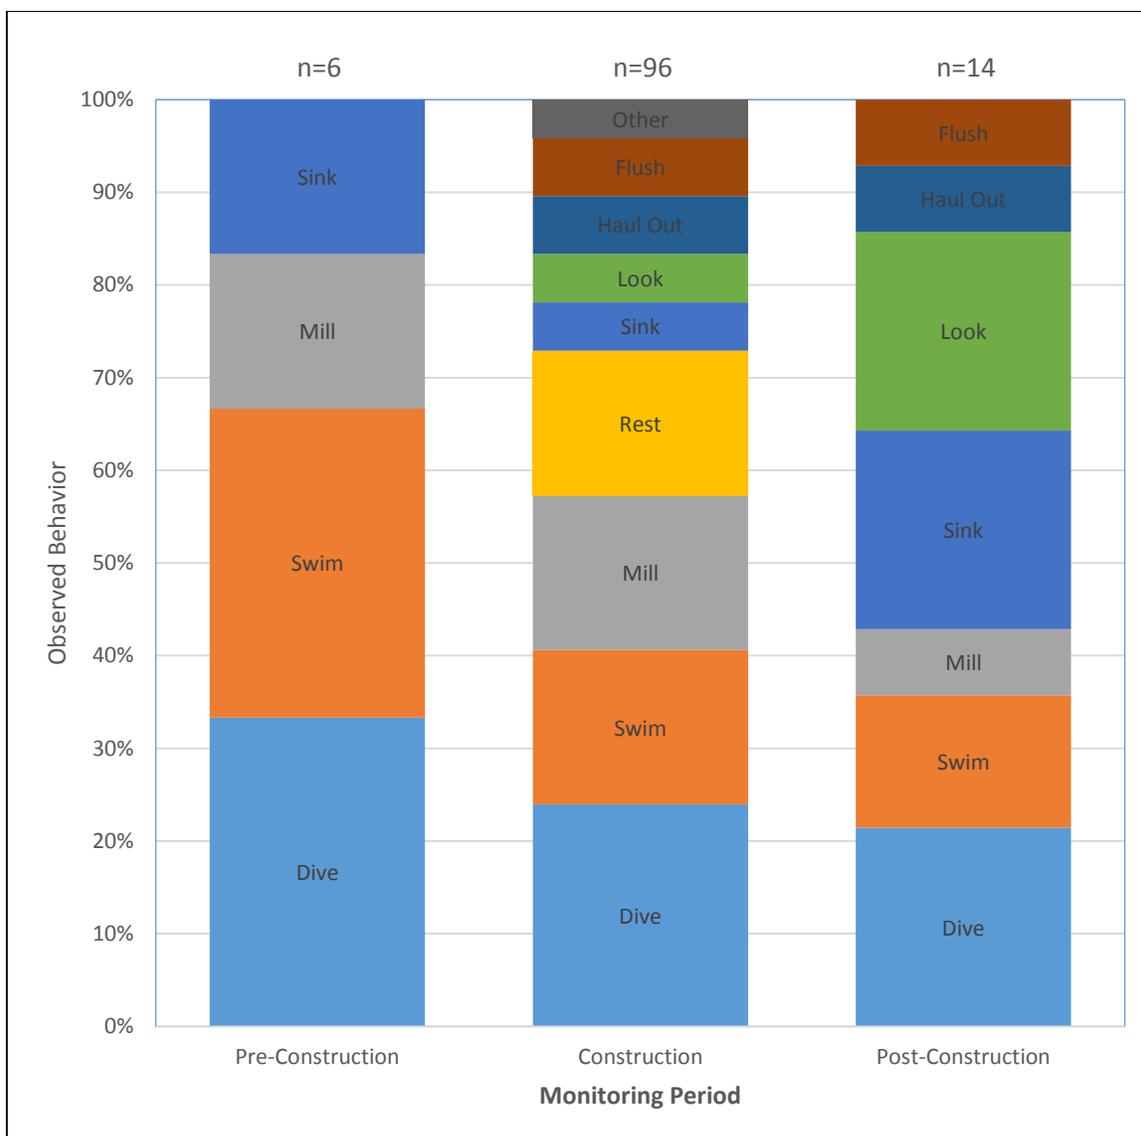
Figure 4 – Harbor seal behaviors by construction monitoring period

During pre-construction monitoring, harbor seals were most frequently observed “diving” and “swimming” (both 33%, n=2) (Figure 4). During construction, harbor seals demonstrated a greater number of behaviors including “diving” (24%, n=23), “swimming” (17%, n=16), “milling” (17%, n=16), and “resting” (16%, n=15). During post-construction monitoring, harbor seals were most commonly observed “diving,” “looking,” and “sinking” (each 21%, n=3). These behavior trends are similar to those observed during the EHW-2 CMP (DoN 2013, 2014, and 2015).

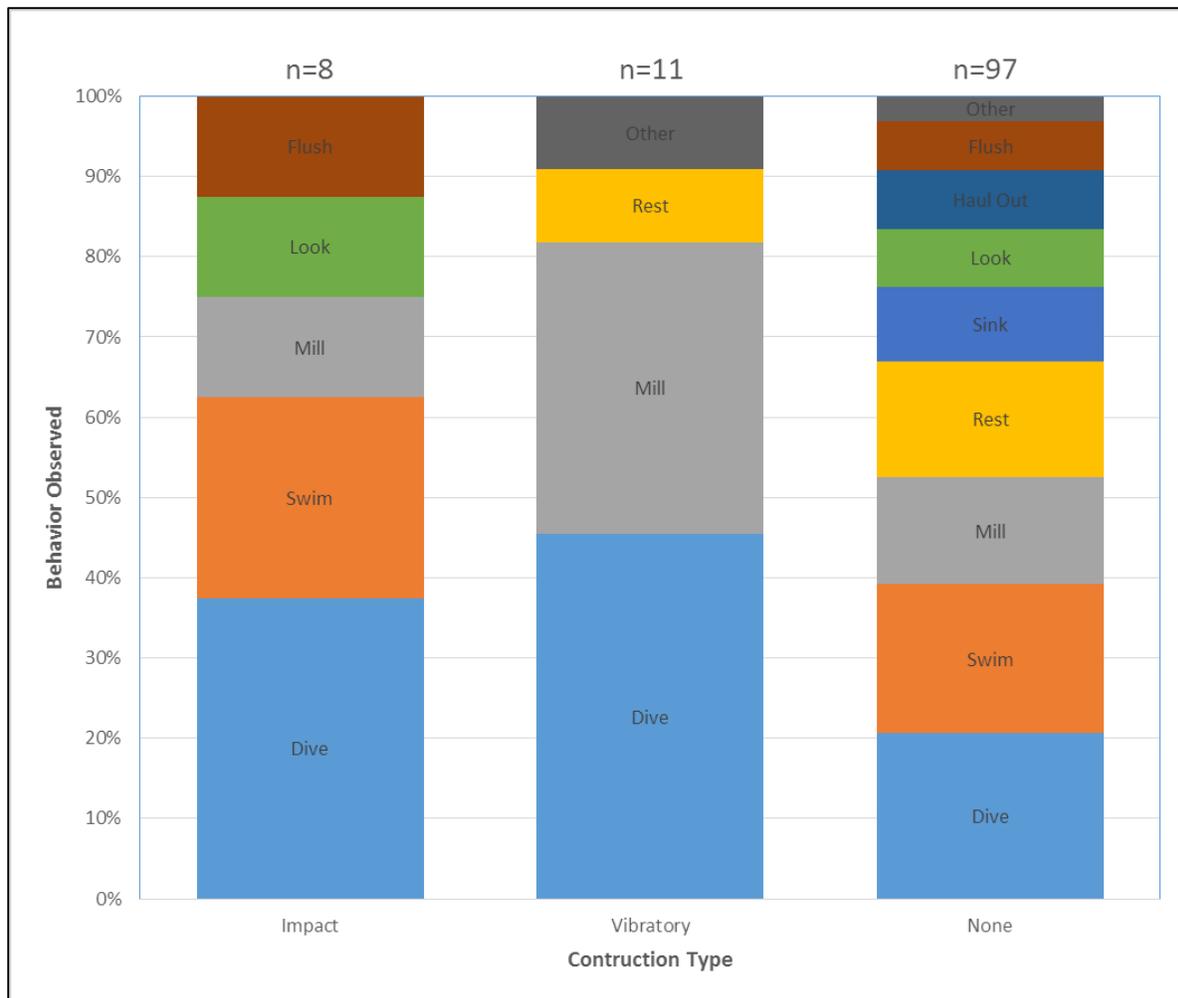
Figure 5 – Harbor seal behaviors by construction type

When analyzed by construction event type, harbor seals were frequently observed “diving” (21%, n=20), “swimming” (19%, n=18), “resting” (14%, n=14), and “milling” (n=13, 13%) during construction periods when pile driving was not occurring (labeled “None” in Figure 5). During vibratory pile driving, harbor seals were most frequently observed “diving” (45%, n=5) and “milling” (36%, n=4). During impact pile driving, harbor seals were most frequently observed “diving” (38%, n=3) and “swimming” (25%, n=2). These behavior trends are also similar to those observed during the EHW-2 CMP (DoN 2013, 2014, and 2015).

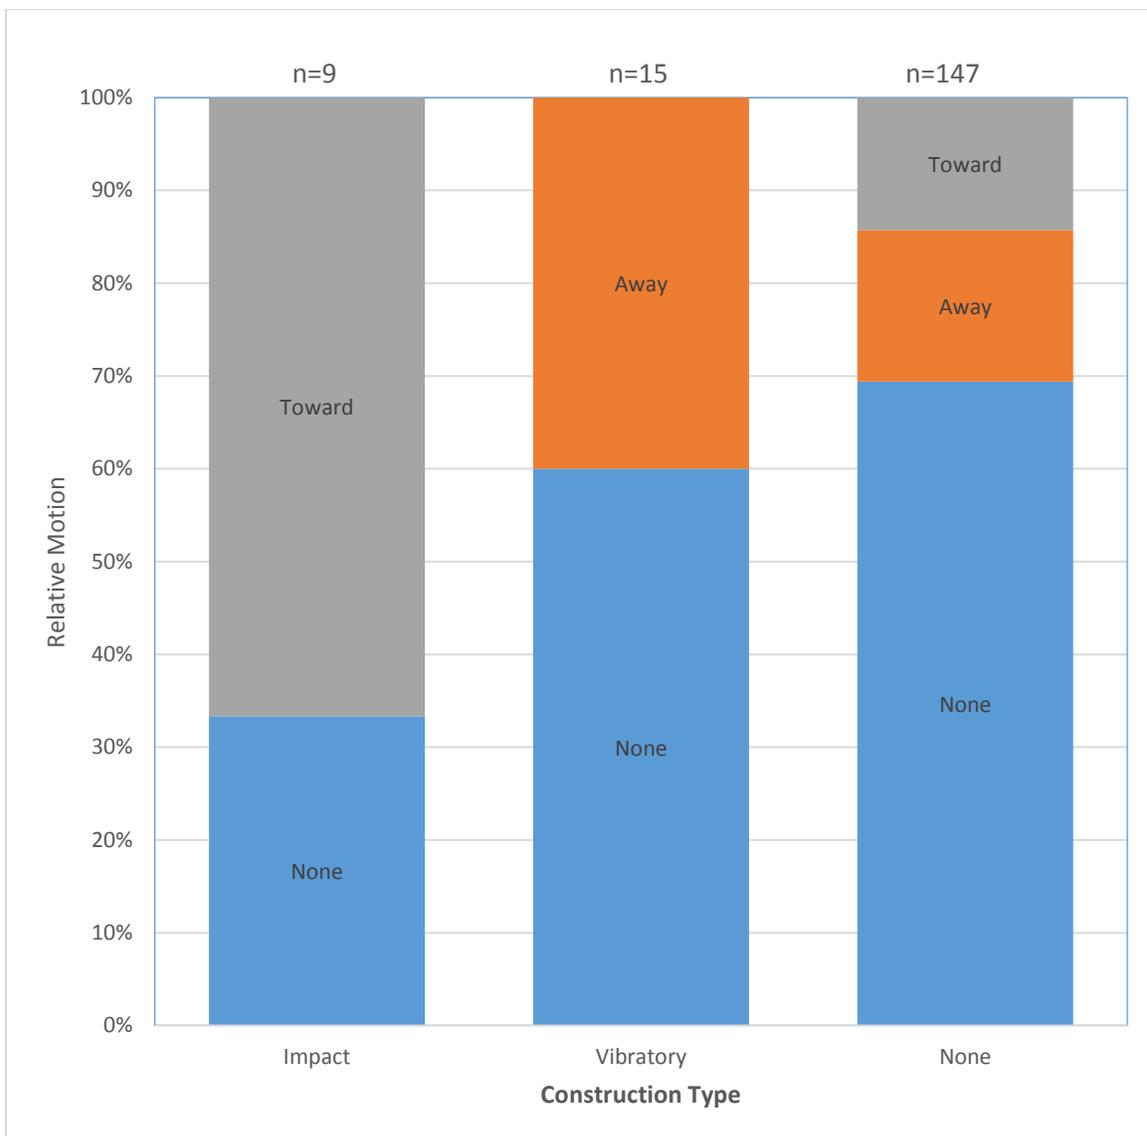
Figure 6 – Harbor seal relative motion by construction type

Because animals moving away from the construction area could indicate avoidance behaviors, the relative motion of observed animals was analyzed. During periods of no pile driving, marine mammals were most frequently observed having no relative motion to the construction area (69%, n=102; Figure 6). During vibratory pile driving, marine mammals were most frequently observed having no relative motion (60%, n=9), and were not observed moving toward the pile. A decrease in the number of animals moving toward the pile during vibratory pile driving was also observed during the EHW-2 CMP (DoN 2013, 2014, and 2015). During impact driving events, animals were observed moving toward the pile (66%, n=6) or with no relative motion (33%, n=3).

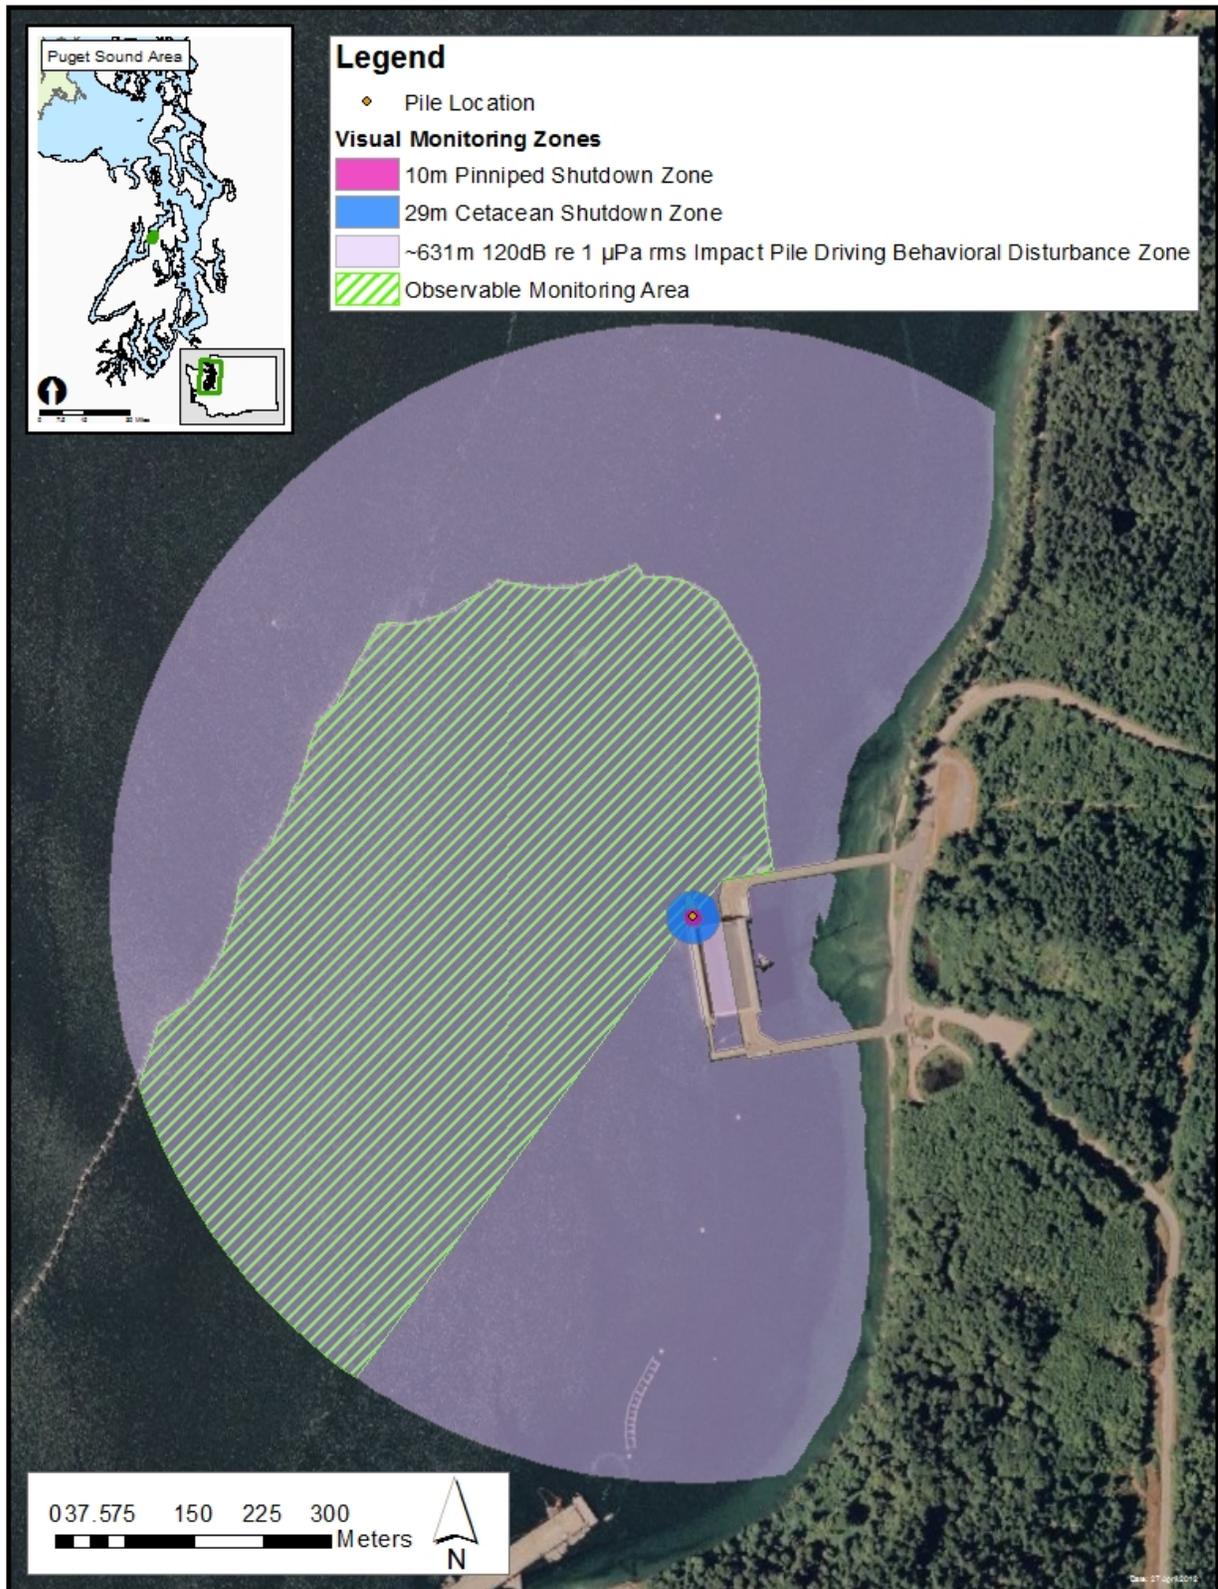
Figure 2-1. Visual Marine Mammal Monitoring Zone with Representative Monitoring Locations Shown.

The 631m behavioral zone for impact pile driving is the distance noise levels are estimated to be at or above 160 dB re 1 μ Pa Level B behavioral threshold (Figure 2-1). A larger Level B behavioral zone, estimated to extend 6.3 km during vibratory pile driving is also present. Because monitoring these two large zones is not practicable, a smaller monitoring zone depicted in Figure 2-1 will be monitored. This zone is based on visibility at the project site. Visibility is effectively limited within the Level B zones by the Port Security Barrier (PSB)

To preclude injury to pinnipeds, a 10 meter radius Shutdown Zone from a pile will be implemented during pile driving. The 10 m Shutdown Zone is based on encompassing the distance to the 190 dB RMS re 1 μ Pa impact pile driving injury zone (calculated at 6 m for pinnipeds). To preclude injury to cetaceans, a 29 meter radius Shutdown Zone will be implemented while pile driving is conducted. This zone is within the Waterfront Restricted Area (WRA) where cetaceans have never been observed.
