**RUSSIAN RIVER ESTUARY OUTLET CHANNEL
ADAPTIVE MANAGEMENT PLAN
2015**

Sonoma County Water Agency

ESA

May 15, 2015

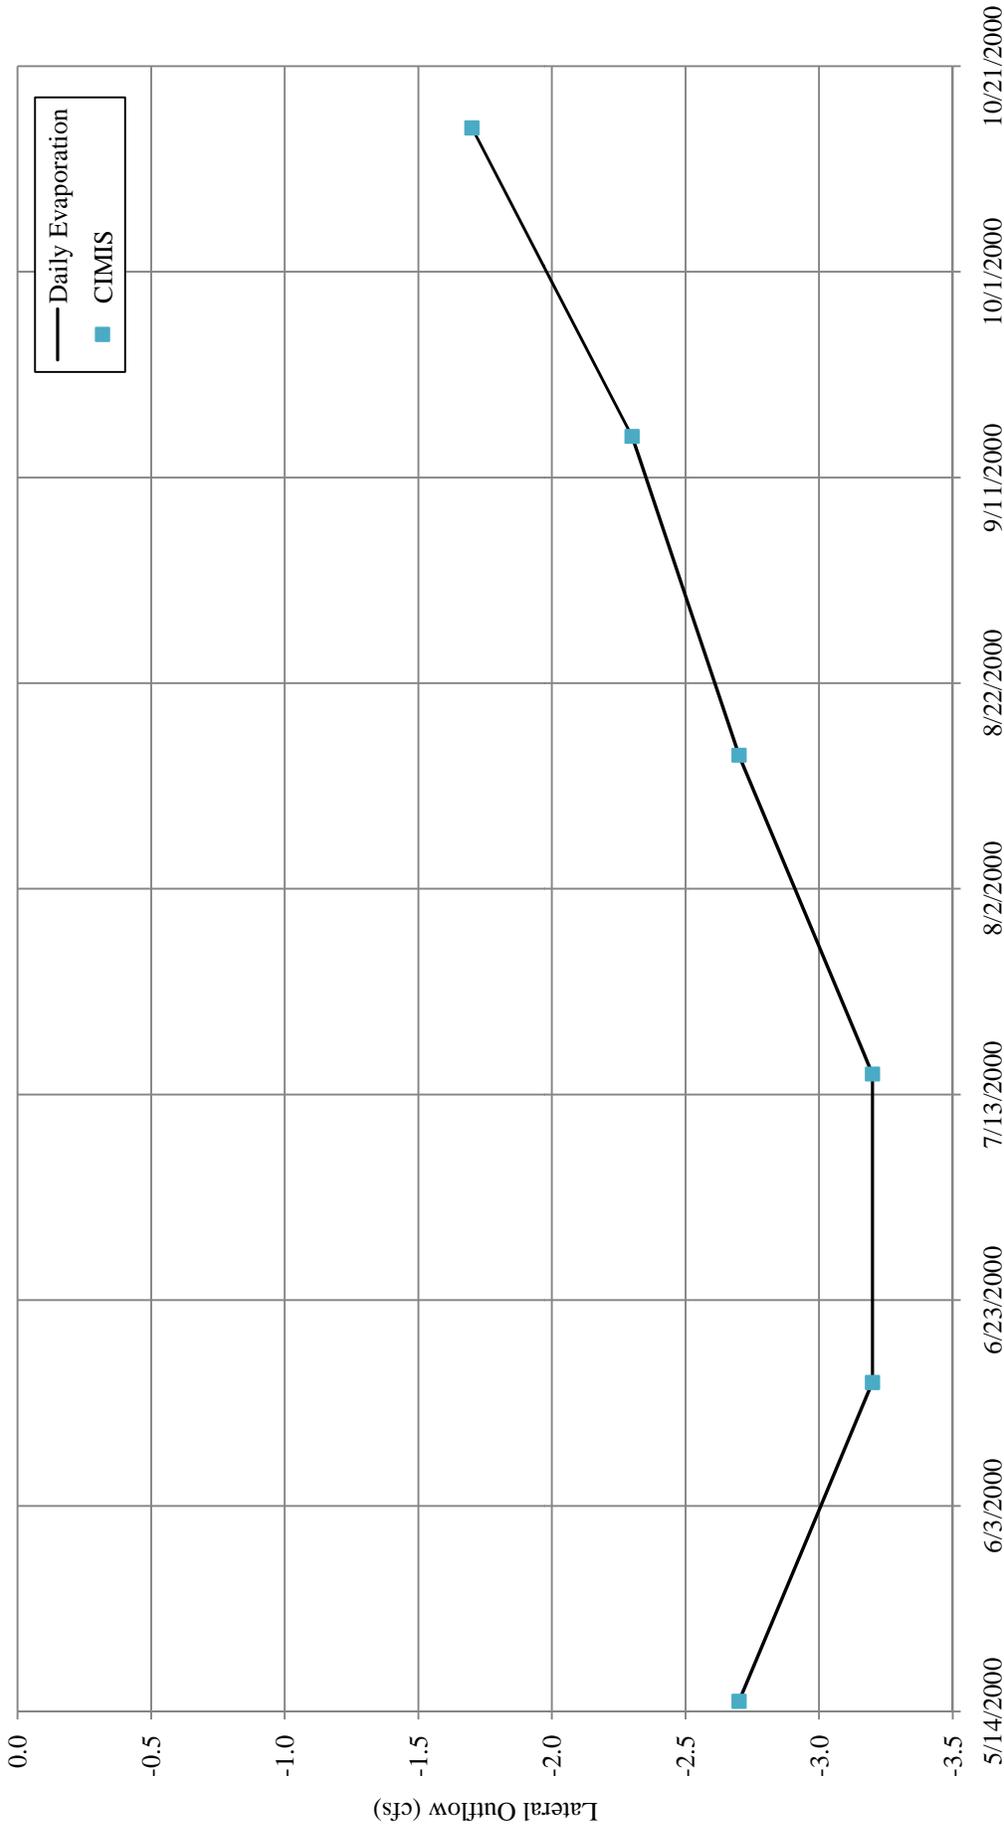
Appendix A-3
Russian River Estuary Outlet Channel Management Plan

Notes: Daily evaporation rates for Russian River lagoon interpolated from CIMIS average monthly evapotranspiration statistics for Zone 1 (Coastal plains and heavy fog). Calculations assume lagoon surface area of 500 acres.

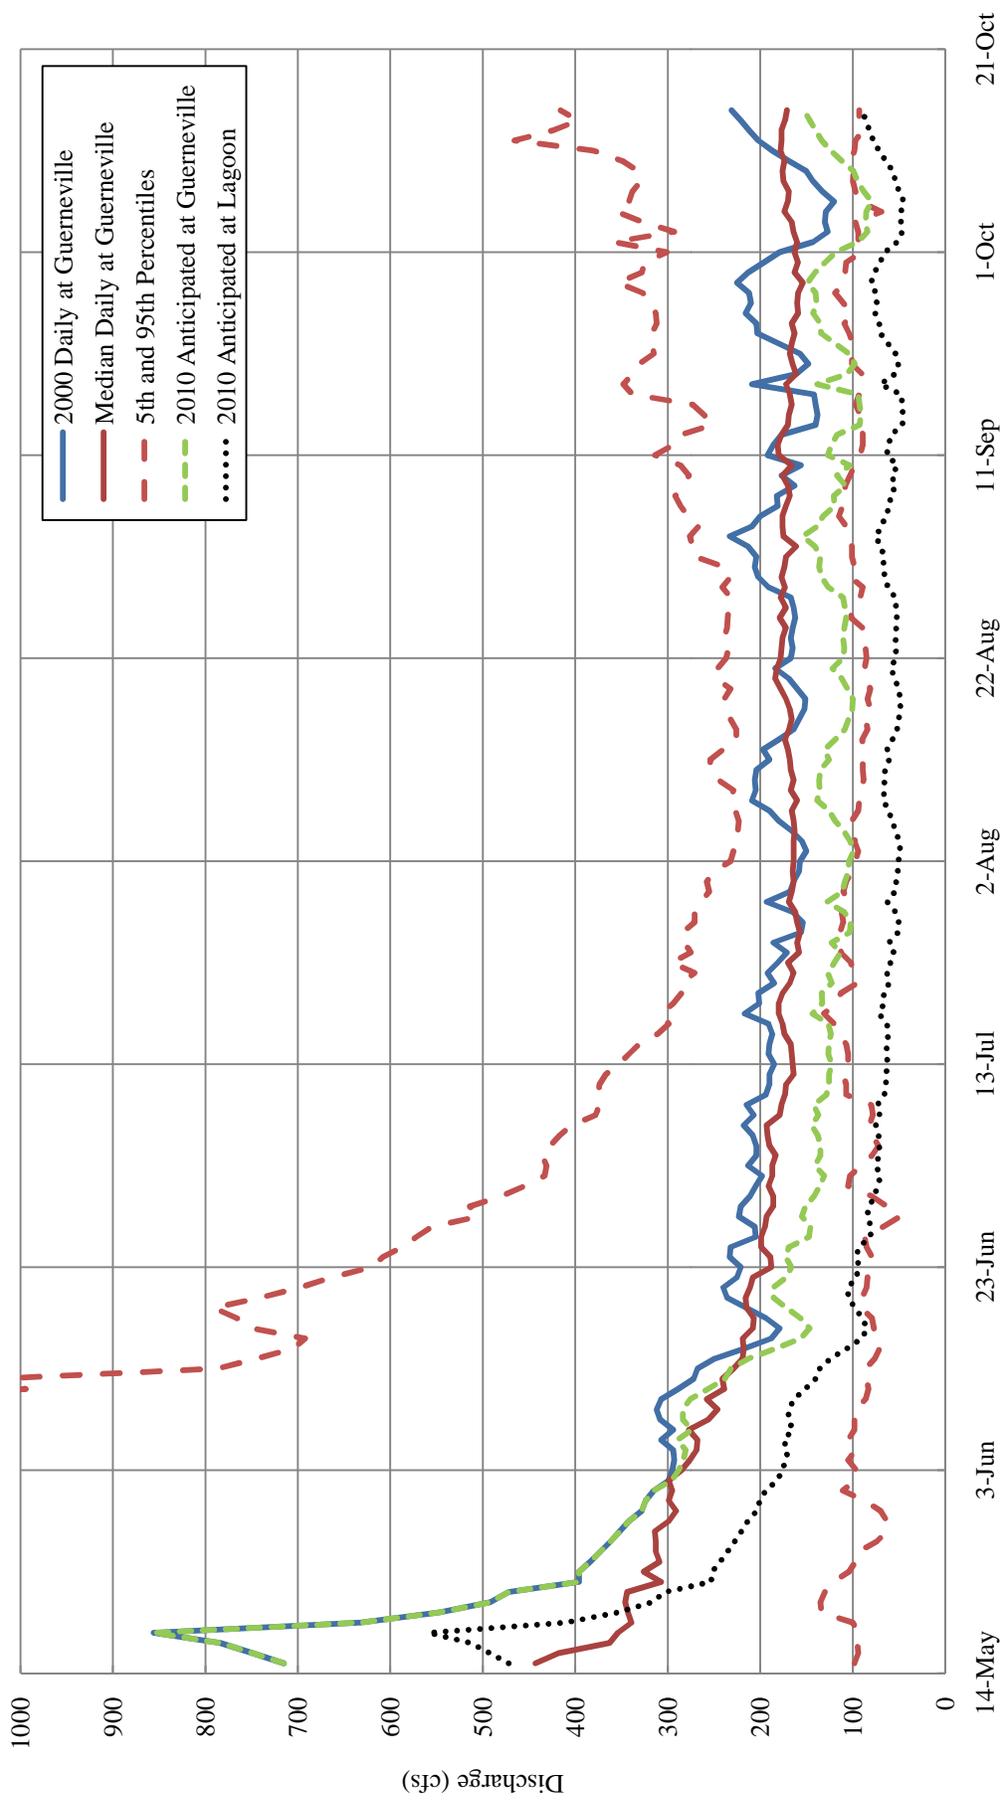
Appendix A-6
 Russian River Estuary Outlet Channel Management Plan

Notes: Median daily discharge calculated from 1970-2008.
 Source: USGS gage 11467000 (Russian River near Guerneville, CA). 2010 anticipated discharge at Guerneville calculated from 2000 discharge by scaling factor to obtain typical summertime flowrates of 120 cfs. 2010 anticipated lagoon inflow calculated based on calibrated seasonal losses from Guerneville to lagoon.

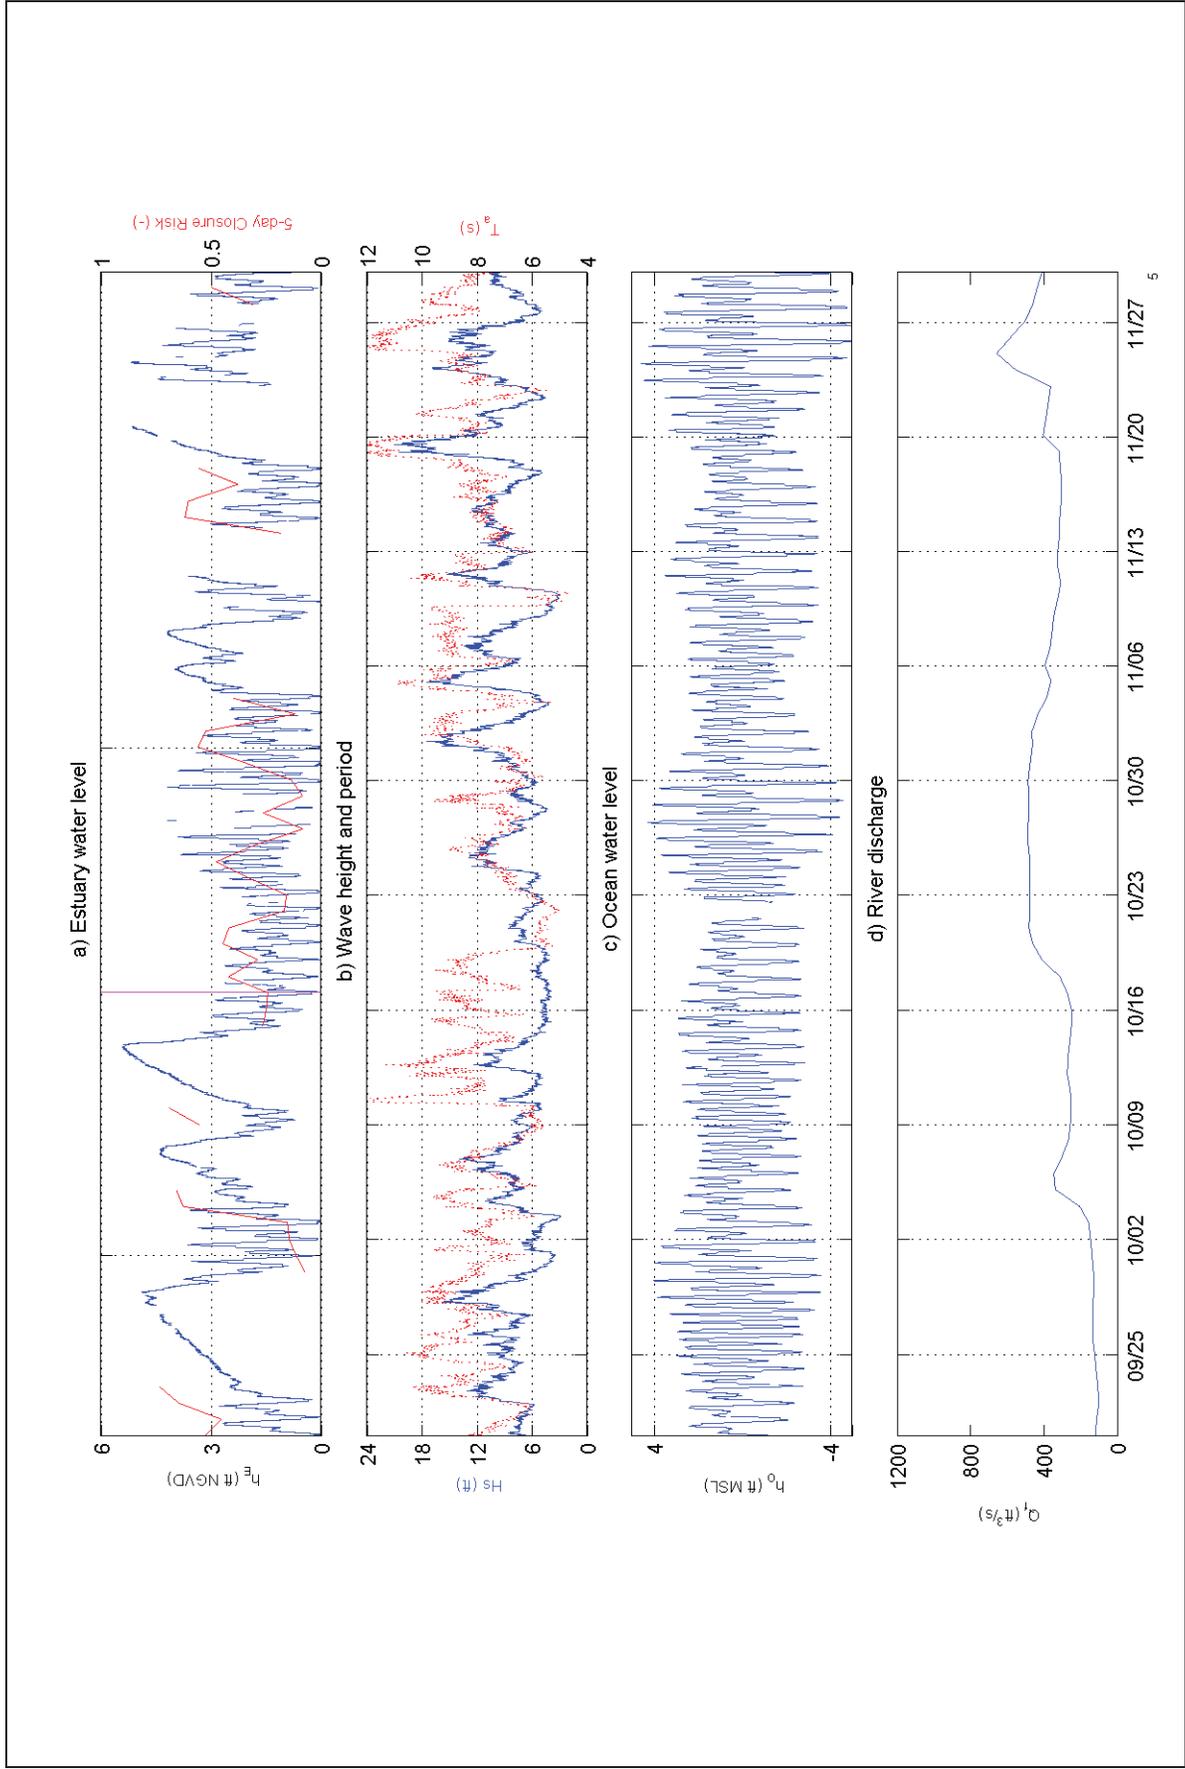
Figure 2
Estuary, Ocean, and River Conditions
September - November 2011

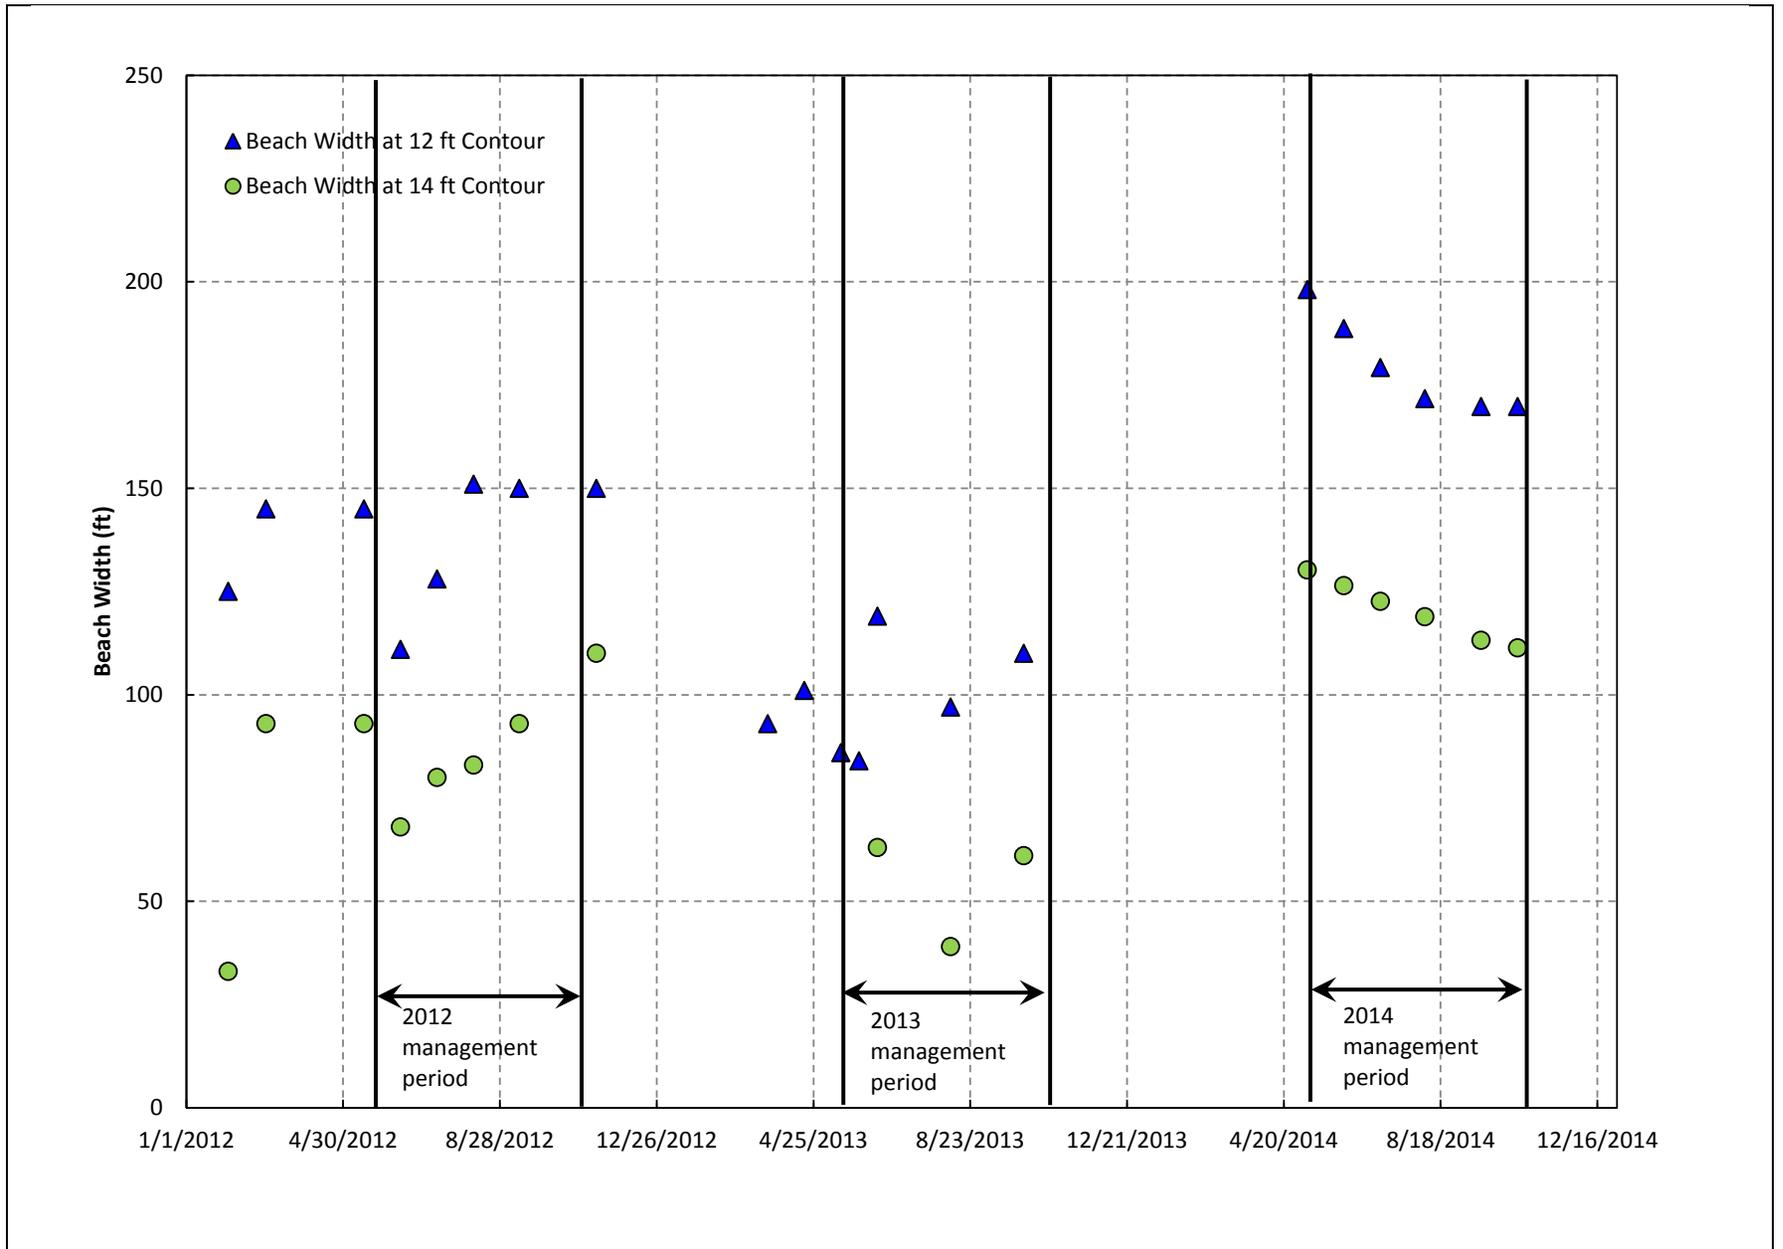
Figure 12
Beach Width During 2012-2014 Management Periods.
